**TUSCARORA LAKE DAM**

(NDI I.D. PA-0049  
DER I.D. 058-027)

~~OWNER: JAYNE'S ORCHARDS~~  
Susquehanna River Basin, Tuscarora  
Creek, Susquehanna County, Pennsylvania.  
PHASE I INSPECTION REPORT

PHASE I REPORT  
NATIONAL DAM INSPECTION PROGRAM  
TUSCARORA LAKE DAM  
NDI I.D. PA-0049  
DER I.D. 058-027

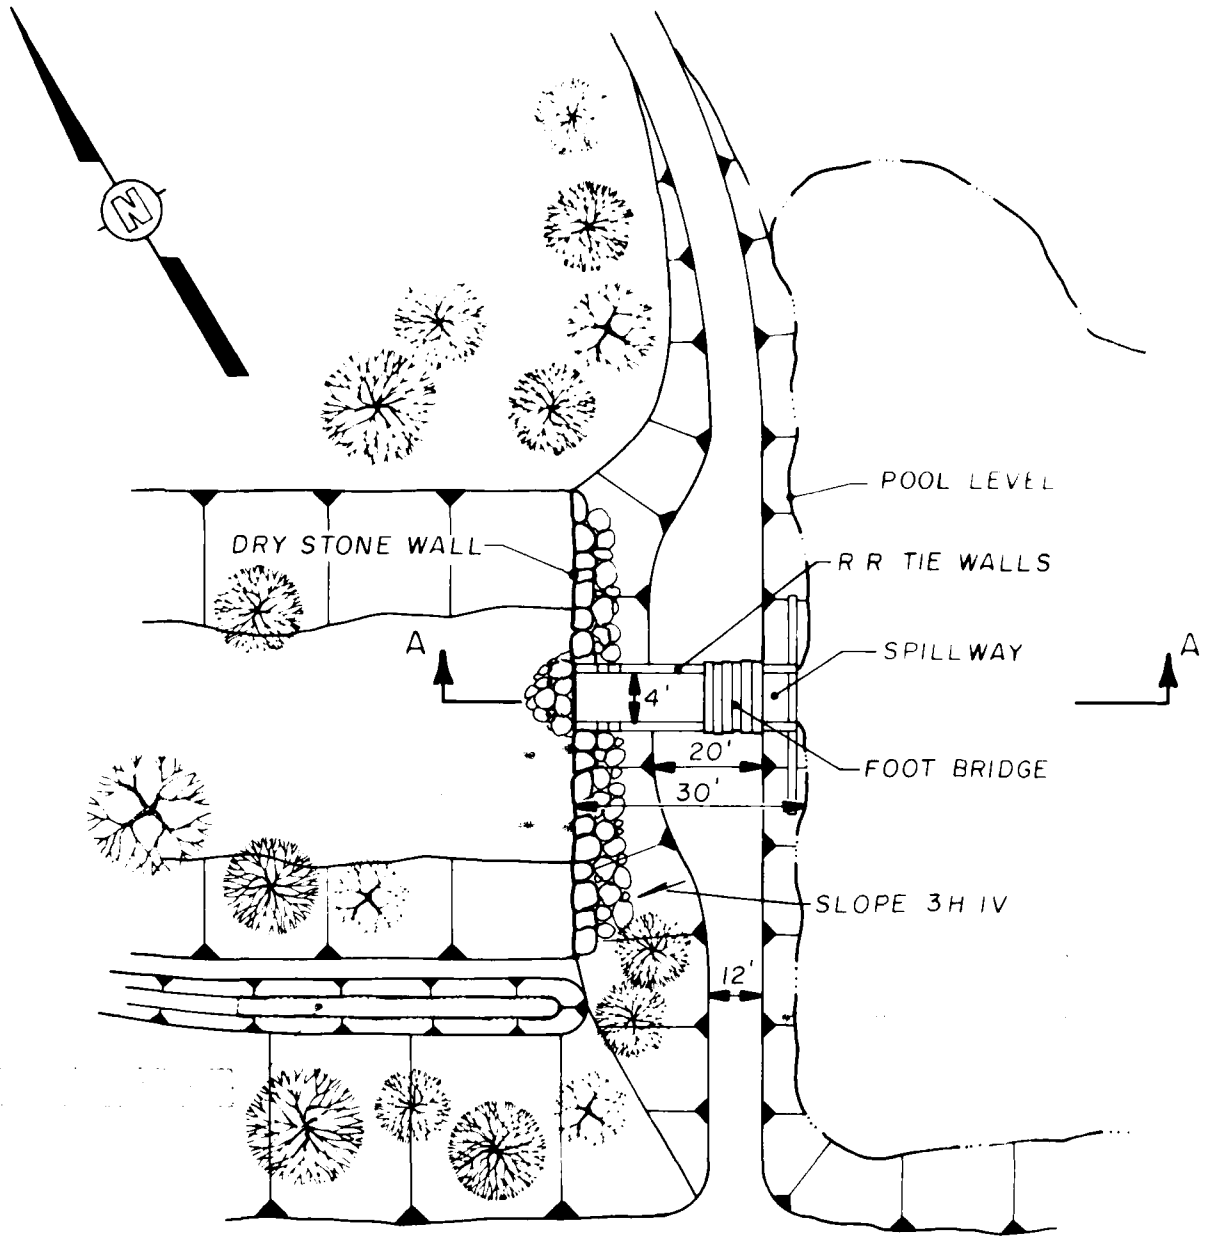
The specific observations are illustrated in Plate 2.

VISUAL EXAMINATION OF	OBSERVATIONS	REMARKS OR RECOMMENDATIONS
JUNCTION OF EMBANKMENT AND ABUTMENT, SPILLWAY AND DAM	No problems observed.	
ANY NOTICEABLE SEEPAGE	Seepage under the dam was observed along the downstream toe. See Plate 2 for seepage location.	
STAFF GAGE AND RECORDER	None	
DRAINS	None

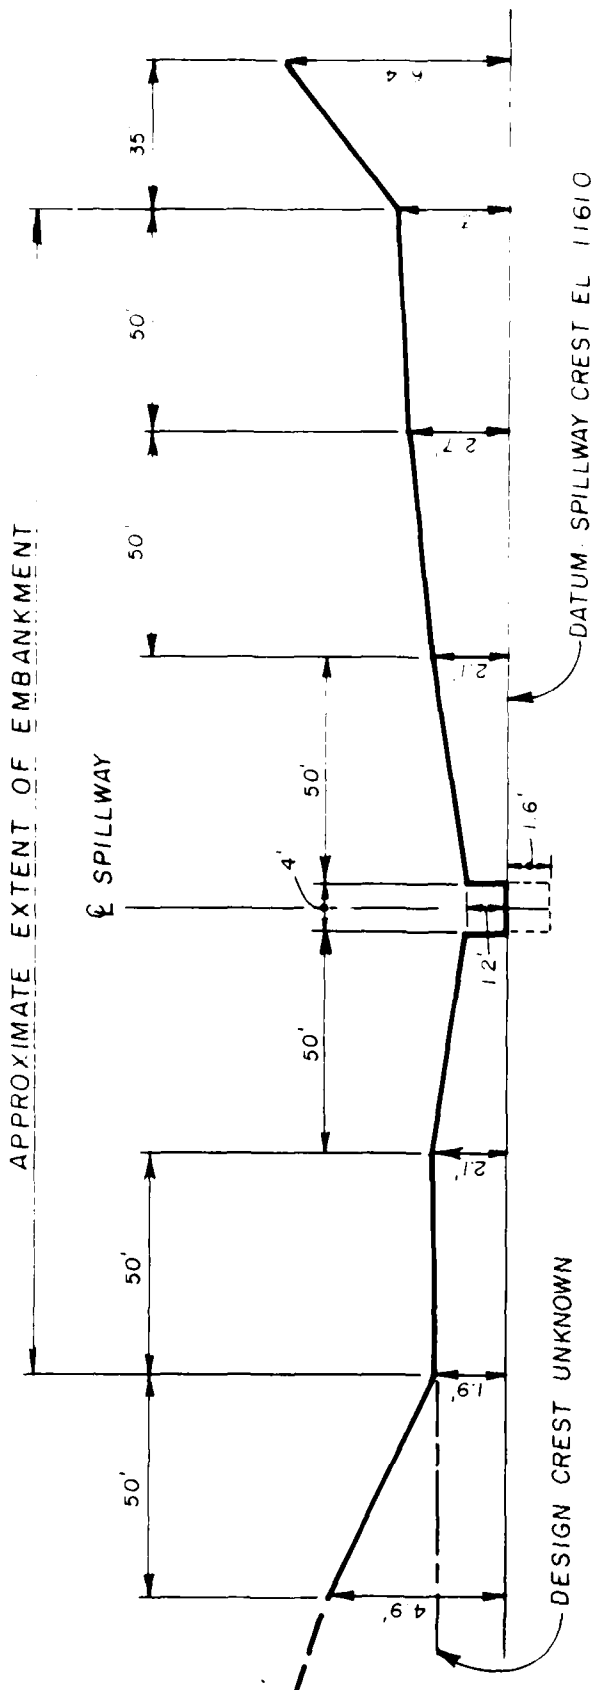
**DAM CREST PROFILE**  
(LOOKING DOWNSTREAM)

The crest of the dam was surveyed relative to the spillway crest elevation, and the crest profile is illustrated in Plate 3. A 30- to 50-foot section of the embankment on each side of the spillway was found to be lower than the remaining portions of the dam.
