National Dam Inspection Program

**BIG ELK LAKE DAM**

(NDI I.D. PA-0056)

~~OWNER: MR. EDGAR SAUER~~  
Susquehanna River Basin, Elk Lake  
Stream, Susquehanna County, Pennsylvania  
PHASE I INSPECTION REPORT

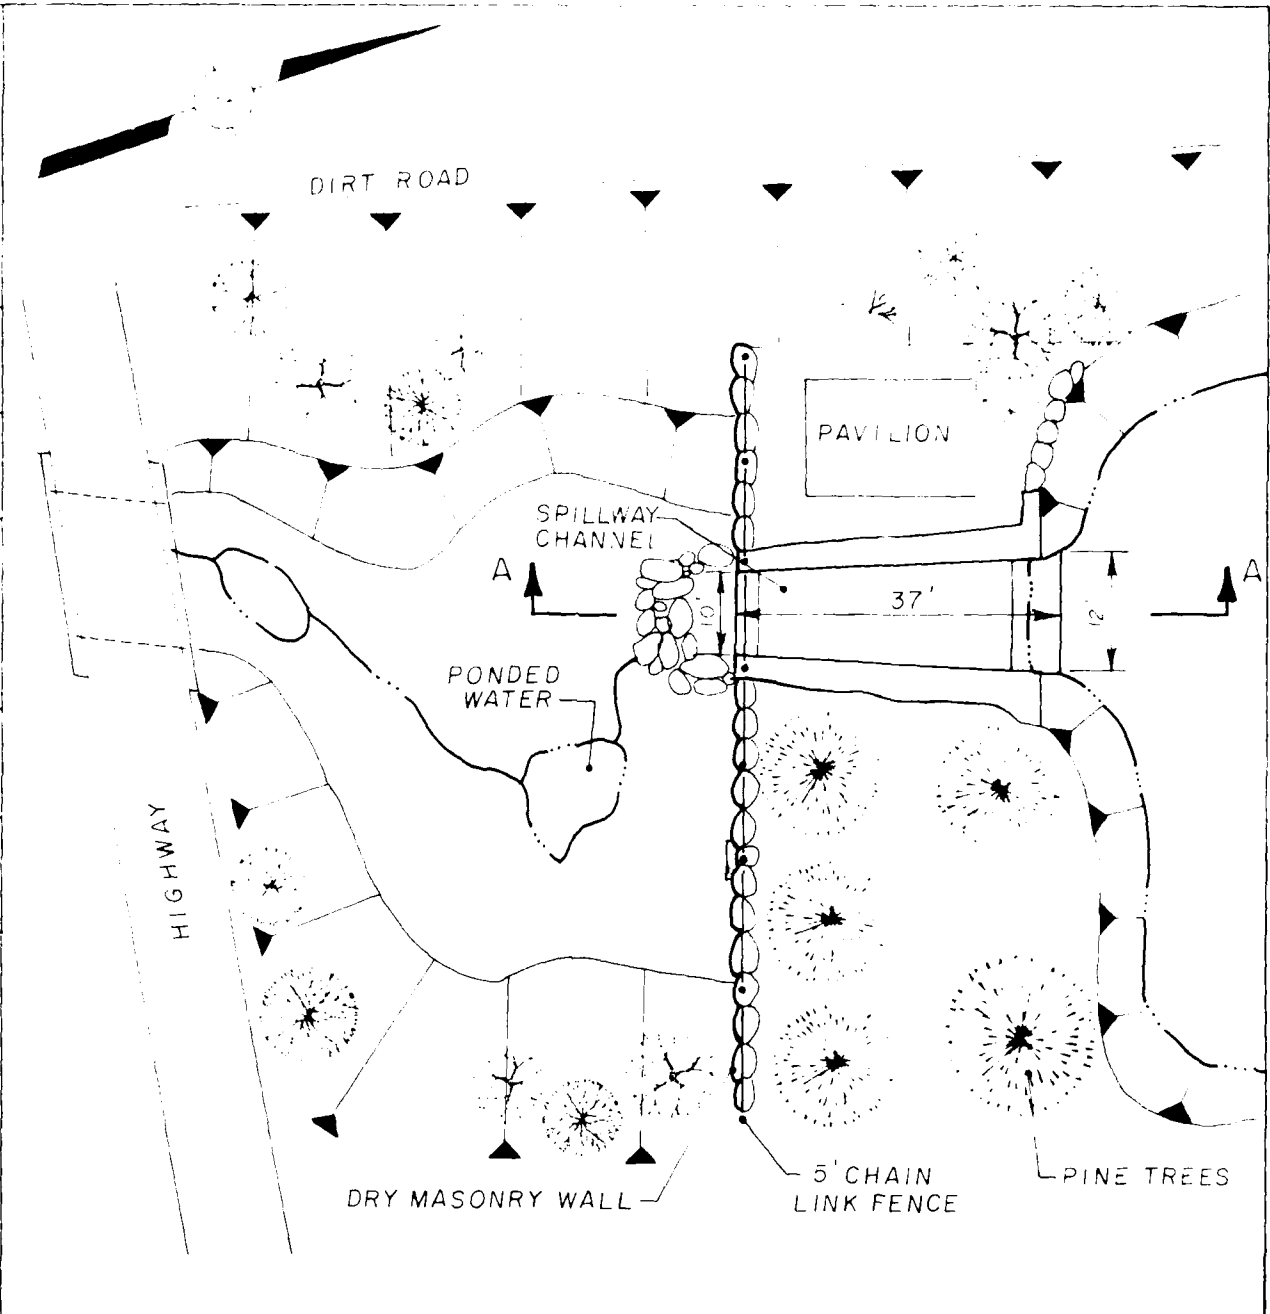
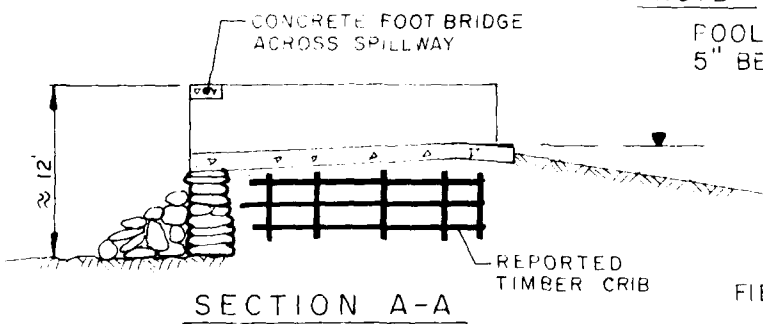
PLATE 2

POOL LEVEL AT DATE OF INSPECTION  
5" BELOW SPILLWAY CREST

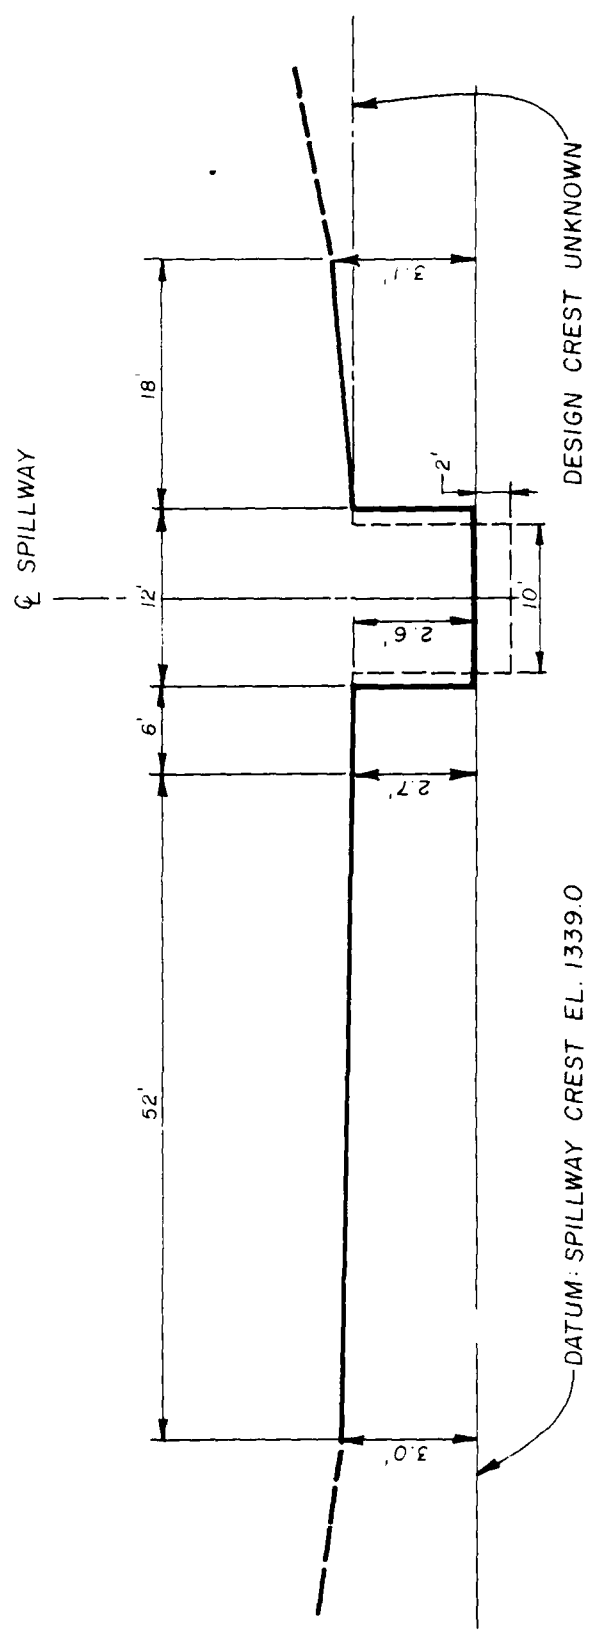
**DAM CREST PROFILE**  
(LOOKING DOWNSTREAM)

The crest of the dam was surveyed relative to the spillway crest elevation and it was found to be relatively uniform. The dam crest profile is illustrated in Plate 3.
