D'APPOLONIA CONSULTING ENGINEERS INC PITTSBURGH PA  
NATIONAL DAM INSPECTION PROGRAM. NEGRO POND DAM (NDI I.D. PA-08--ETC(U)  
MAR 81

PHASE I REPORT  
NATIONAL DAM INSPECTION PROGRAM

NAME OF DAM: Negro Pond Dam  
STATE LOCATED: Pennsylvania  
COUNTY LOCATED: Wyoming  
STREAM: Little Mehoopany Creek, tributary of the Susquehanna River  
SIZE CLASSIFICATION: Small  
HAZARD CLASSIFICATION: High  
OWNER: Mr. Melvin Morris  
DATE OF INSPECTION: November 15, 1980 and February 4, 1981

NEGRO POND DAM  
NDI I.D. PA-0889  
DER I.D. 066-010  
NOVEMBER 12, 1980

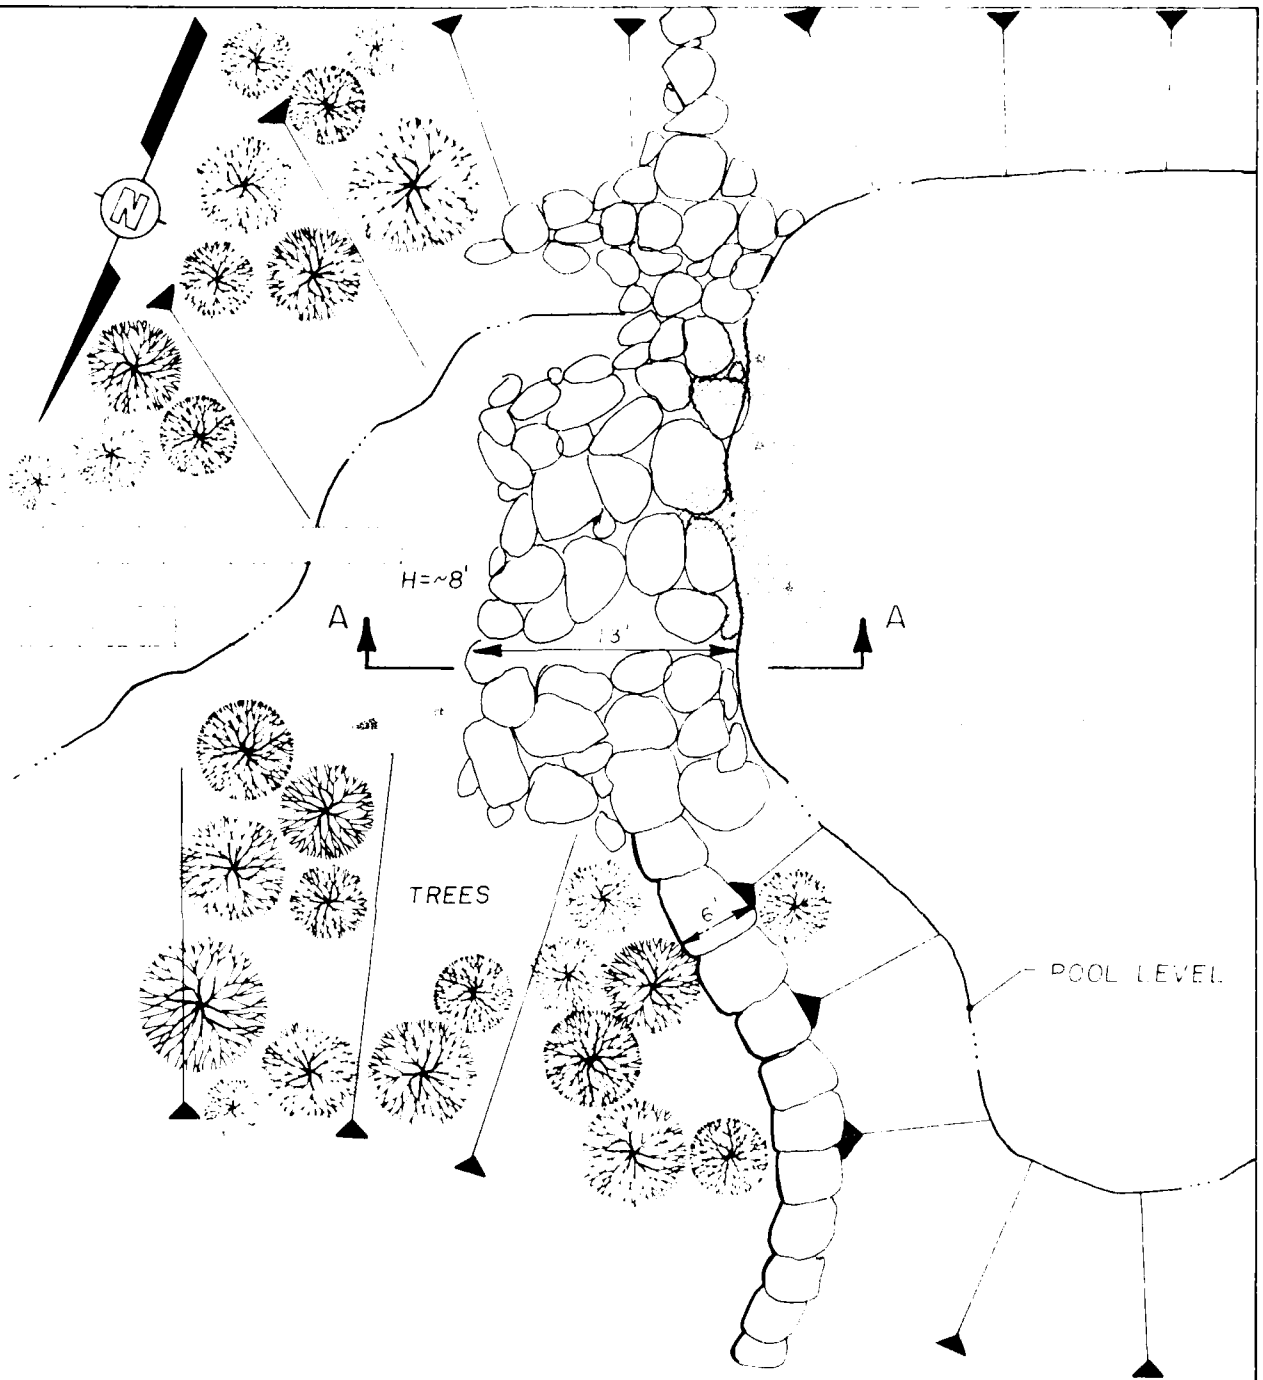
SECTION A-A

(1) Embankment. No information is available on the design of the dam. As shown in Plate 2, the dam is essentially a mound of large stones with an approximate length of 125 feet and a maximum height of 11 feet above the downstream toe. The geometry of the dam is undefined such that the side slopes and dam crest cannot be accurately characterized.

The specific observations are illustrated in Plate 2.

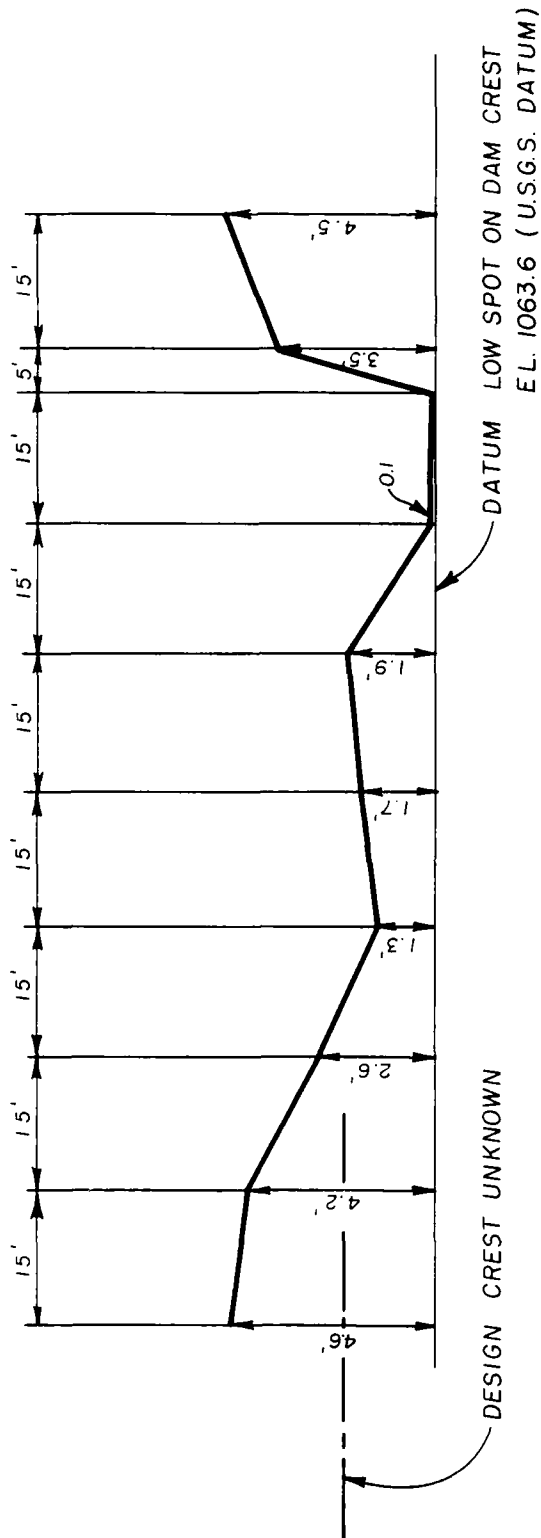
# **DAM CREST PROFILE** (LOOKING DOWNSTREAM)

The crest of the dam was surveyed and it was found to be very irregular in shape. The dam crest profile is illustrated in Plate 3.
