ECHO LAKE DAM

PHASE I INSPECTION REPORT.

6 NATIONAL DAM INSPECTION PROGRAM.
Echo Lake Dam (NDI Number PA-00957, DER
Number 48-3)

PHASE I INSPECTION PROGRAM
NATIONAL DAM INSPECTION PROGRAM

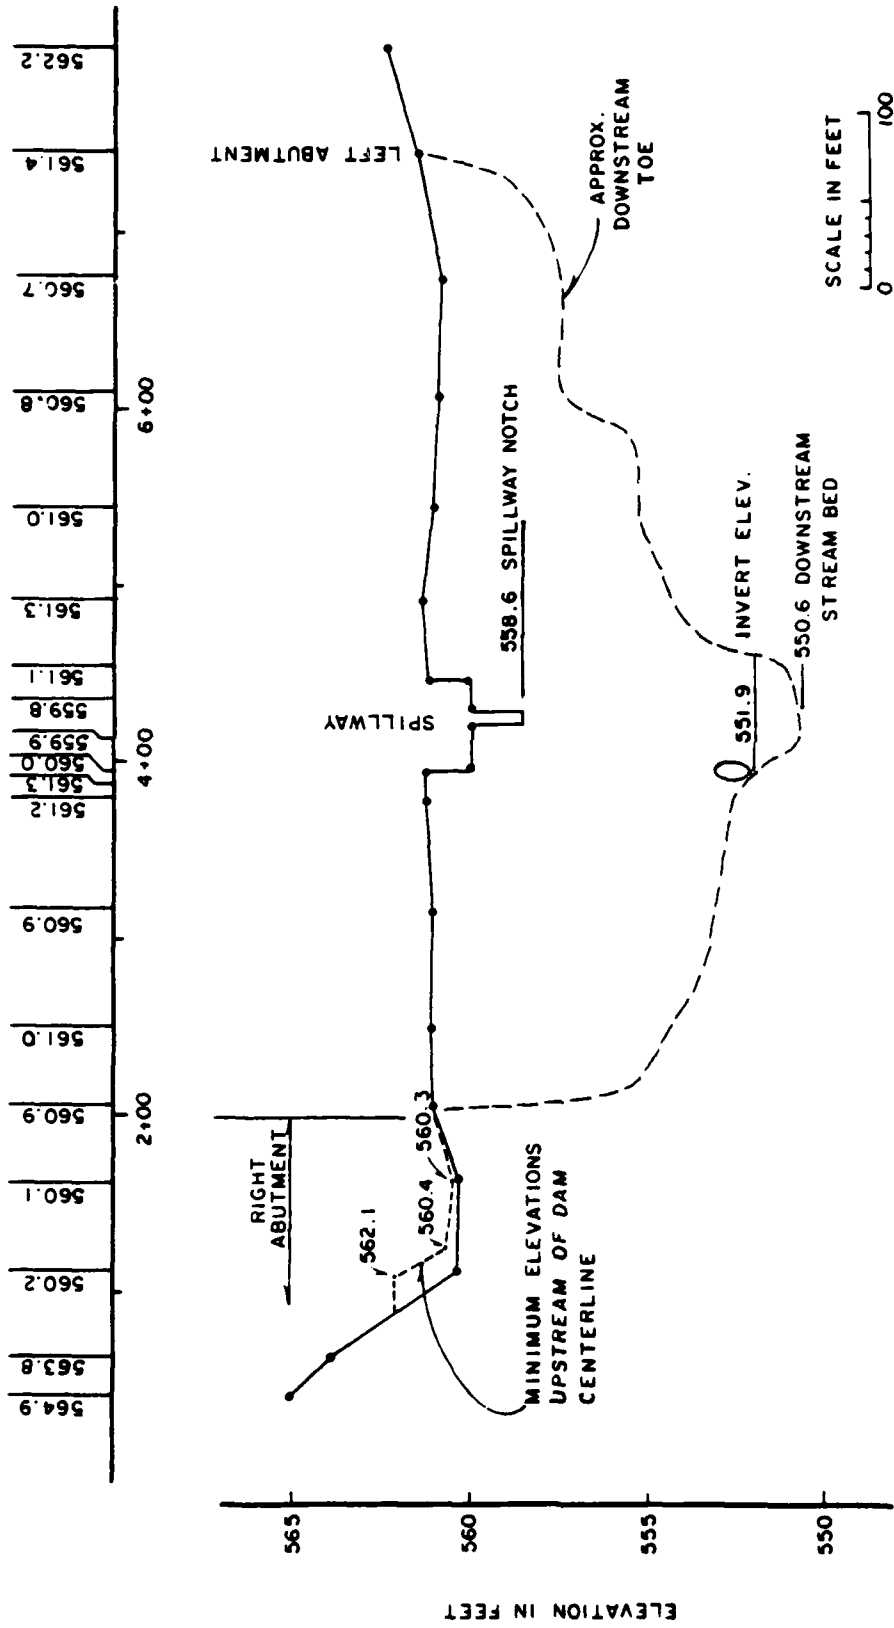
PROFILE ALONG CREST
ECHO LAKE DAM
SHEET 58 OF 11

b. Dam. The vertical alignment of the dam crest was checked and the profile is shown on Sheet 5B, Appendix A. There were no distortions in alignment or grade that would be indicative of movement within the embankment or foundation. The crest elevation ranges from 560.7 to 561.4. The minimum elevation of 560.1 is in the right abutment area beyond the embankment. The minimum elevation in the right abutment area upstream of the dam which must be overtopped before water can flow over the right abutment is 560.3. The crest width ranges from 11 to 16 feet and supports a well maintained growth of grass. It was reported that broken shale covered with topsoil and seeded, has been placed on low areas of the embankment crest and on damaged areas at the waterline. A bench, created by wave erosion, was observed at the summer water line on the upstream embankment face, occasionally exposing underlying riprap. A flatter upstream embankment slope covered with broken shale was observed below the water level.
