POTOMAC RIVER BASIN
CARBAUGH RUN DAM
SOUTH MOUNTAIN RESTORATION CENTER

NDI NO. PA-00881
DER NO. I-077

ADAMS COUNTY, PENNSYLVANIA
PHASE I INSPECTION REPORT
NATIONAL DAM INSPECTION PROGRAM

Name of Dam: CARBAUGH RUN DAM
State & State No.: PENNSYLVANIA, 1-077
County: ADAMS
Stream: CARBAUGH RUN
Date of Inspection: October 10, 1980

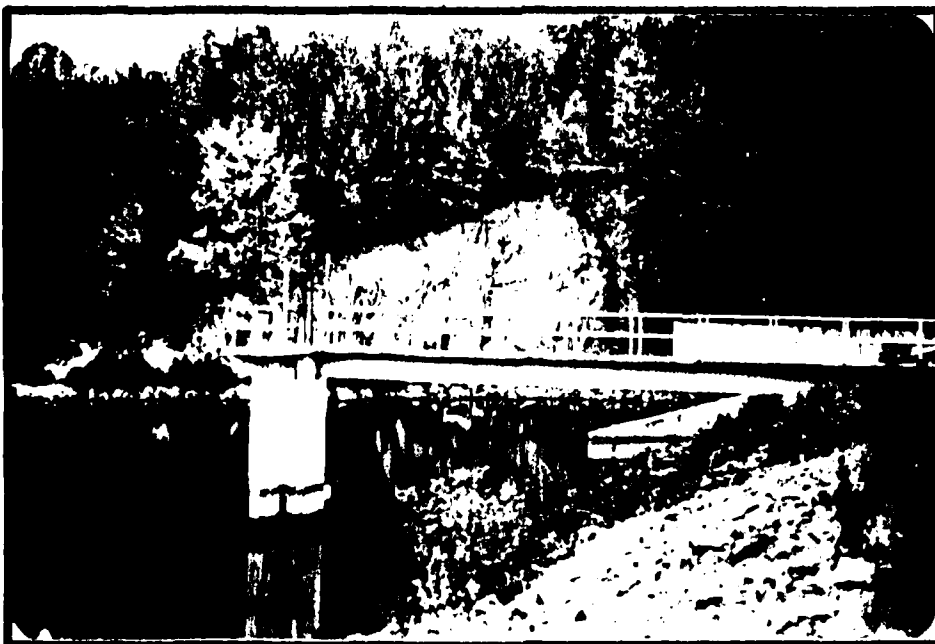
The intake control tower (Photograph No. 3) is located close to the spillway forebay area at the upstream toe. There are three gate operator stands on the platform. One gate controls the flow through the 60-inch diameter outlet pipe. This 24-inch gate is generally slightly open to meet the minimum downstream flow criteria. The other two gates control the water supply intake. The tower appears to be in good condition with a slight deterioration of the concrete at the normal pool level. Access to the tower is by a footbridge from the crest of the dam. A 2.5-inch displacement was noticed at the bearing of the bridge at the abutment. This condition is not considered serious. The abutment is constructed on the fill and it is possible that the abutment has moved. The 60-inch diameter outlet pipe terminates in the stilling basin.

Visual inspection of the intake control tower did not detect signs of structural instability. Although the footbridge has moved in relation to the abutment, this movement is probably caused by movement of the abutment in the fill. It apparently has stabilized and is not considered to be a serious problem.

INTAKE TOWER & FOOTBRIDGE - NO. 3

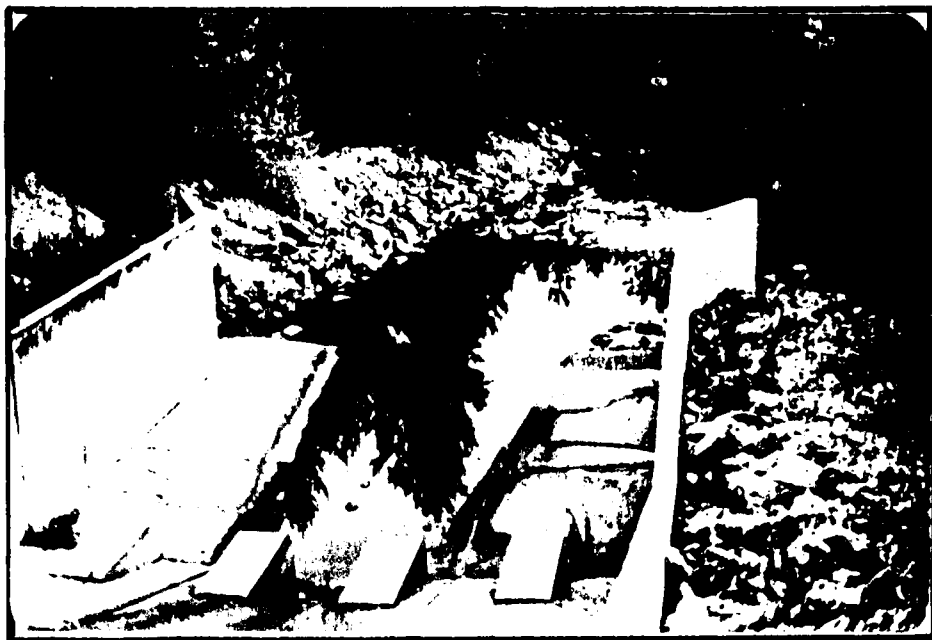
STILLING BASIN - NO. 8
