FULLER'S LAKE DAM

NDI No. PA 00073
PennDER No. 58-121
Dam Owner: Frederick Hoal

PHASE I INSPECTION REPORT NATIONAL DAM INSPECTION PROGRAM

Fuller's Lake Dam, Susquehanna County, Pennsylvania
NDI No. PA 00073, PennDER No. 58-121
Salt Lick Creek
Inspected 27 October 1980

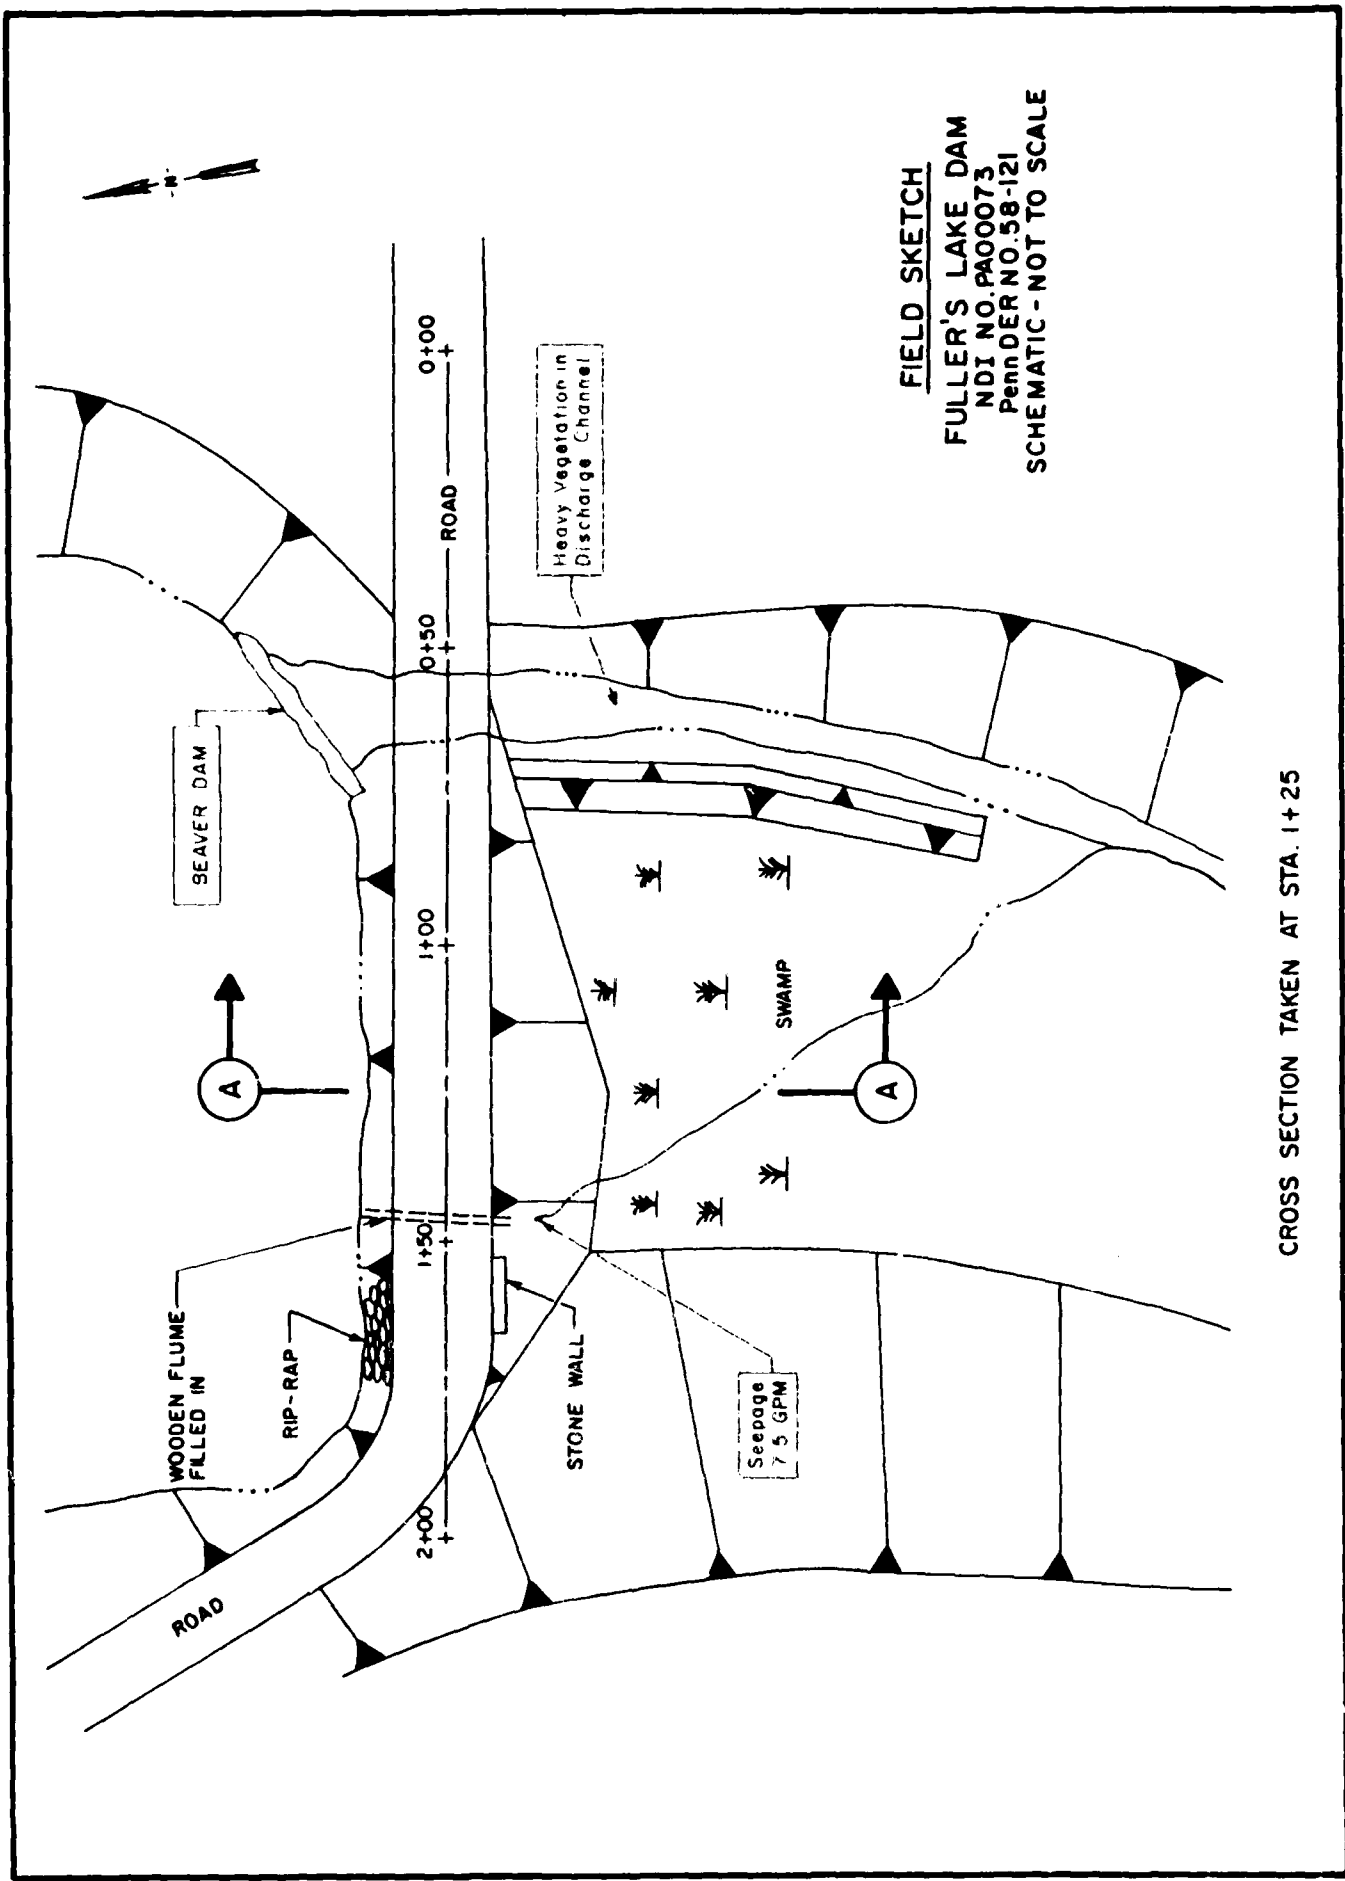
FIELD SKETCH
FULLER'S LAKE DAM
 NDI NO. PA00073
 PENN DER NO. 58-121
 SCHEMATIC - NOT TO SCALE

- b. Dam - Clear seepage was observed exiting the downstream slope at a rate of approximately 7.5 g.p.m. The vegetation and the erosion channel away from the seep indicated that the seepage has been occurring for a long period of time. The seep is located 8 feet vertically below the crest of the dam, at station 1+40 (see Field Sketch in Appendix A).
