DuBOIS CREEK DAM

NDI No. PA 00064
PennDER NO. 58-8
Dam Owner: Keystone Water Company

PHASE I INSPECTION REPORT NATIONAL DAM INSPECTION PROGRAM

DuBois Creek Dam, Susquehanna County, Pennsylvania
NDI No. PA 00064, PennDER No. 58-8
DuBois Creek
Inspected 28 October 1980

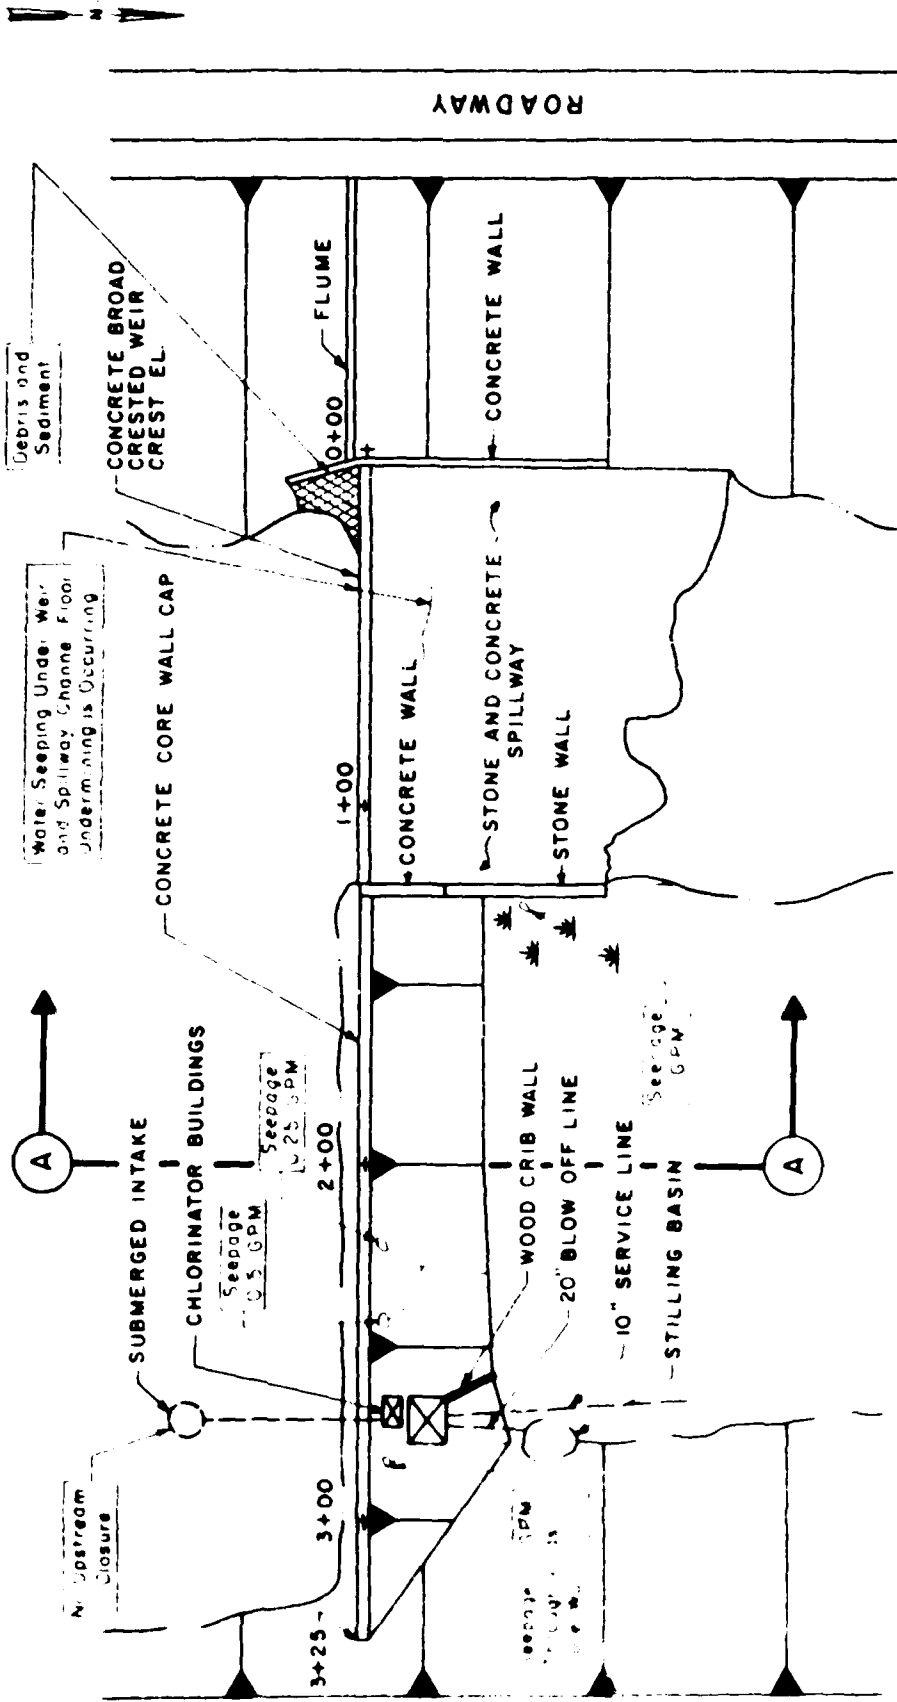
FIELD SKETCH

- b. Dam - Seepage was observed at three locations passing through deteriorated portions of the concrete core wall. The most severe of these locations was near Station 2+85 (see Field Sketch in Appendix A) where approximately 10 gallons per minute (g.p.m.) of seepage was occurring. These seepage areas are the result of progressive deterioration of the exposed areas of the concrete core wall. The seepage has caused erosion gullies and slight irregularities on the downstream face of the dam.
