LAKE KIMBERLY DAM

NDI NO. PA-00949

PHASE I INSPECTION REPORT

NATIONAL DAM INSPECTION PROGRAM

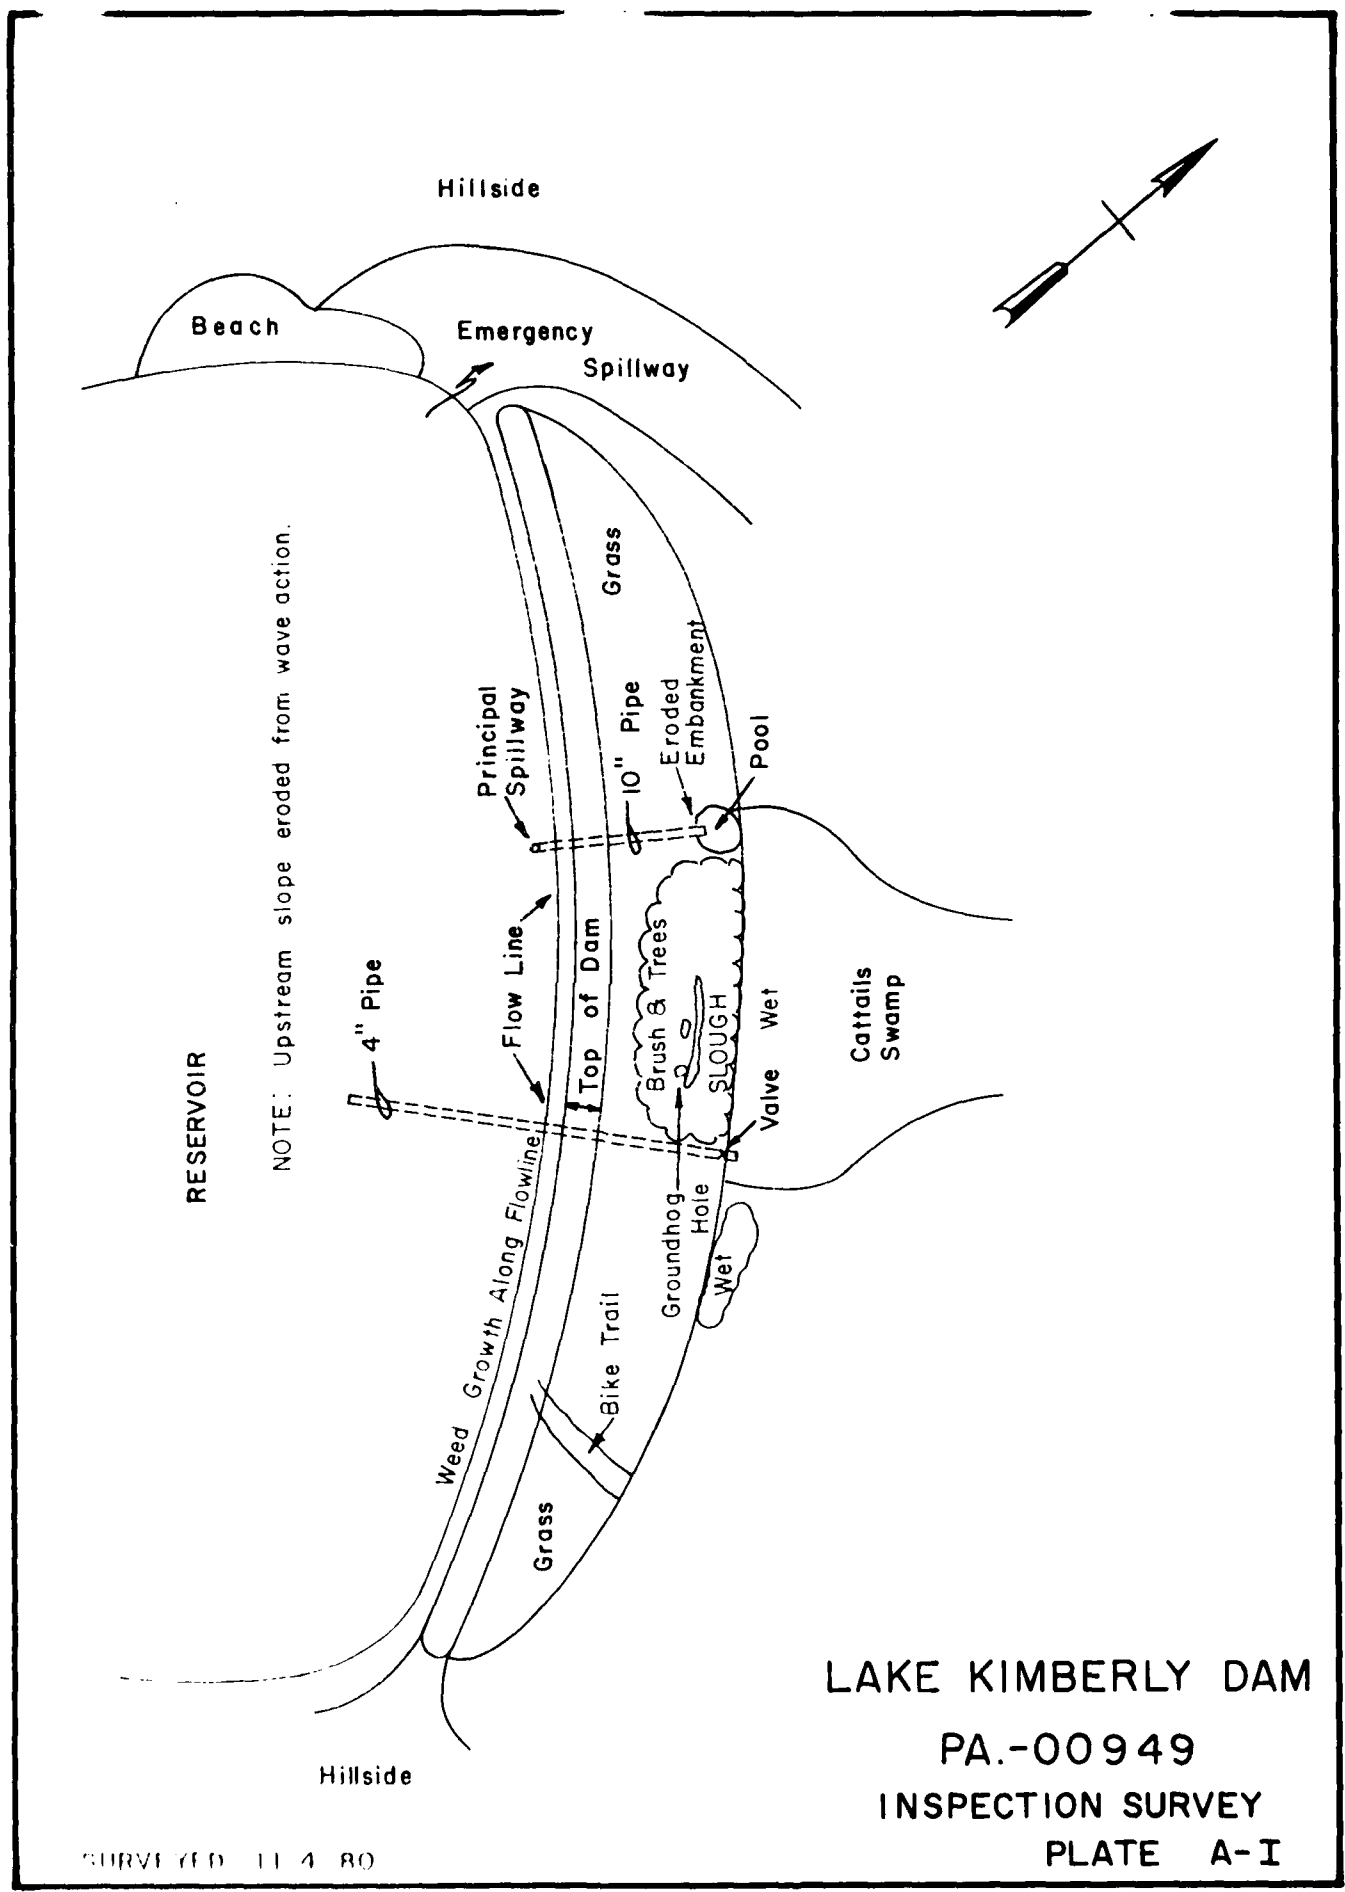
LAKE KIMBERLY DAM
 PA.-00949
 INSPECTION SURVEY
 PLATE A-I

Records of operation are not maintained by the owner. Within one or two weeks after construction was completed, a slough occurred on the downstream slope in the area indicated on Plate A-I. This condition has not been improved nor repaired.

NOTE: Upstream slope eroded from wave action.

4. That the slough on the downstream slope be repaired and reseeded under the direction of an engineer experienced in the design and construction of dams.

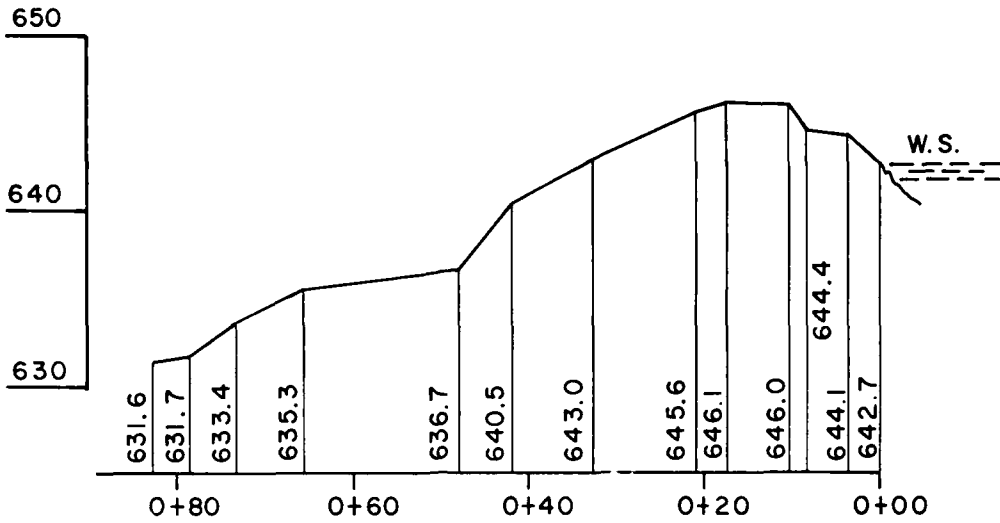
EMBANKMENT SECTION STA. 3+20
IN AREA OF SLIDE

A large slough and heave occurred shortly after construction was completed. The owner stated that no further movement has occurred since that time. Information indicating the cause of this slide is not available. Heavy growth of briar prevented close observation. The erosion of the downstream slope at the outlet of the 10-inch discharge pipe should be repaired. Wave action is receding the upstream slope. The crest of the dam has an irregular profile.

B. UNUSUAL MOVEMENT BEYOND TOE	One area has been displaced forming a bench on the downstream slope.
C. SLOUGHING OR EROSION OF EMBANKMENT OR ABUTMENT SLOPES	A major slough or slope failure is evident on the downstream slope. Refer to cross section. Erosion is occurring due to wave action on the upstream slope. Groundhog hole located in slumped area.

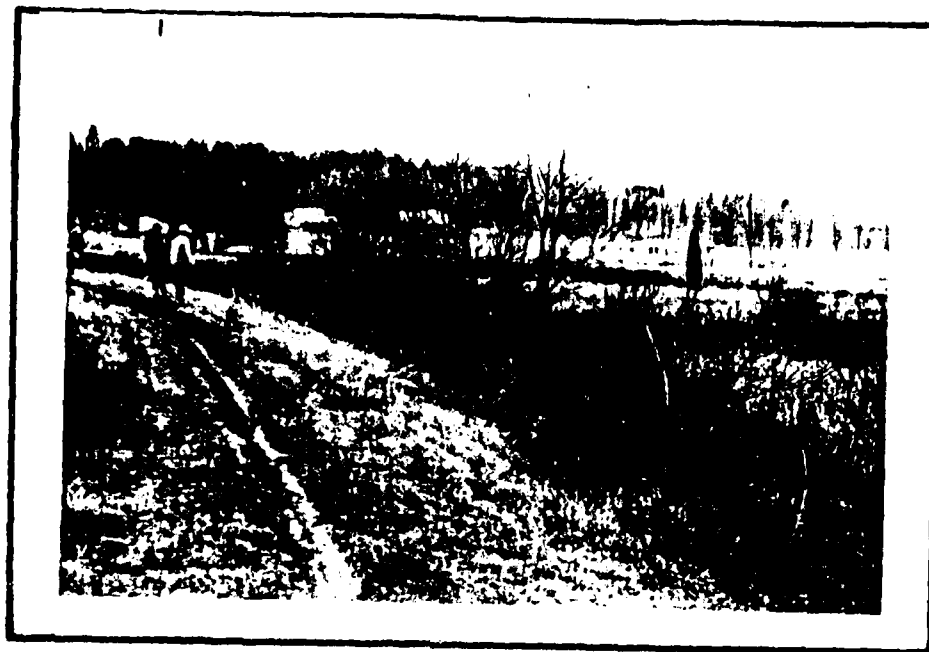
The downstream slope, near the left and right abutments, is flat and in good condition with a good grass mat protection, except where the bike trail has killed the grass. The center portion of the downstream slope is overgrown with trees, briars and brush (Photograph No. 4). In this area a 50 foot long slope failure was observed (Photographs No. 8 and 9 and Plate A-III, Appendix A). The owner stated that this slough occurred one or two weeks after construction was completed. Repairs were never made. Heavy brush in this area prevented close observation. Seepage was not detected during the inspection. The pool level was several feet below normal at that time. A woodchuck hole is located in this slough area.

BRUSH & TREES ON DOWNSTREAM SLOPE - NO. 4

The overall evaluation of the facilities indicates that Lake Kimberly Dam is in poor condition. The growth of trees, brush and weeds should be removed, and the upstream slope should be protected from wave action. The crest profile is irregular and should be brought to a uniform elevation higher than the emergency spillway elevation in order to prevent overtopping. The downstream slope should be repaired where the slough has occurred and where the outlet pipe has eroded the embankment. The outlet pipe should be extended beyond the downstream toe of the embankment, and a rock protected plunge pool should be constructed at the end of the outlet pipe.

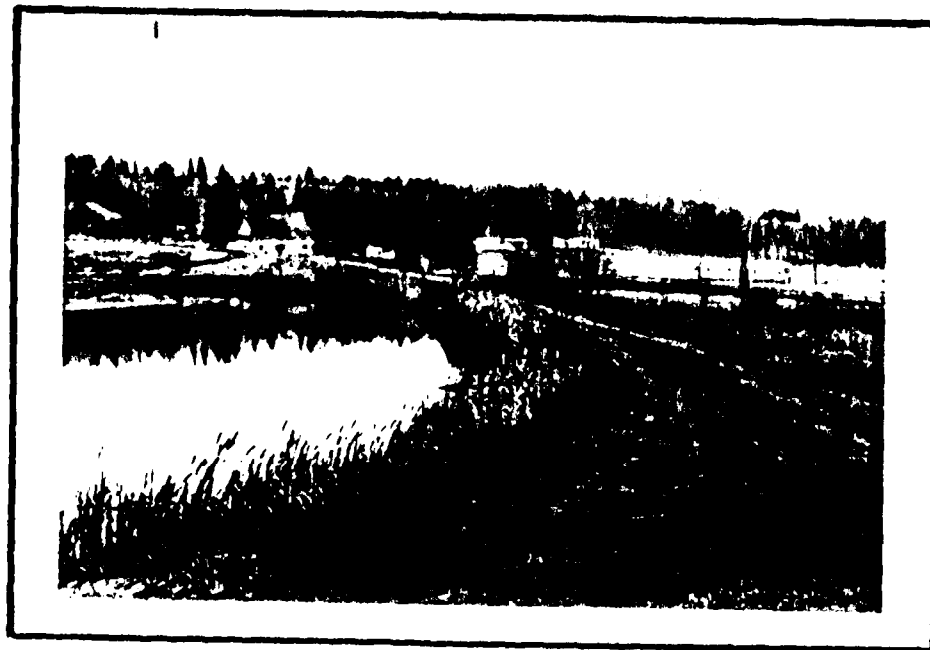
CATTAILS ON UPSTREAM SLOPE - NO. 5

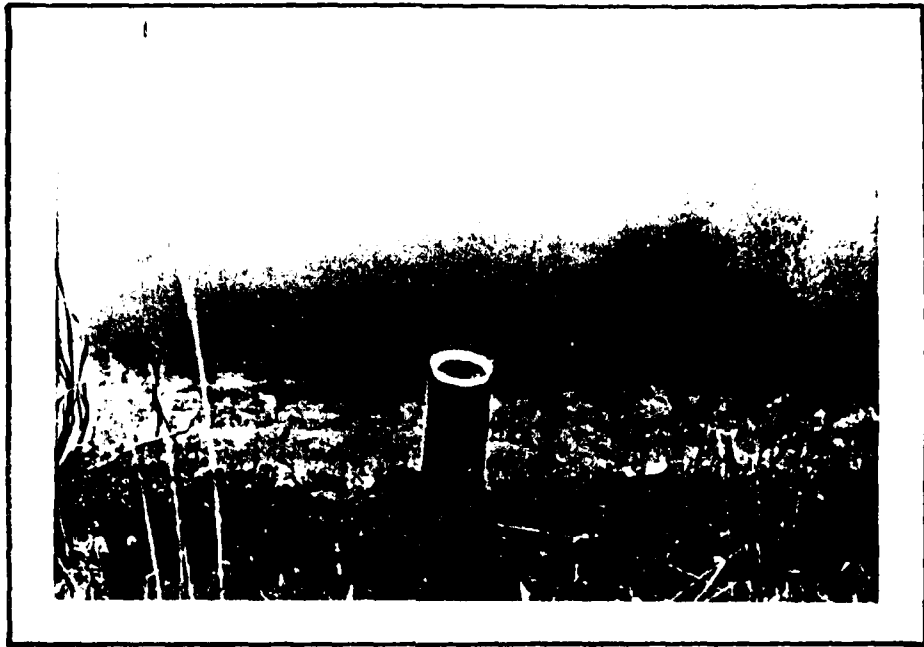
The principal spillway is an 8-inch drop inlet pipe located on the upstream slope. The 8-inch diameter pipe was obstructed with a plastic container. This obstruction should be removed. This vertical pipe is connected to a 10-inch horizontal discharge pipe which discharges above the downstream toe in a small eroded plunge pool (Photograph No. 7). The embankment at this location has been eroded to a near vertical slope. It appears that a section of the pipe has been broken off.

8-INCH OUTLET PIPE - NO. 6
