SUSQUEHANNA RIVER BASIN
- WOLFF FARM DAM
PETERS ORCHARDS COMPANY

NDI NO. PA-01115
DER NO. 21-179

CUMBERLAND COUNTY, PENNSYLVANIA
PHASE I INSPECTION REPORT
NATIONAL DAM INSPECTION PROGRAM

PHASE I REPORT
NATIONAL DAM INSPECTION PROGRAM

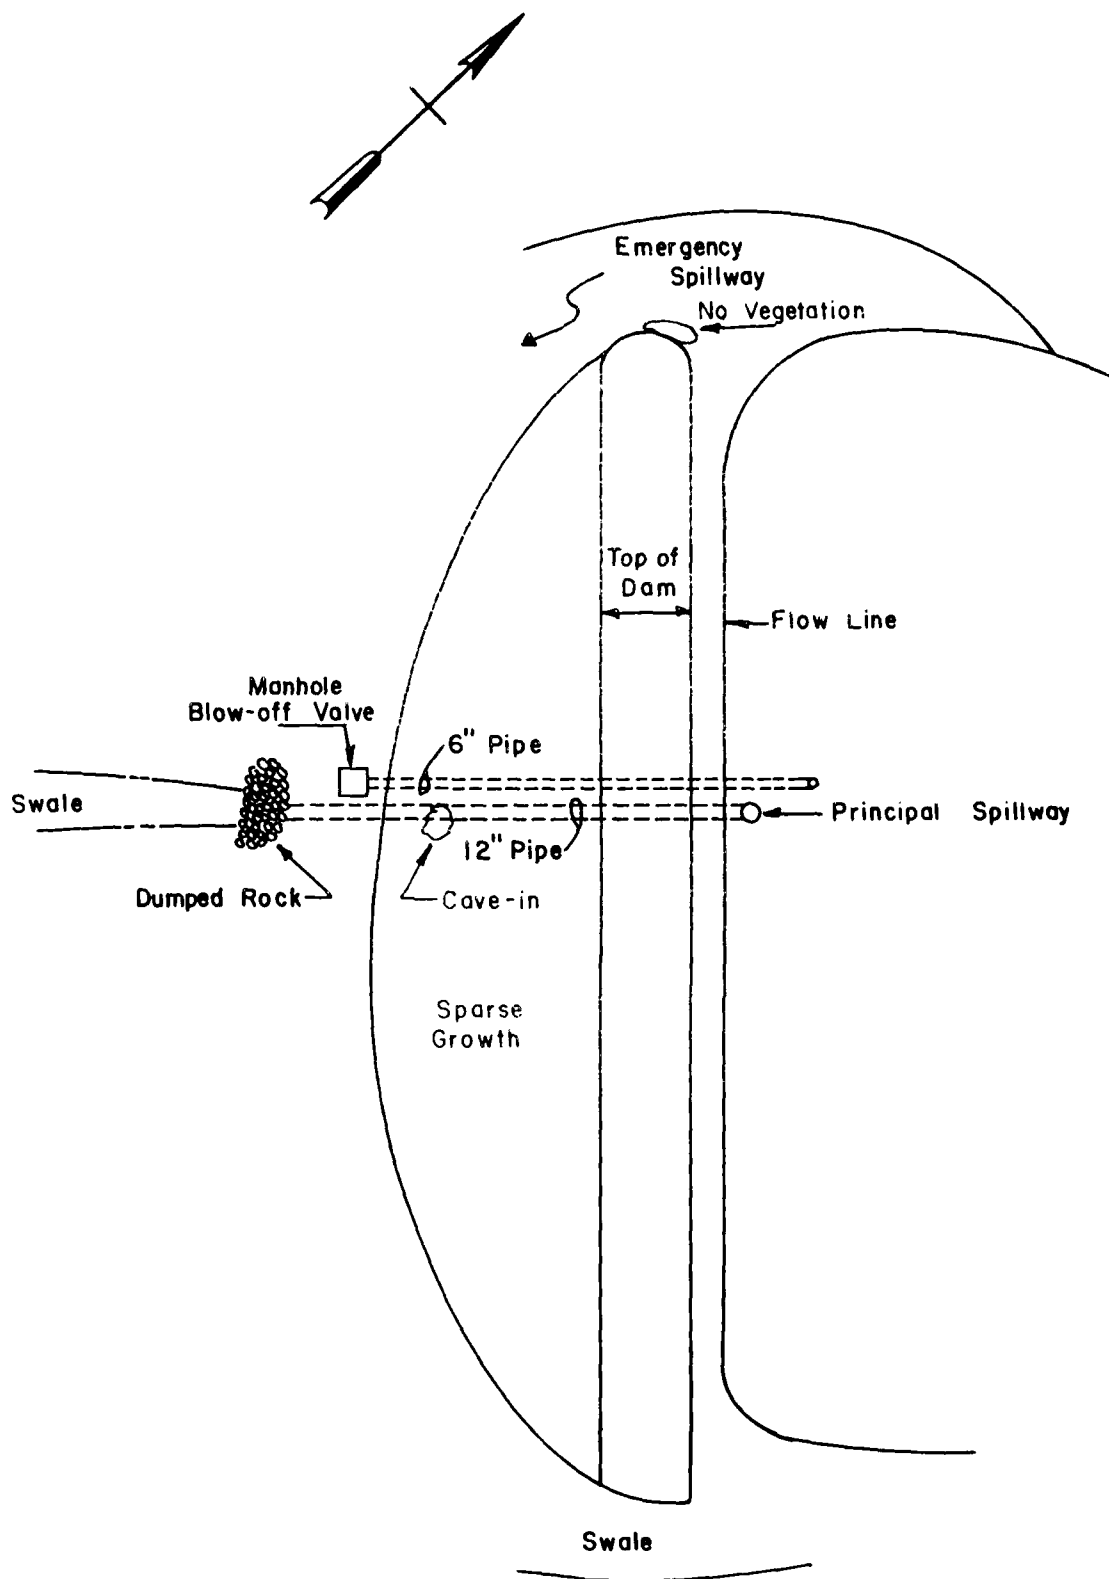
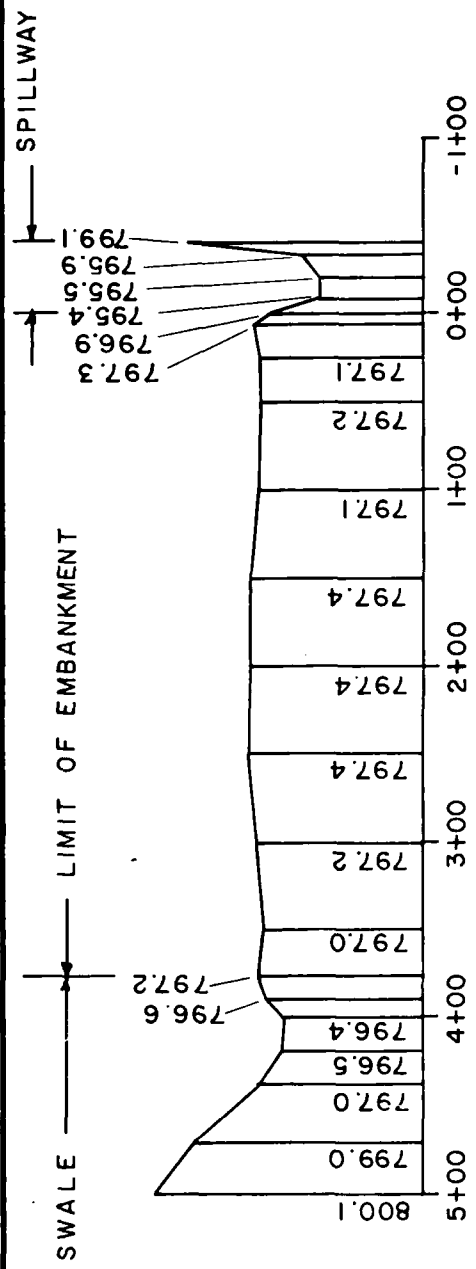
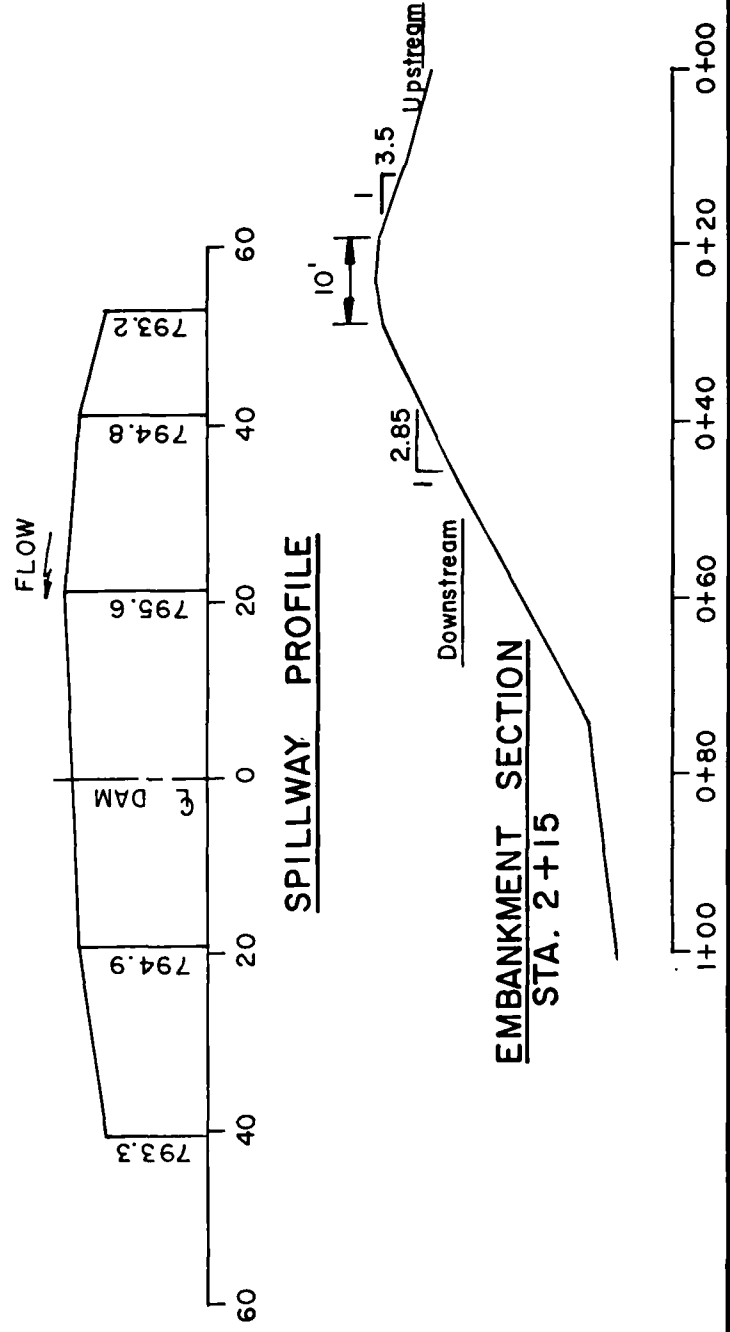
WOLFF FARM DAM
 PA-01115
 INSPECTION SURVEY
 PLATE A-I

The exposed upstream slope below normal pool level is about 3.5H to 1V. The crest of the dam is on a straight alignment and has a well maintained grass cover. The surveyed profile (Plate A-II, Appendix A) indicates about half a foot variation in elevation along the crest and a low swale beyond the left abutment. This swale has a good grass cover and can be used as an overflow section. The downstream slope is uniform with a sparse growth of mowed weeds (Photographs No. 4 and No. 7). The exposed embankment surface consists of a sandy soil and could be easily eroded if overtopping would occur. A small subsidence area was noticed near the downstream toe over the 12-inch principal spillway outlet pipe. It is possible that a leak exists in the outlet pipe in this area and is the source of the settlement.

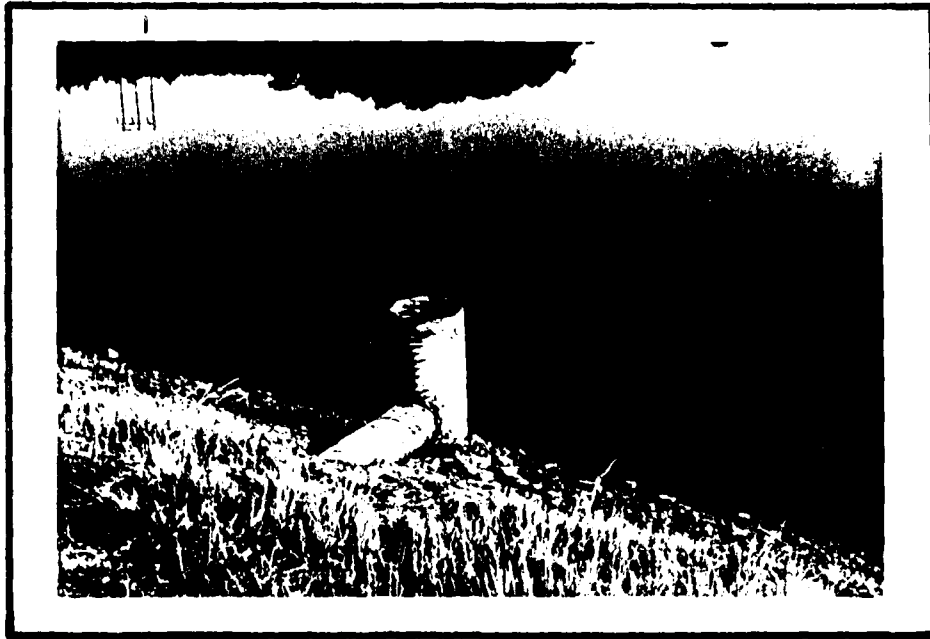
The principal spillway consists of an 18-inch drop inlet pipe which discharges through a 12-inch corrugated metal pipe (Photograph No. 6). This spillway was installed after the 1972 Agnes storm to reduce the flow through the grassed spillway in the right abutment. The outlet pipe was constructed close to the surface through the embankment (Photograph No. 7). The pipe daylights at the downstream toe. To prevent erosion, heavy riprap has been placed over the outlet, reducing

DETAIL OF PRINCIPAL SPILLWAY INTAKE - NO. 6

The rock protection at the outlet pipe should be rearranged so as not to block the open end of the pipe.
