DELAWARE RIVER BASIN  
TRIBUTARY TO HARVEY RUN  
HILLOCH DAM  
DELAWARE COUNTY, PENNSYLVANIA

NDI NO. PA 00933  
DER NO. 23-89

PHASE I INSPECTION PROGRAM  
NATIONAL DAM INSPECTION PROGRAM

*Hilloch Dam, NDI Number PA-00933, DER. 23-89  
Delaware River Basin Tributary to Harvey Run,  
Delaware County, Pennsylvania*

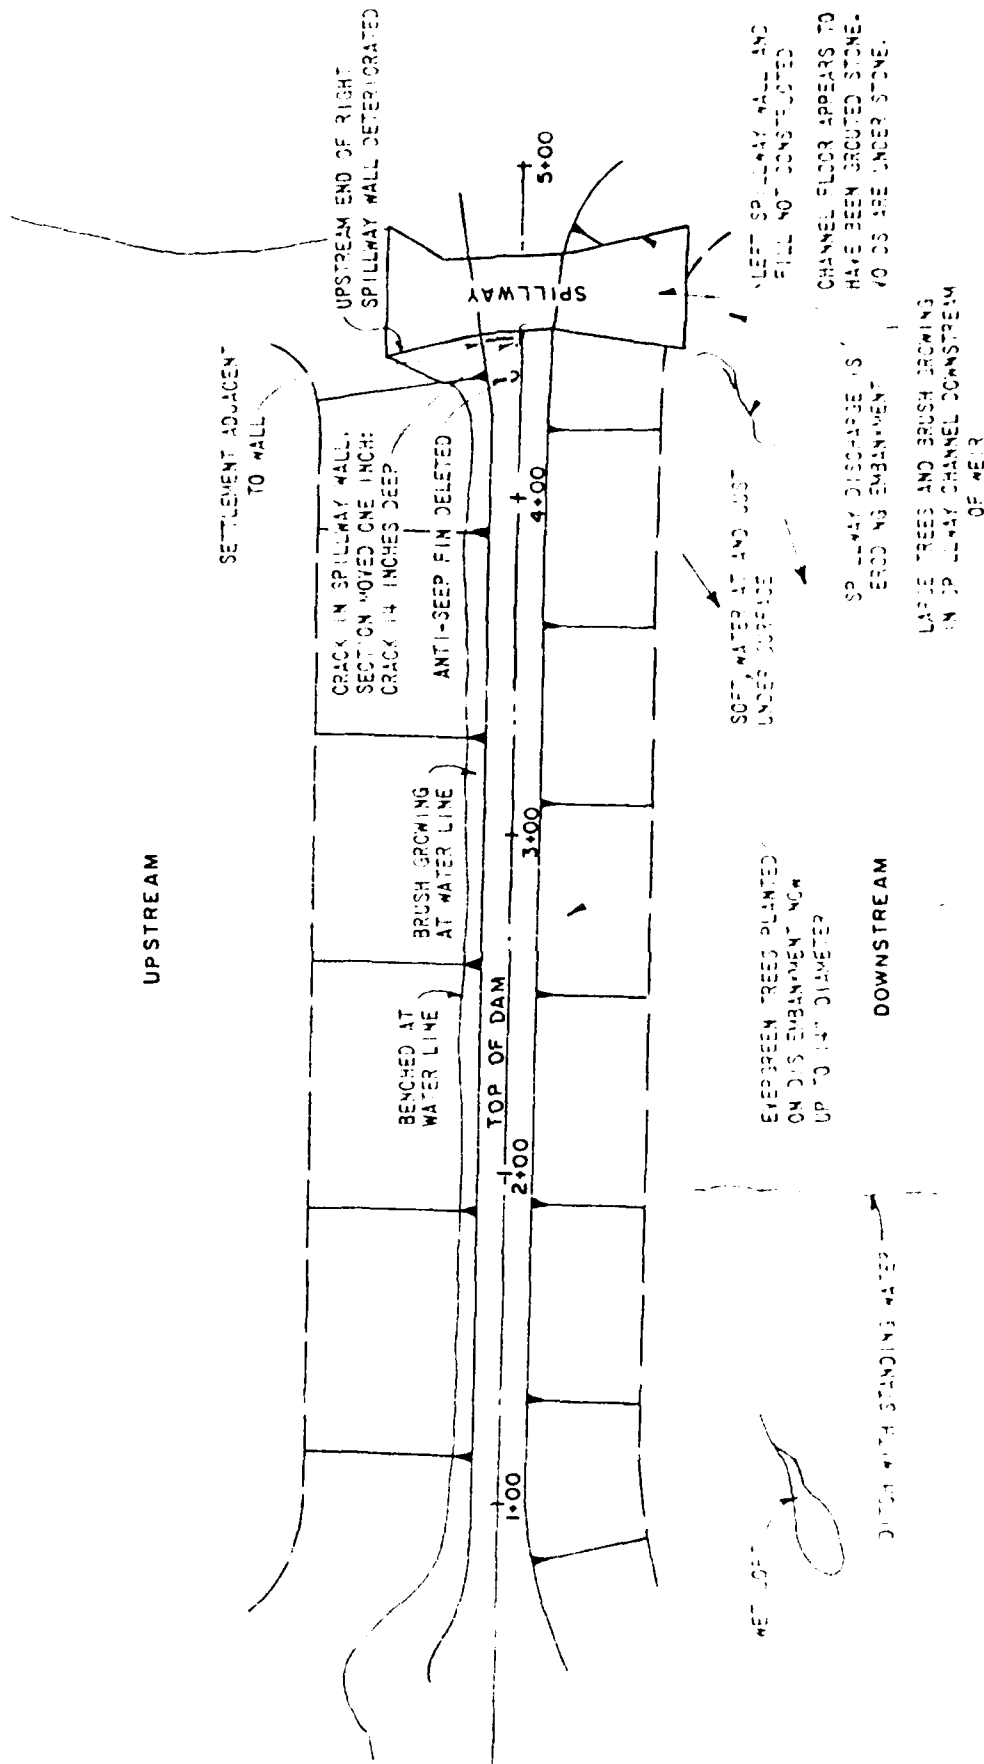
FIELD OBSERVATION PLAN  
HILLOCH DAM

CRACK IN SPILLWAY WALL, SECTION MOVED ONE INCH; CRACK 14 INCHES DEEP

RUPTURED DOWNSTREAM WATER FLOW IN UNDERGROUND
