WESTCOLANG LAKE DAM

NDI I.D. NO. PA-00396
PENNDER I.D. NO. 52-4

PHASE I INSPECTION REPORT
NATIONAL DAM INSPECTION PROGRAM.

14 MAR 1981

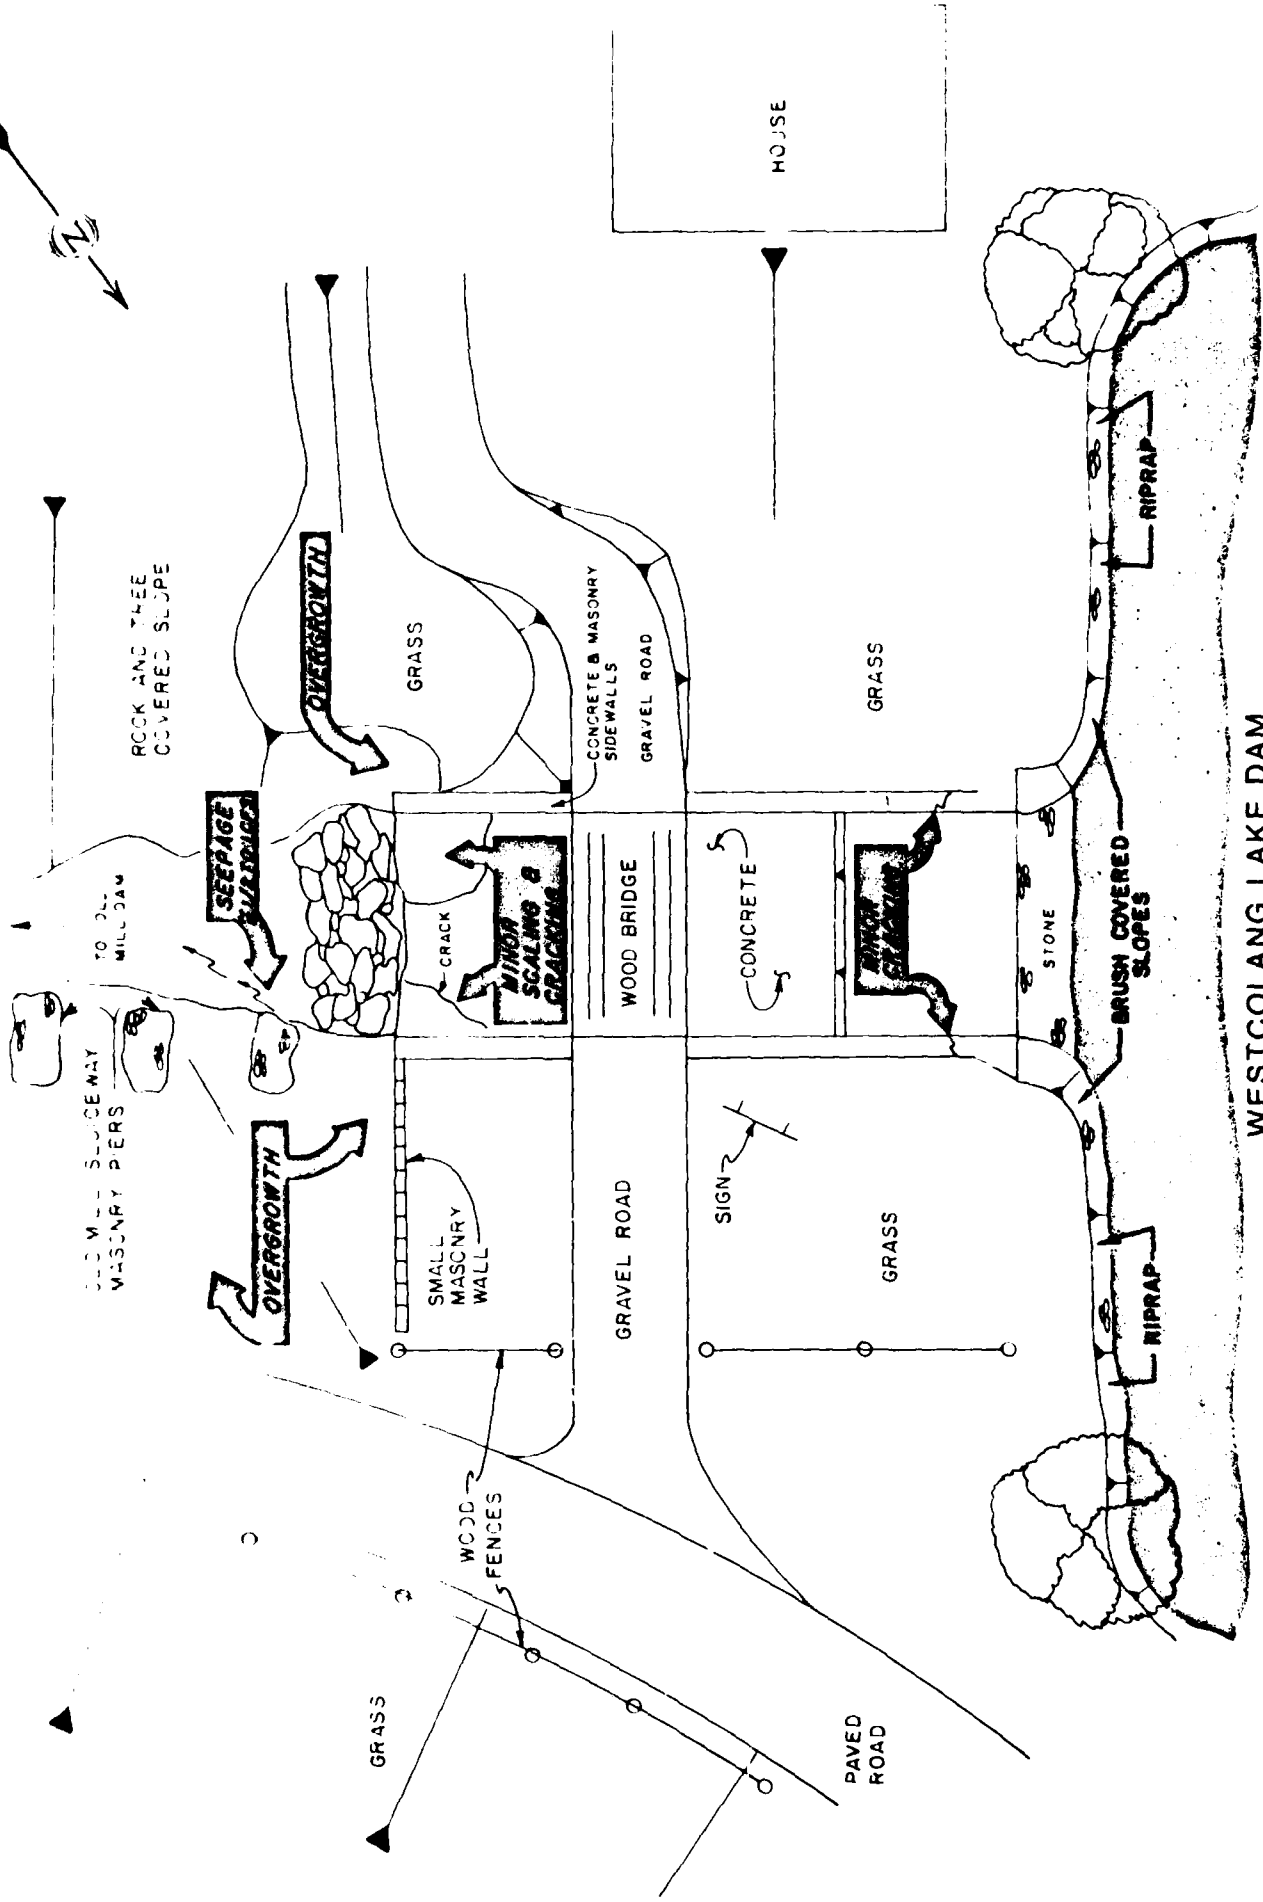
WESTCOLANG LAKE DAM
GENERAL PLAN-FIELD INSPECTION NOTES

b. Embankment. Observations made during the visual inspection reveal the embankment is adequately maintained and presently in good condition. The left and right abutment slopes immediately downstream of the dam are covered with thick brush which partially obscures view of the facility. No evidence of seepage through the downstream embankment face, sloughing, erosion, animal burrows or excessive settlement was noted. Seepage was encountered in the rock lined discharge channel about 30 feet downstream of the embankment. The seepage, estimated at about 1/2 to 1 cfs, appeared to be emanating from the left side of the channel near an old masonry pier that previously supported a sluiceway for the old saw mill no longer in existence (see Photographs 3 and 8, Appendix C and "General Plan - Field Inspection Notes," Appendix A).

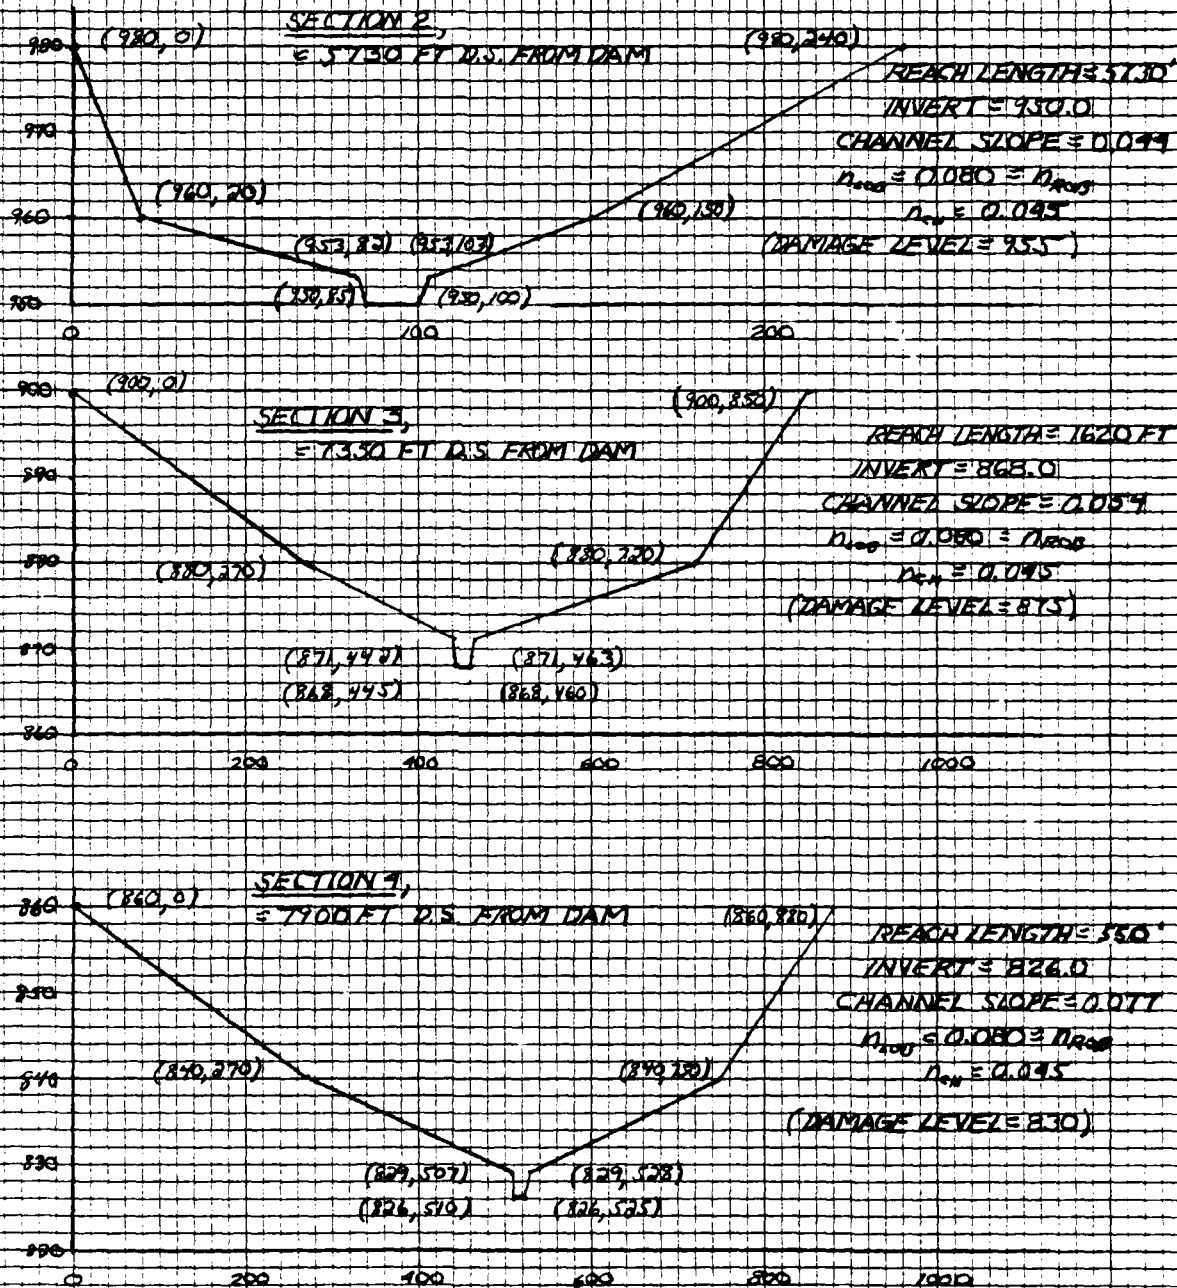
DOWNSTREAM ROUTING SECTIONS

Three potential centers of damage were investigated in the analysis. At Section 2 (see Figure 1), located about 1.1 miles downstream from Westcolang Lake Dam, the peak water surface elevations resulting from the breaches ranged up to about 2.3 feet above

At Section 3 (see Figure 1), located about 1.4 miles downstream from the dam, all breach outflows remained below the damage level of the nearby structures.

The third potential damage center is located at Section 4, located about 1.5 miles downstream from the dam. At this section, the maximum water surface levels resulting from the breaches ranged up to about 1.8 feet above the peak non-breach level, or approximately 1.5 feet above the damage level of the residences (Appendix D, Sheet 14).

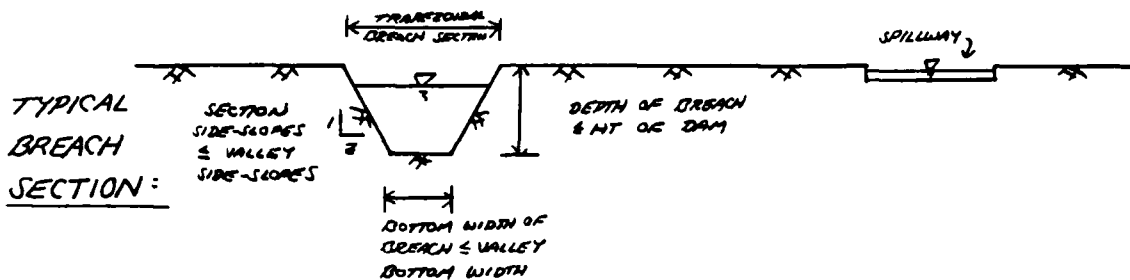
BREACH ASSUMPTIONS

The portion of Westcolang Lake Dam which is most likely to fail due to overtopping is the embankment area adjacent the spillway structure, where the downstream face of the embankment is steepest, and where the greatest depth of breach would occur. The breach was assumed to extend vertically only to the base of the dam, although the bottom of the natural lake occurs at a lower elevation. Since foundation conditions are unknown, it is possible that a breach could extend to greater depths.

Four breach models were analyzed for Westcolang Lake Dam, involving one set of breach dimensions and four possible failure times. The breach section chosen was considered to be the maximum section likely to fail near the spillway structure. The four failure times (total time for breach section to reach its final dimensions) were assumed to be a prolonged time of 12.0 hours, and three relatively rapid times of 4.0, 2.0, and 1.0 hours. The prolonged breach was assumed to commence immediately upon overtopping, while the three more rapid breaches were assumed to commence as the depth of overtopping reached about 1.0-foot or after about an hour of overtopping. All breaches were assumed to occur under 1/2 PMF conditions (see Appendix D, Sheet 12).

THE PORTION OF THE DAM WHICH WOULD MOST LIKELY FAIL FROM OVERTOPPING IS THE AREA AROUND THE SPILLWAY STRUCTURE ITSELF, WHERE THE DOWNSTREAM FACE OF THE EMBANKMENT IS STEEPEST, AND WHERE THE GREATEST DEPTH OF BREACH WOULD OCCUR.
