BEAVER POND DAM

NDI I.D. NO. PA-00408
PENNDER I.D. NO. 52-13

⑥ PHASE I INSPECTION REPORT
NATIONAL DAM INSPECTION PROGRAM.

11 MAR 1981

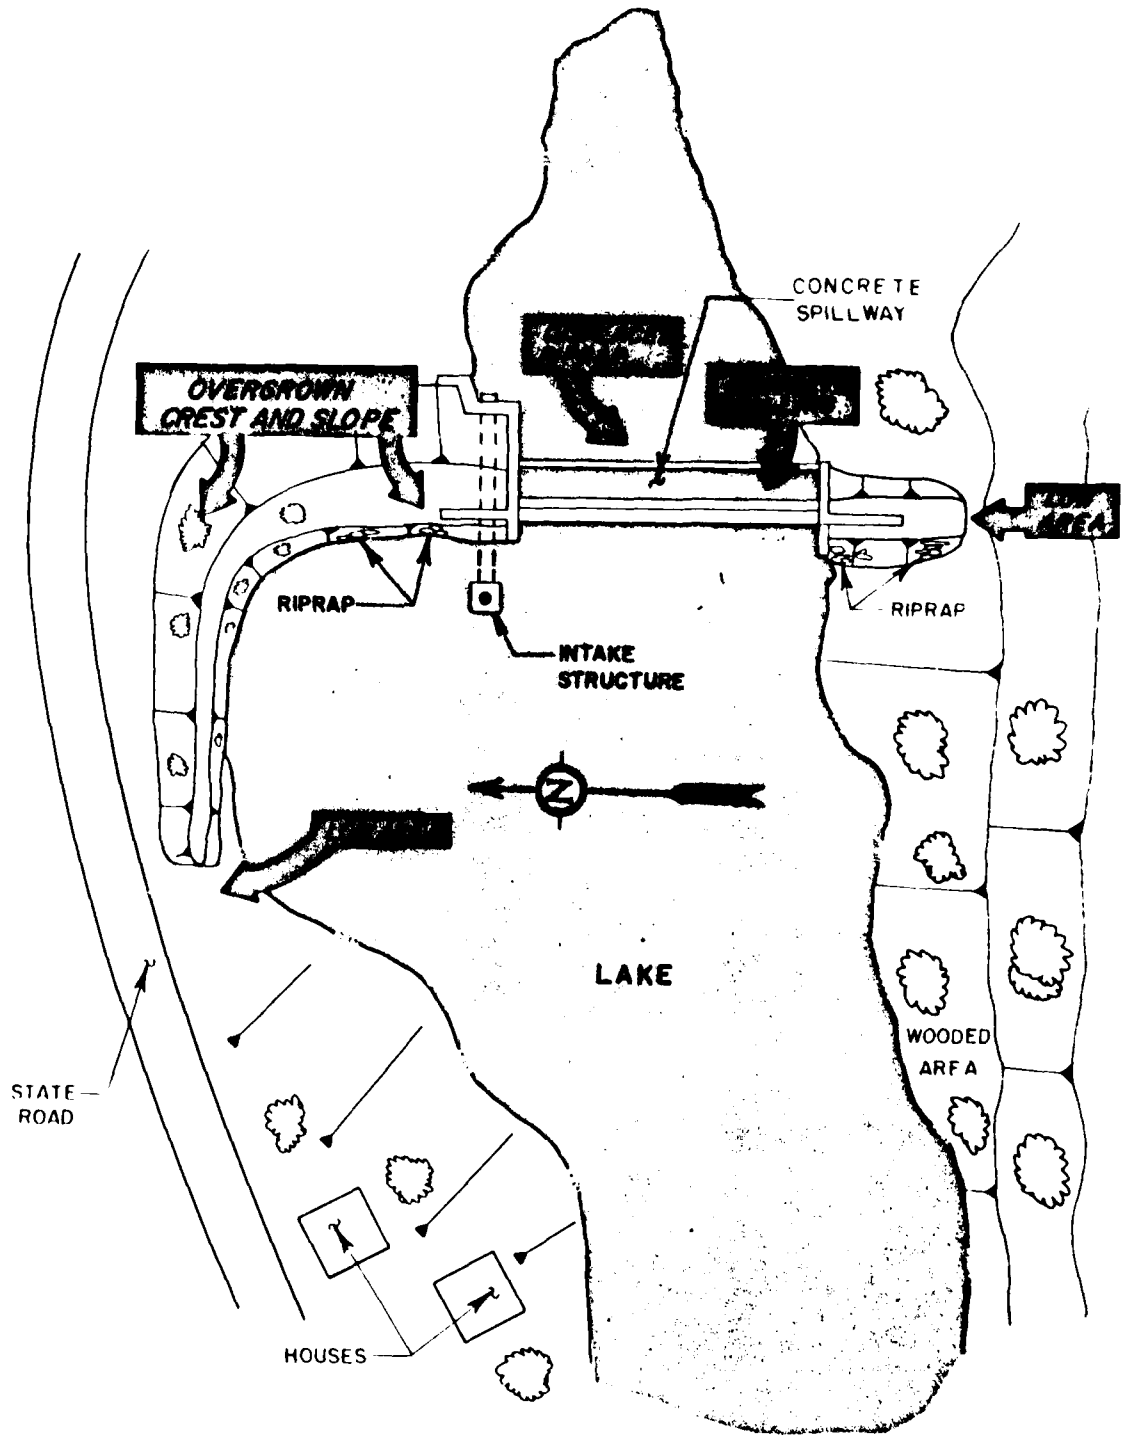
BEAVER POND DAM
GENERAL PLAN-FIELD INSPECTION NOTES

The overall condition of the facility is considered to be good. Low areas were noted at or near both embankment-abutment junctions. These levels should be verified by an accurate survey and remedial measures implemented. The operability of the sluice gate should be verified. Efforts should also be made to clear embankment overgrowth from both the upstream and downstream slopes. Some concrete deterioration is evident in the spillway and spillway apron which should be repaired along with the rearrangement of displaced riprap observed in the discharge channel. In addition, potential obstructions to free spillway discharge such as the large stump and boat dock section observed in the spillway forebay should be removed.

1. Low areas approximately one-foot below the design crest elevation occur in both the left and right abutments. An accurate survey is recommended and the areas should be regraded consistent with the design top of dam elevation.
