**PURDY (STUMP POND) DAM**

NDI No. PA 00063

**PHASE I INSPECTION REPORT**  
**NATIONAL DAM INSPECTION PROGRAM**

February 1981

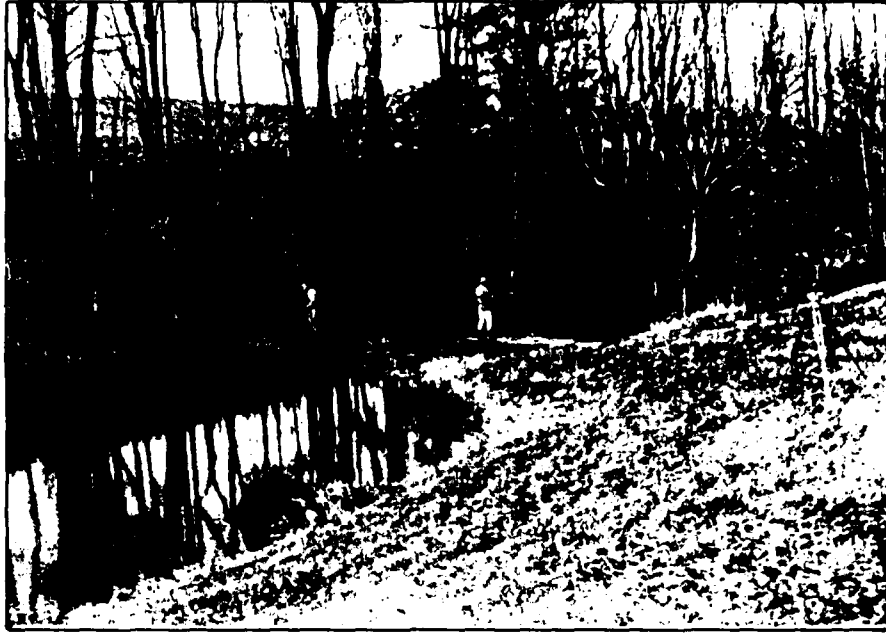
**PHOTO 1. View of Upstream Side of Dam from Right Shoreline**

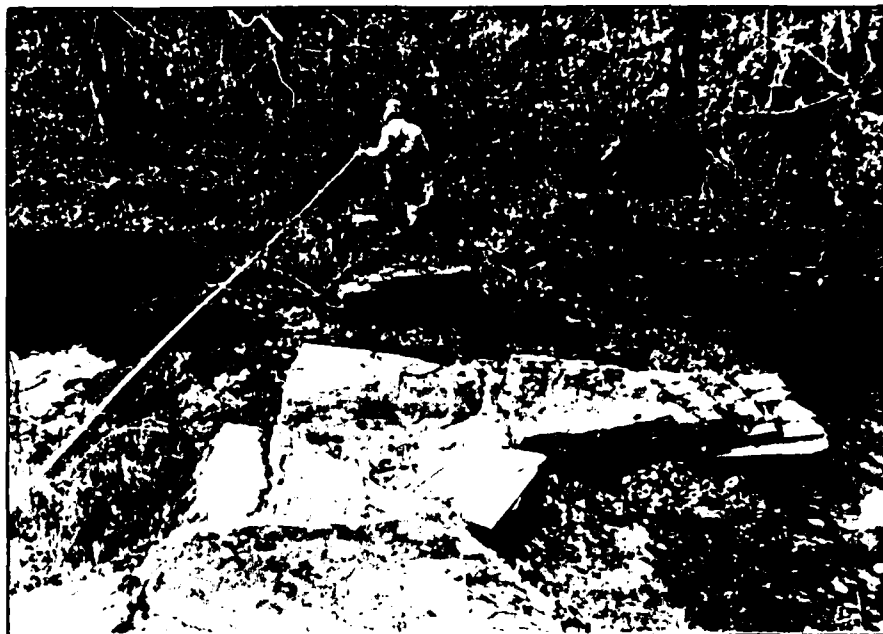
**PHOTO 3. View Across Crest of Dam from Right Abutment**
