LAKE WALTER DAM

3 NDI I.D. PA-0080

7 PHASE I INSPECTION REPORT

NAME OF DAM: Lake Walter Dam
STATE LOCATED: Pennsylvania
COUNTY LOCATED: Susquehanna
STREAM: Spring Run, Tributary of Meshoppen Creek
SIZE CLASSIFICATION: Small
HAZARD CLASSIFICATION: High
OWNER: Mr. Ray O. Walter
DATE OF INSPECTION: November 13, 1980 and February 5, 1981

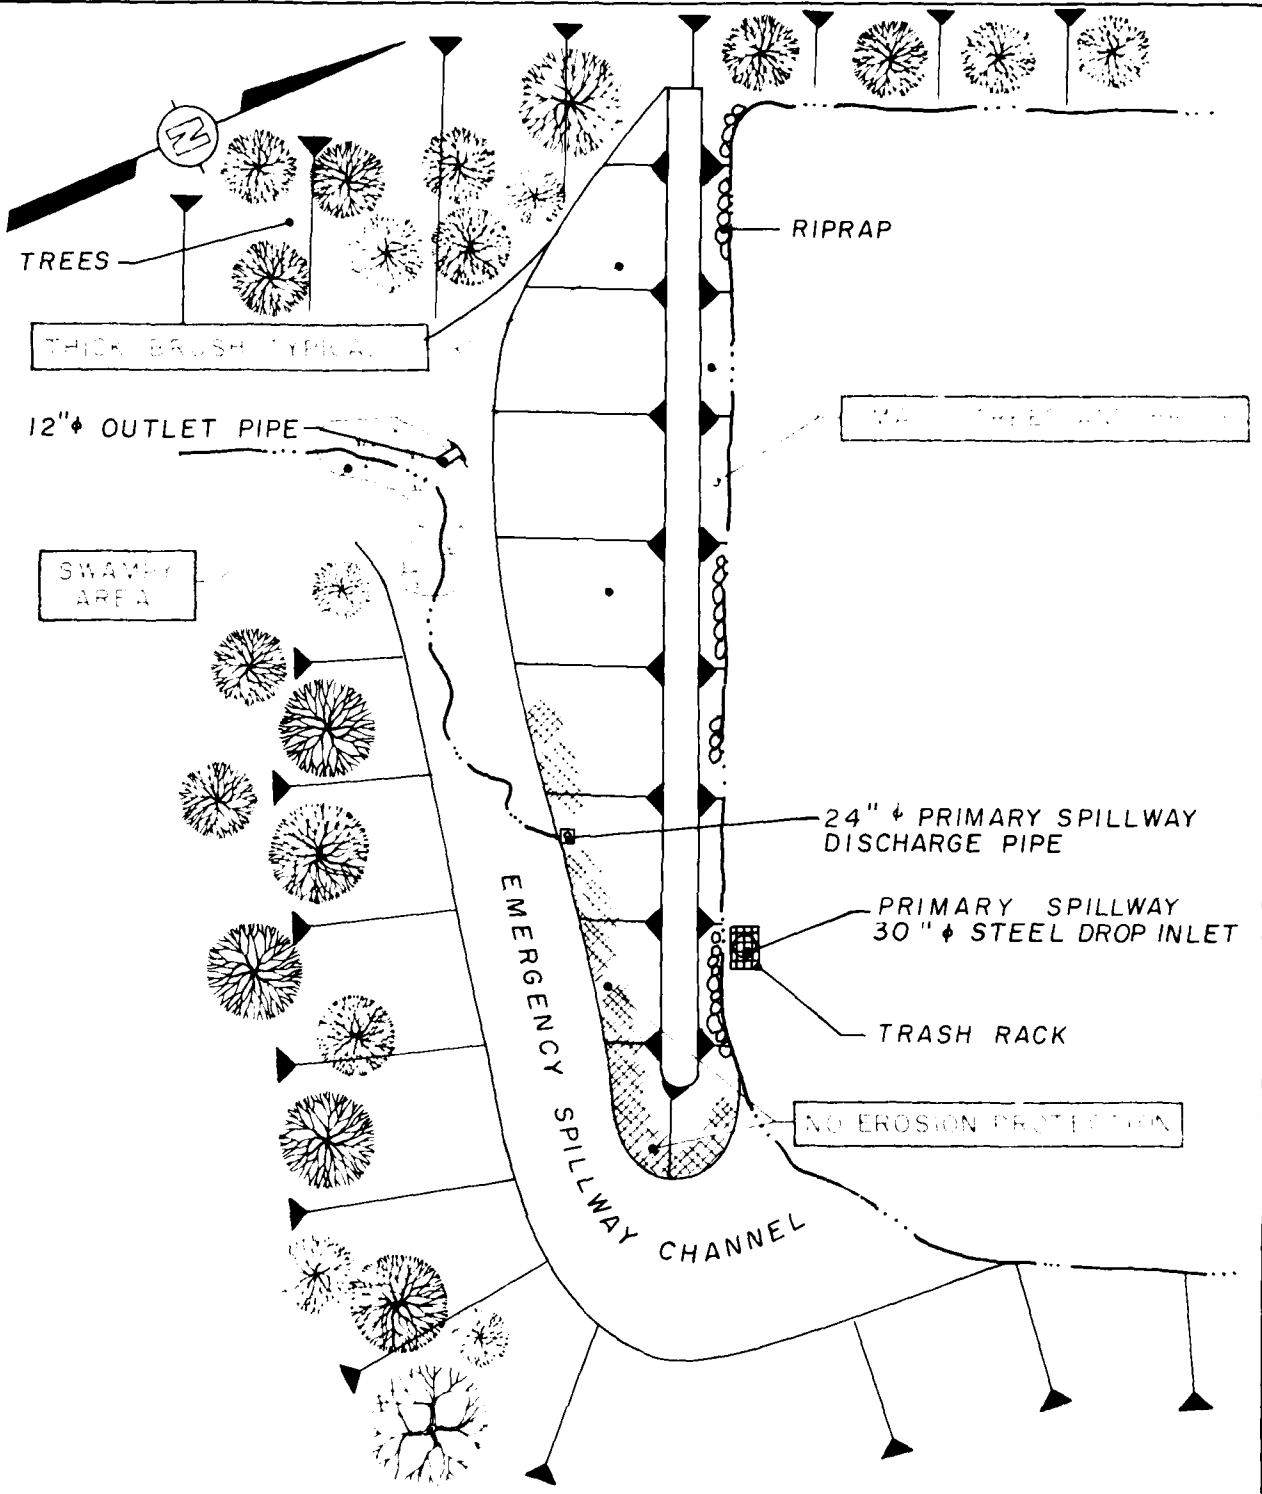
PLATE 5
 LAKE WALTER
 GENERAL PLAN
 FIELD INSPECTION NOTES
 FIELD INSPECTION DATE: NOV. 13, 1980

VISUAL EXAMINATION OF	OBSERVATIONS	REMARKS OR RECOMMENDATIONS
JUNCTION OF EMBANKMENT AND ABUTMENT, SPILLWAY AND DAM	No signs of distress observed.	
ANY NOTICEABLE SEEPAGE	No measurable seepage was found. There is a wet area below the toe of the dam. See Plate 5 for location.	
STAFF GAGE AND RECORDER	None	
DRAINS	None

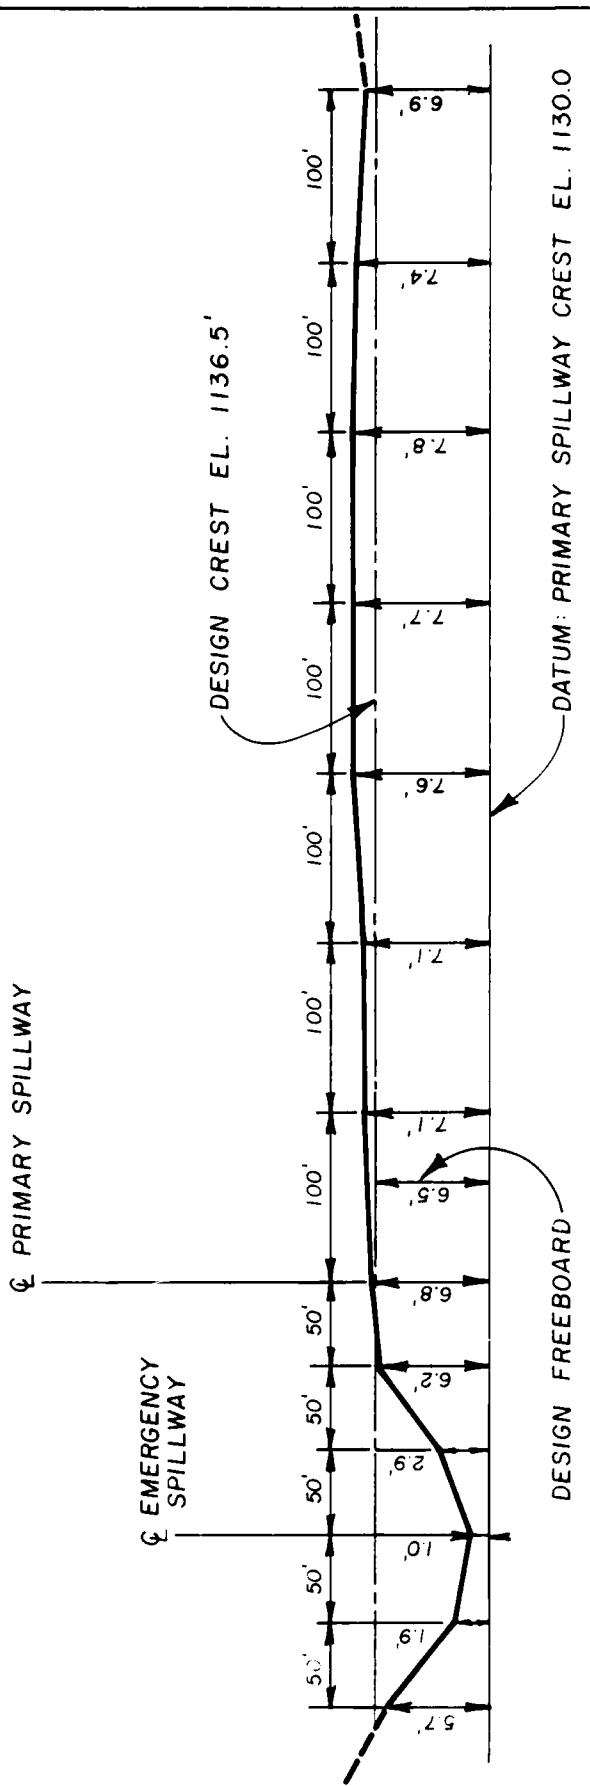
DAM CREST PROFILE
(LOOKING DOWNSTREAM)

The top of the dam was surveyed relative to the spillway crest elevation and was found to have some vertical irregularities. Although the design freeboard for the dam is 6.5 feet, the field survey indicated freeboards ranging from 6.8 feet to 7.8 feet. The lowest area occurred in a section adjacent to the emergency spillway. The dam crest profile according to field measurements is illustrated in Plate 6.
