PAGE'S LAKE DAM

Number (NDI No. PA 00062
PennDER No. 58-5)
~~Dam Owner: Lakeside Outing Club.~~

PHASE I INSPECTION REPORT NATIONAL DAM INSPECTION PROGRAM

Page's Lake Dam, Susquehanna County, Pennsylvania
NDI No. PA 00062, PennDER No. 58-5
Salt Lick Creek
Inspected 27 October 1980

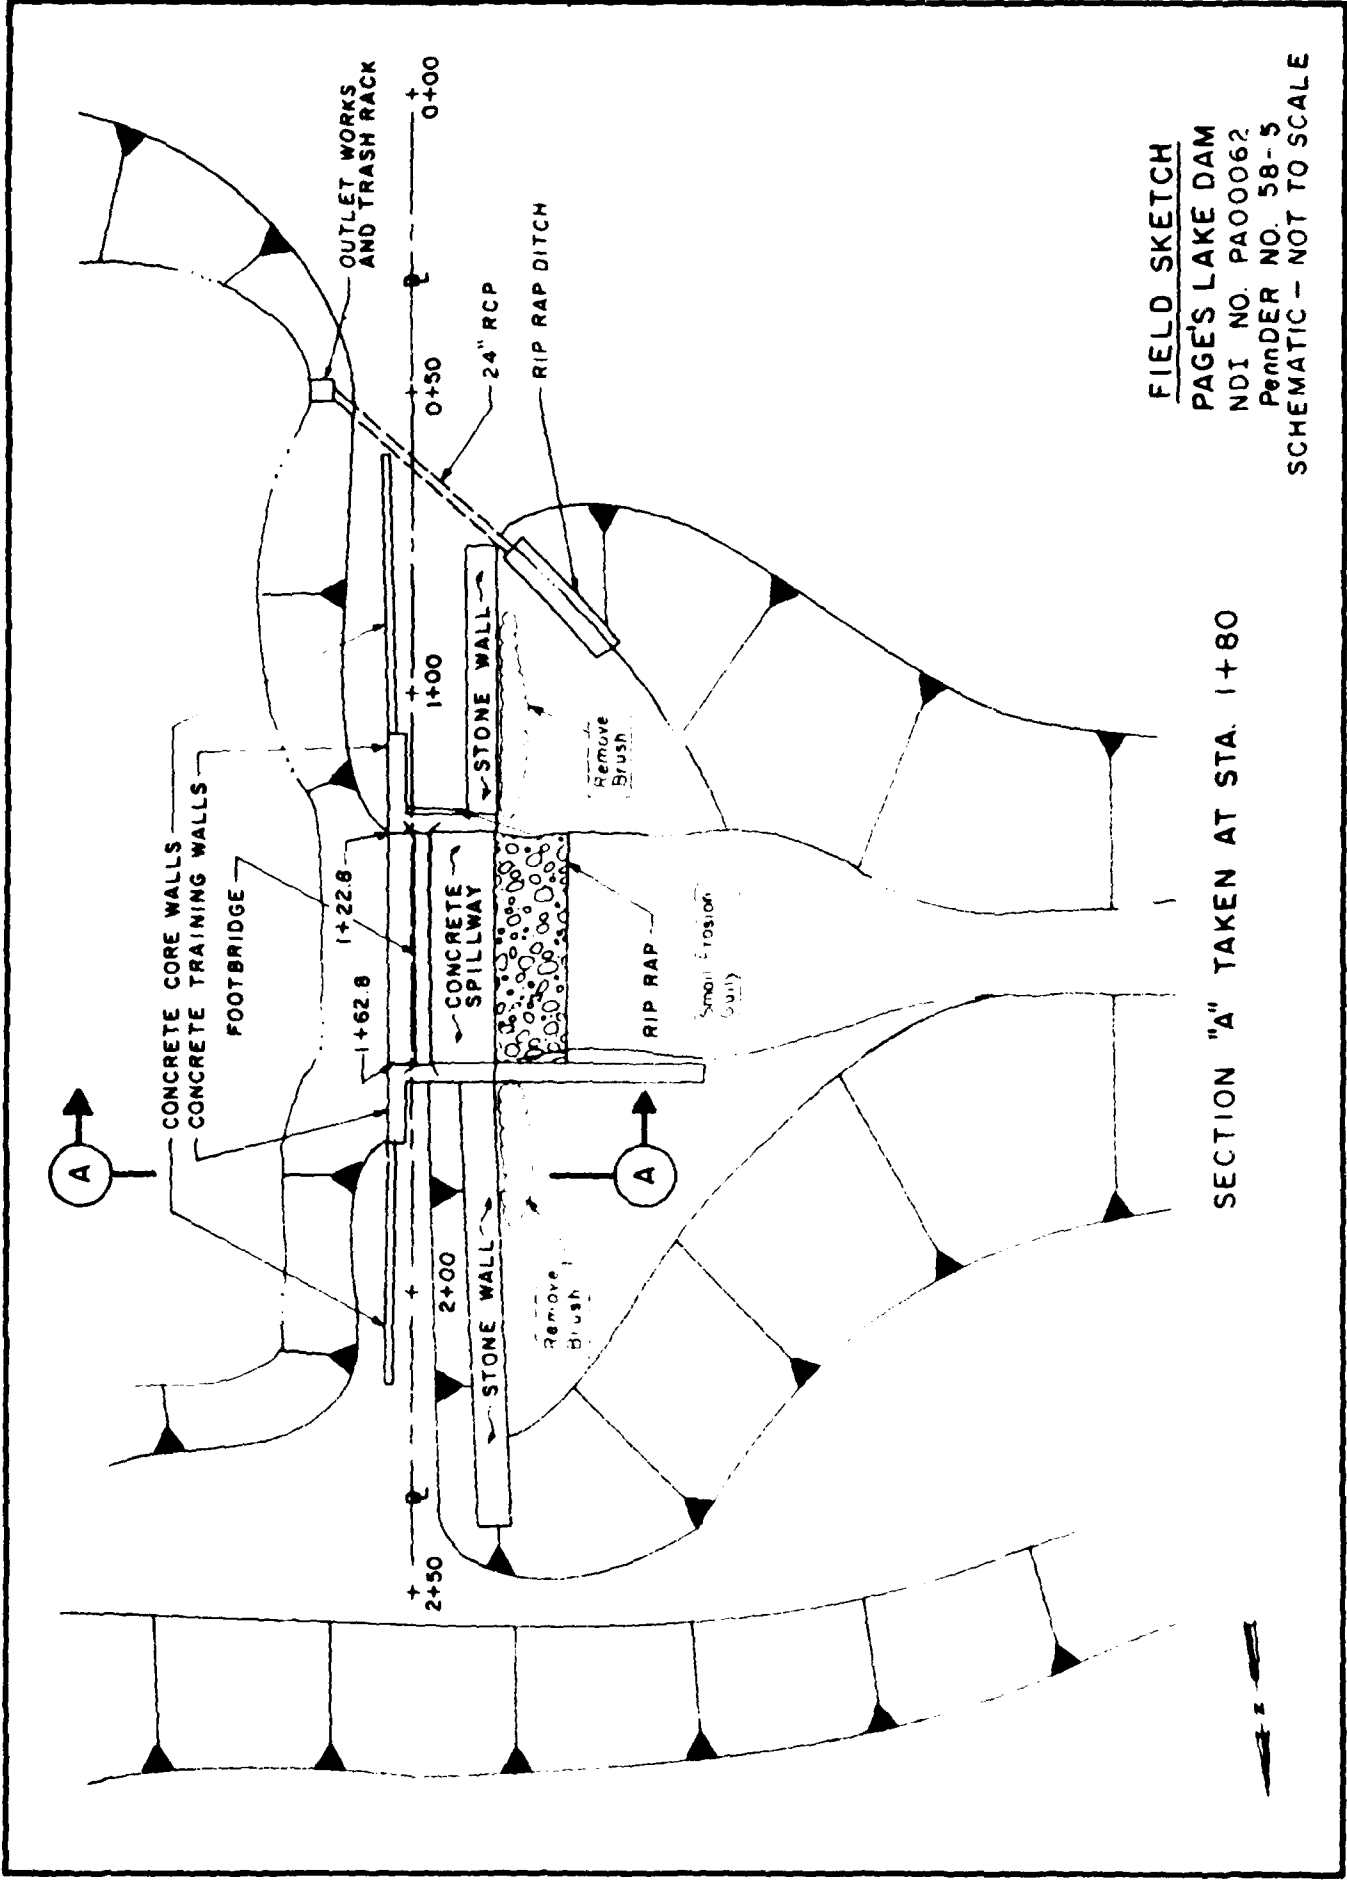
FIELD SKETCH

VISUAL EXAMINATION OF	OBSERVATIONS	REMARKS OR RECOMMENDATIONS
LEAKAGE	None observed	
STRUCTURE TO ABUTMENT/EMBANKMENT JUNCTIONS	Small erosion gully along left training wall and embankment.	Fill in gully and reseed area.
DRAINS	None observed	
WATER PASSAGES	None observed	
FOUNDATION	No problems observed

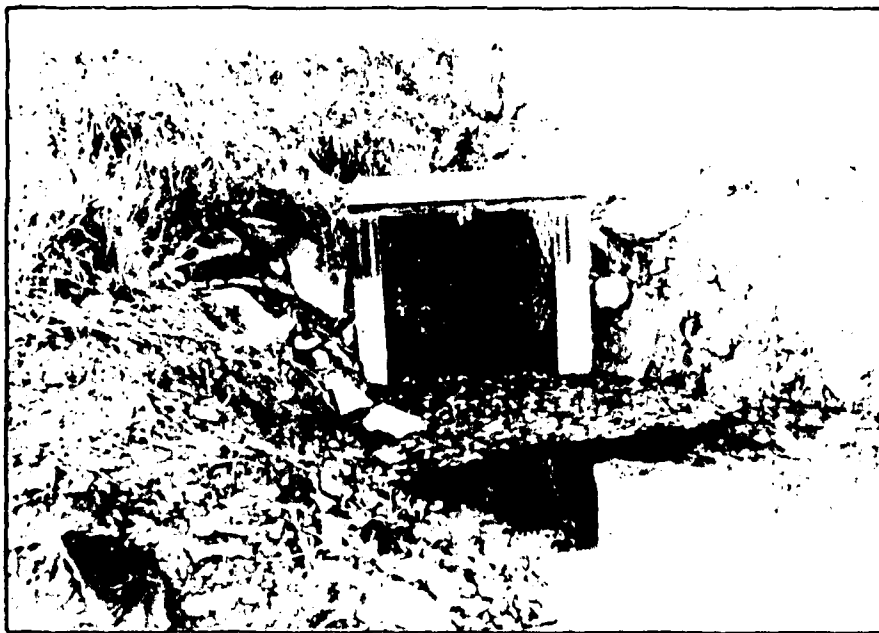
PHOTO 6. Close-up View of Intake for Outlet Conduit

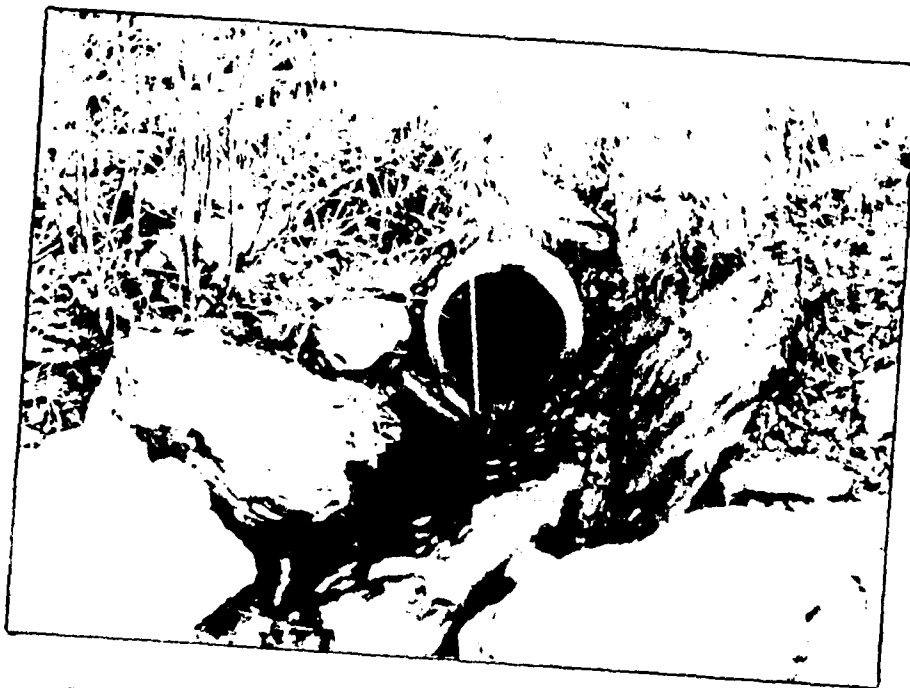
PHOTO 8. Close-up View of Downstream End of Outlet Conduit
