Dam Inspection
MARKUNAS DAM

NDI PA-0114
DER 50-063

PERRY COUNTY, PENNSYLVANIA

PHASE I INSPECTION REPORT

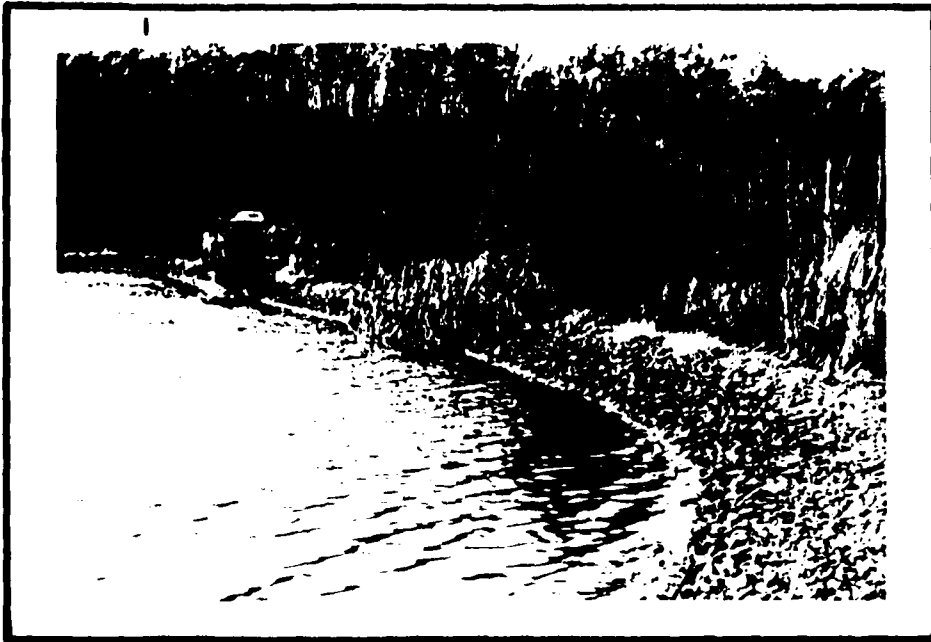
UPSTREAM SLOPE AND DROP INLET - NO. 2

The upstream slope above the normal pool elevation is covered with high weeds, some trees and brush. There were no indications of wave damage or erosion on the slope. The pool level was 2.7 feet below its normal elevation at the time of inspection.

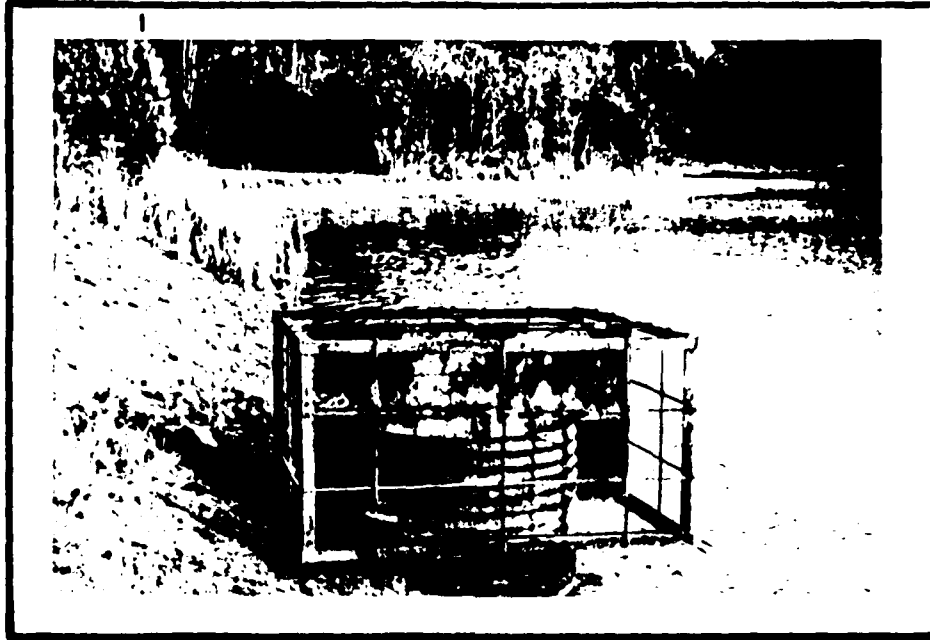
DETAIL OF DROP WELL - NO. 4

Note: Normal pool elevation was estimated from the U.S.G.S. Quadrangle sheet at elevation 695.0. This elevation is used in this report as the top of the principal spillway (Photograph No. 4).

The principal spillway consists of a 42-inch vertical drop inlet corrugated metal pipe (Photograph No. 4). To prevent clogging of the intake, a metal screen has been placed over the top of the pipe. The clearance of the screen over and around the inlet appears to be adequate to prevent a serious restriction of the opening. The vertical pipe is about 20.5 feet in height and is located about 16 feet upstream from the centerline of the dam. A 24-inch corrugate pipe extending through the embankment provides the outlet of the principal spillway (Photograph No. 5). Water discharges into a small pool at the end of this pipe. It appeared that at the upstream side of the 42-inch vertical pipe, stoplogs closed an opening at the bottom of the inlet. Some water was seeping through these logs. It is assumed that an upstream horizontal pipe was used during construction as a temporary outlet.

Provisions should be made for removal of the stoplogs in the outlet conduit in the event of an emergency.

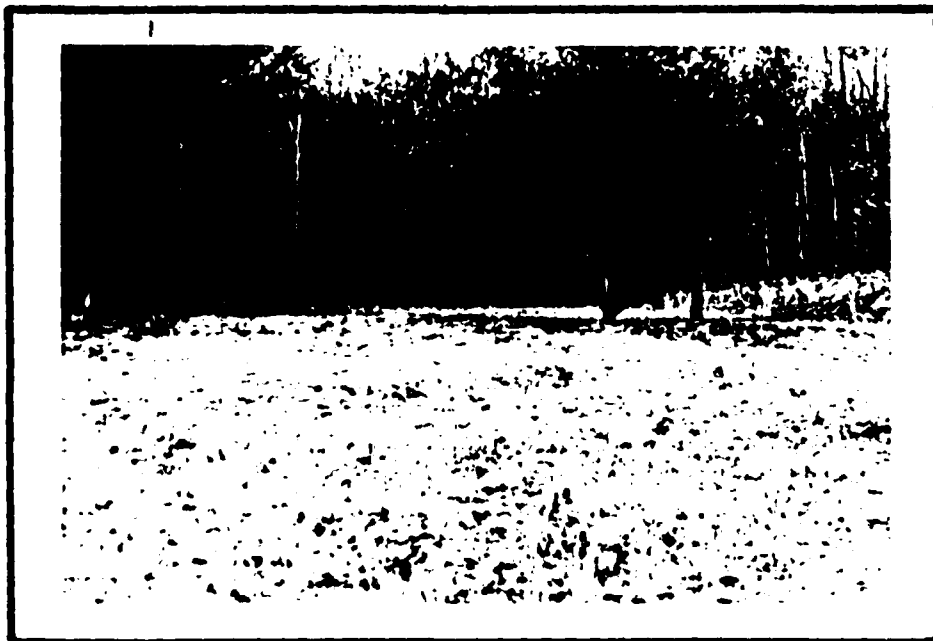
EMERGENCY SPILLWAY LOOKING DOWNSTREAM - NO. 7

An emergency spillway is located in the right abutment. It appears that this spillway was created by excavating natural ground. The approach channel is directly from the reservoir, and the spillway has a wide, flat, sparsely sodded channel which discharges into a downstream wooded area away from the embankment.

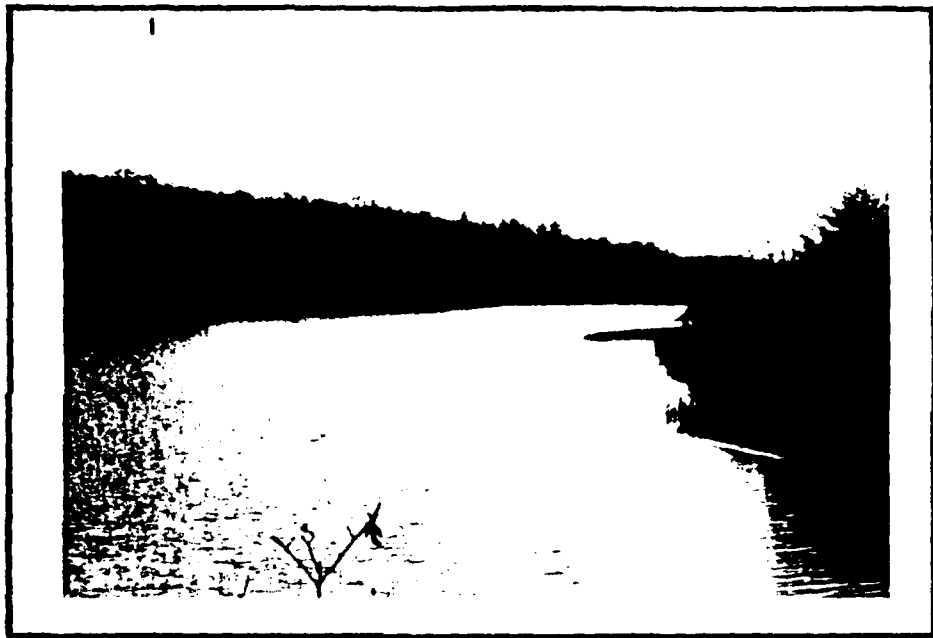
RESERVOIR - NO. 8

The reservoir area has moderate slopes on the left side consisting of abandoned farm land. The right side of the reservoir consists of steeper wooded slopes. The banks are stable and sedimentation is not expected to be a serious problem.
