OHIO RIVER BASIN
GLADE RUN
BUTLER COUNTY,
PENNSYLVANIA

NDI No. PA 01071
PENN DER No. 10-60

① National Dam Inspection Program
GLADE RUN DAM.
(NDI Number PA 01071)
(PENN DER Number 10-60)
PENNSYLVANIA FISH COMMISSION.

PHASE I INSPECTION REPORT.
NATIONAL DAM INSPECTION PROGRAM

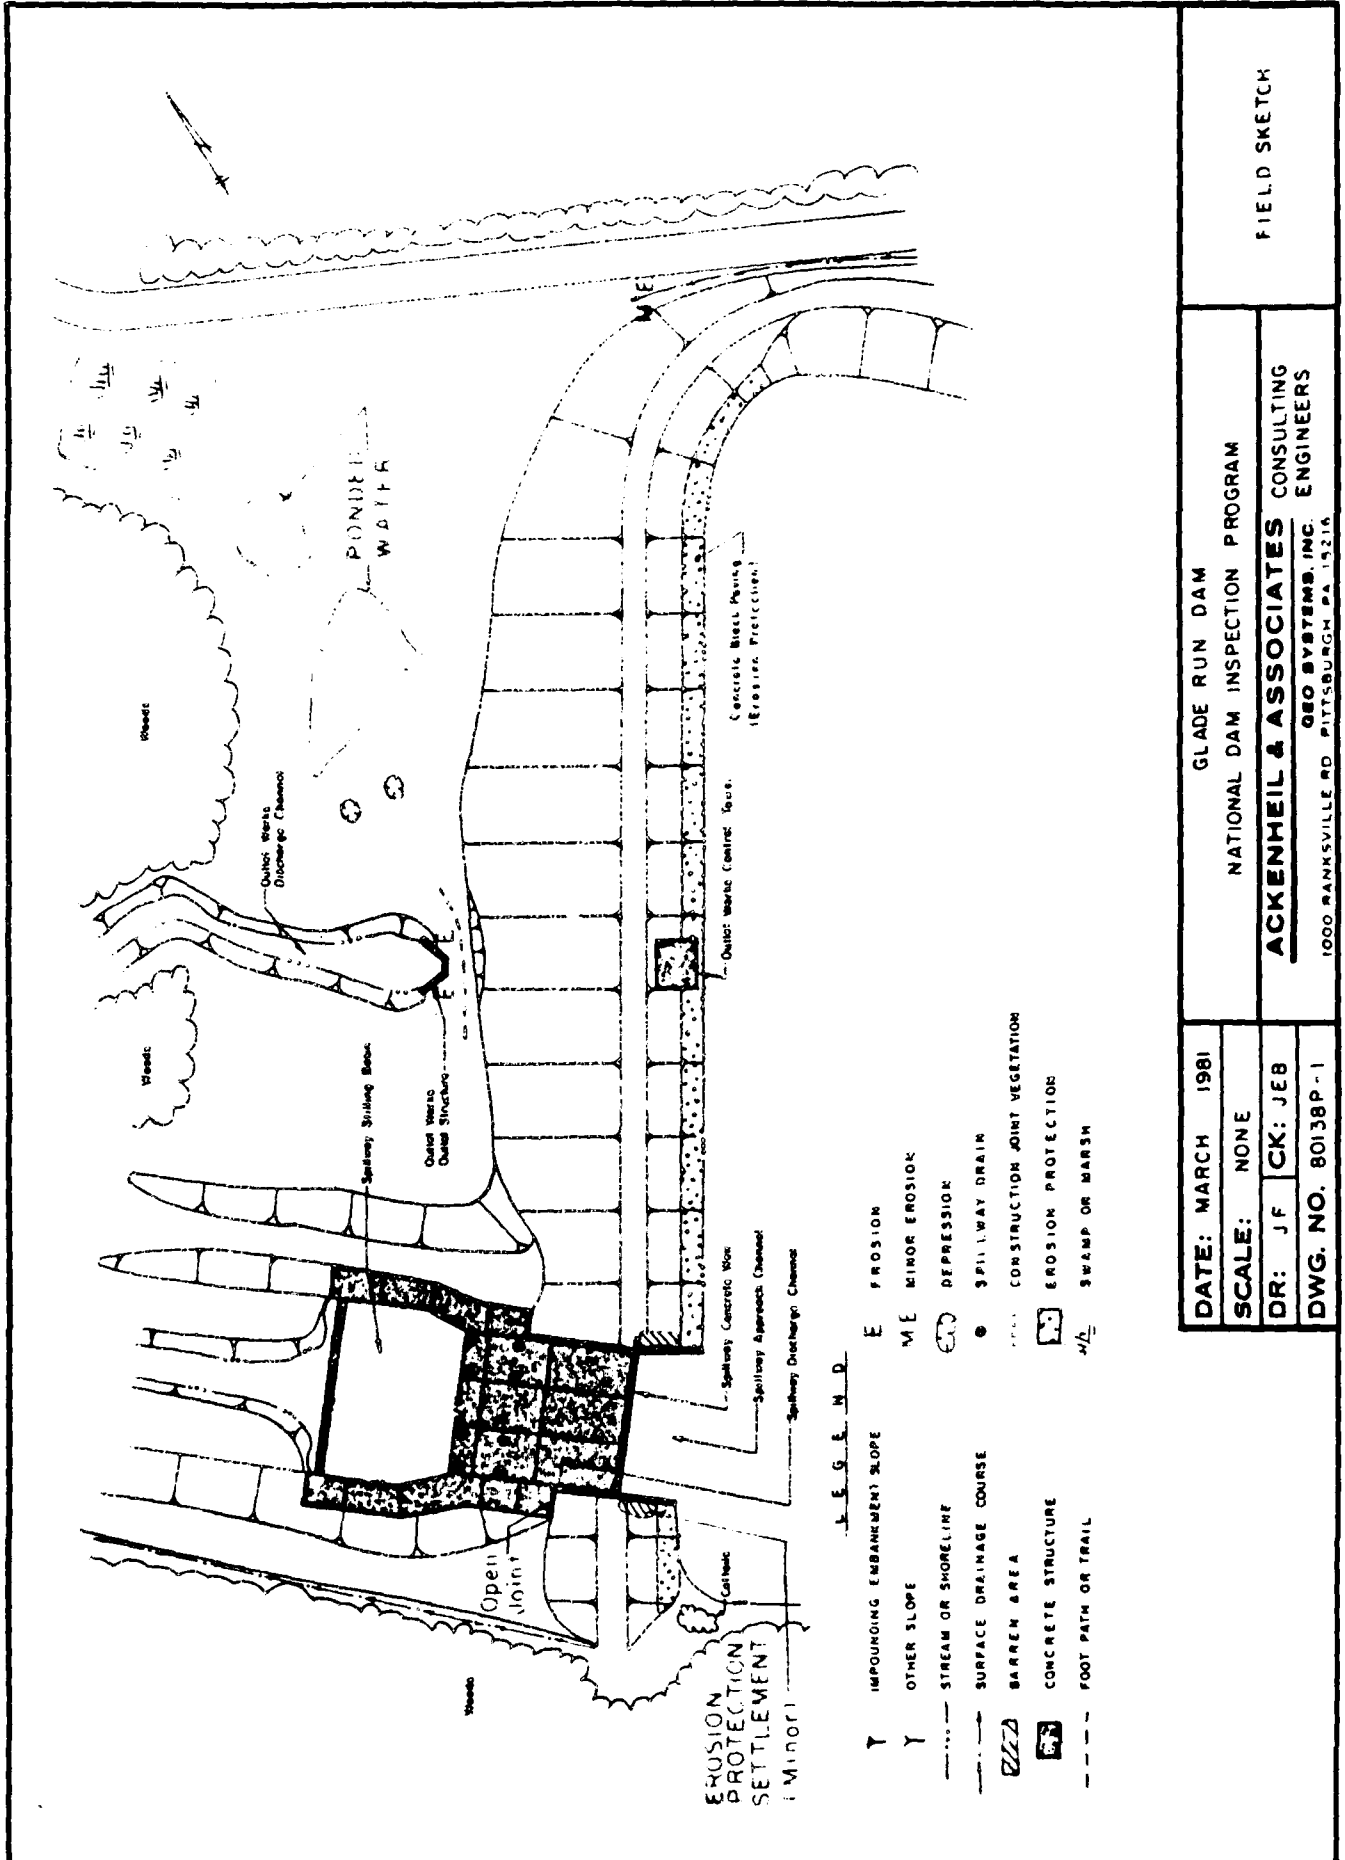
FIELD SKETCH

Minor settlement of the erosion protection was noted immediately to the left of the spillway's left training wall.

EROSION PROTECTION SETTLEMENT (MINOR)

c. Repair of the minor settlement in the concrete block pavement near the left spillway training wall.
