PHASE I REPORT
NATIONAL DAM INSPECTION PROGRAM

NAME OF DAM: Chamberlain Pond Dam
STATE LOCATED: Pennsylvania
COUNTY LOCATED: Wyoming
STREAM: Little Mehoopany Creek, tributary of the Susquehanna River
SIZE CLASSIFICATION: Small
HAZARD CLASSIFICATION: High
OWNER: Mr. Robert Witlock
DATE OF INSPECTION: November 12, 1980 and February 4, 1981

CHAMBERLAIN POND DAM
NDI I.D. PA-0890
DER I.D. 066-011
NOVEMBER 12, 1980

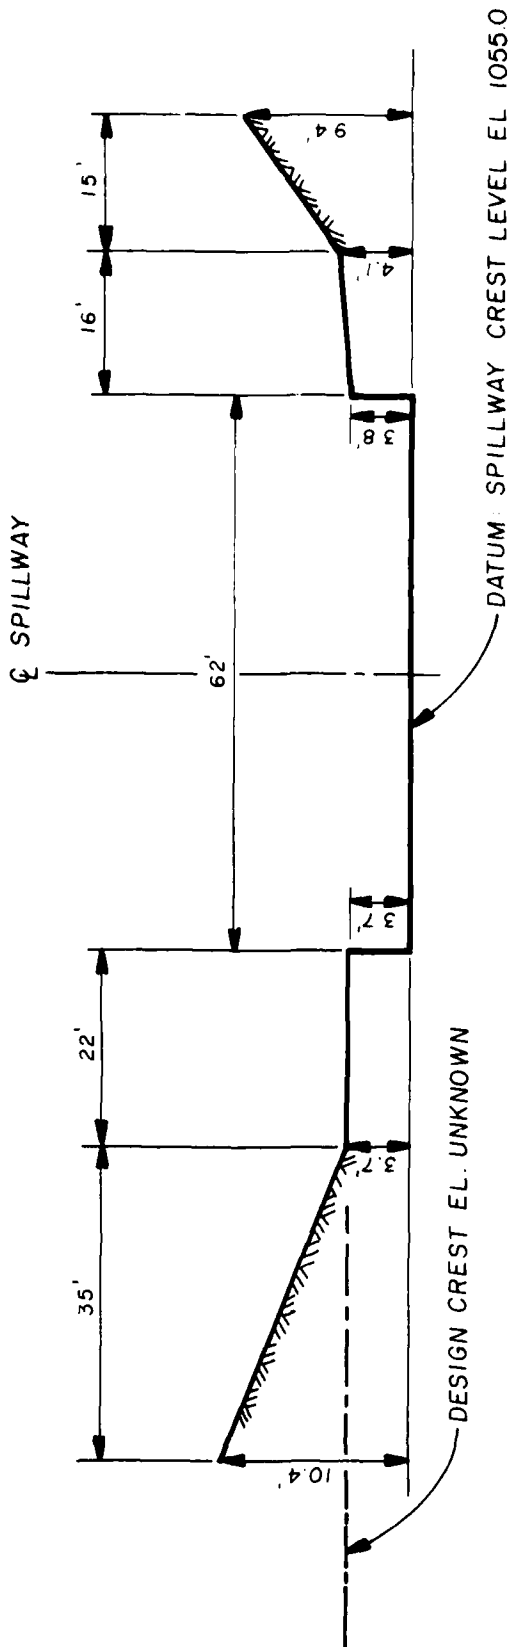
DAM CREST PROFILE
(LOOKING DOWNSTREAM)

The crest of the dam was surveyed relative to the spillway crest elevation and it was found that the low spot on the crest is the left abutment area. The profile of the embankment is relatively uniform and is illustrated in Plate 3. The available freeboard is 3.7 feet from the normal pool level to the top of the dam.
