RARITAN RIVER BASIN,
ELECTRIC BROOK, MORRIS COUNTY,
NEW JERSEY.

GEORGE LAKE DAM

(NJ 00825)

**PHASE 1 INSPECTION REPORT,
NATIONAL DAM SAFETY PROGRAM**

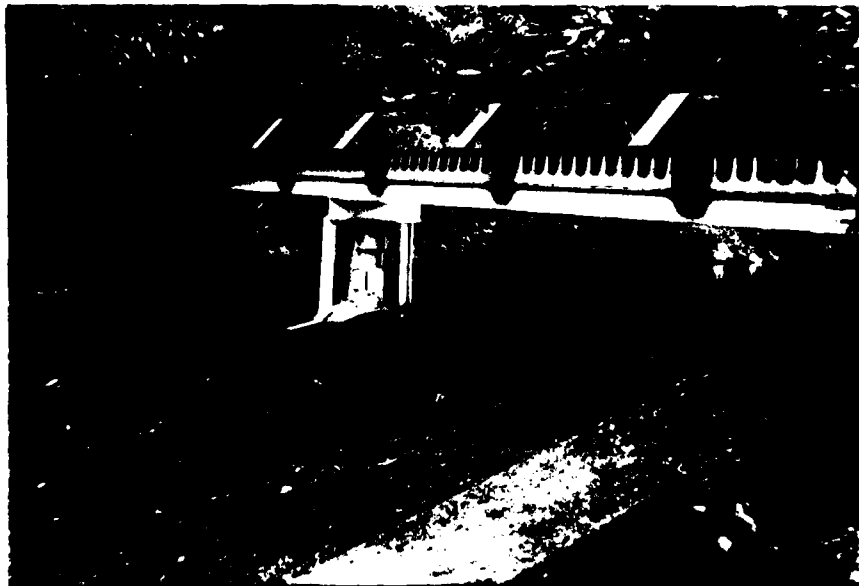
View of Spillway Crest
