National Dam Safety Program  
D.M. (NJ-71447)  
**ATLANTIC COASTAL BASIN,  
WRANGEL BROOK, OCEAN COUNTY,  
NEW JERSEY. Phase 1  
Inspection Report.**

# UPPER KESWICK DAM

## NJ 00047

### PHASE 1 INSPECTION REPORT NATIONAL DAM SAFETY PROGRAM

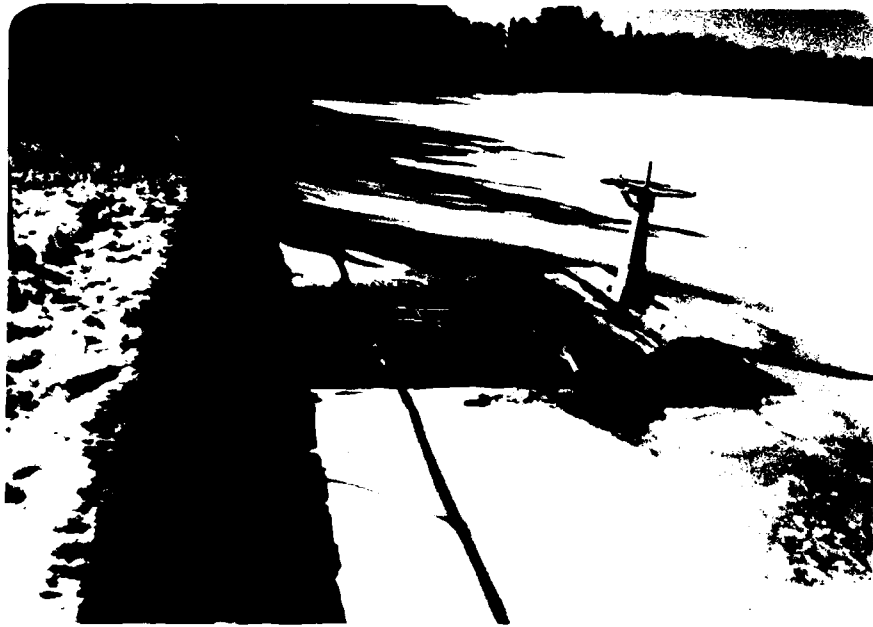
Photo 1 - View of spillway, lake and upstream slope of dam looking to the right. Note brush and small trees on slope.

(4) All trees and brush should be removed from the side slopes to avoid problems which may develop from roots. The embankment face should then be reseeded to develop a growth of grass for surface erosion protection.

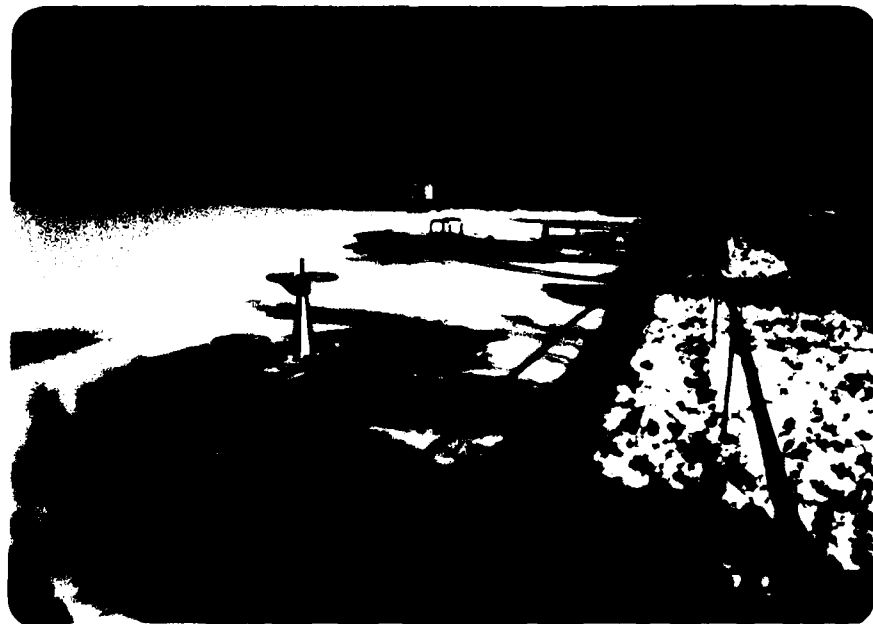
Photo 2 - View of spillway, lake and upstream slope of dam looking to the left. Note brush and trees on slope.

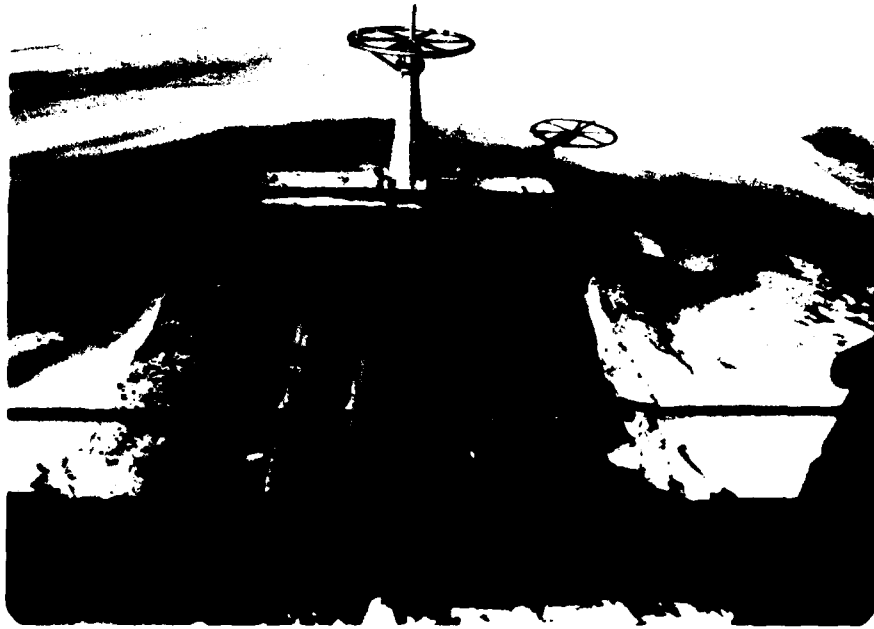
The spillway is in good condition. No cracks in the concrete caps were noted only spalling. The timber trash rack appeared in good condition.

Photo 3 - View of spillway from top of dam.

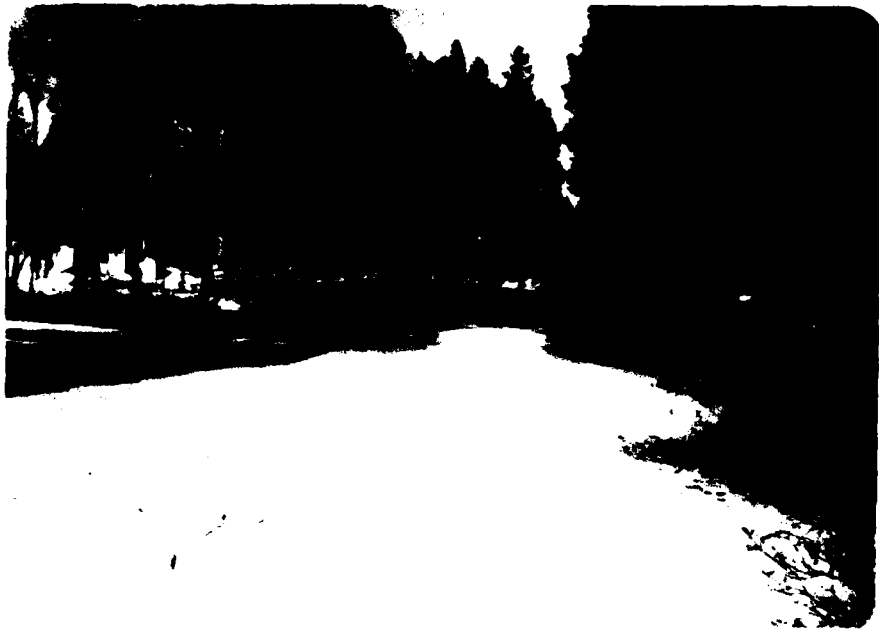
Photo 9 - View of timber bridge where the downstream channel enters the lower lake.
