NATIONAL DAM SAFETY PROGRAM. SILVER LAKE DAM (NJ00469), WALLKIL--ETC(U)

4. TITLE (and Subtitle) Phase I Inspection Report National Dam Safety Program Silver Lake Dam, NJ00469 Sussex County, N.J.	5. TYPE OF REPORT & PERIOD COVERED FINAL

SILVER LAKE DAM (NJ00469)

Name of Dam: Silver Lake Dam, I.D. NJ00469
State Located: New Jersey
County Located: Sussex
Drainage Basin: Wallkill River
Stream: Tributary to Franklin Pond Creek
Date of Inspection: December 19, 1980

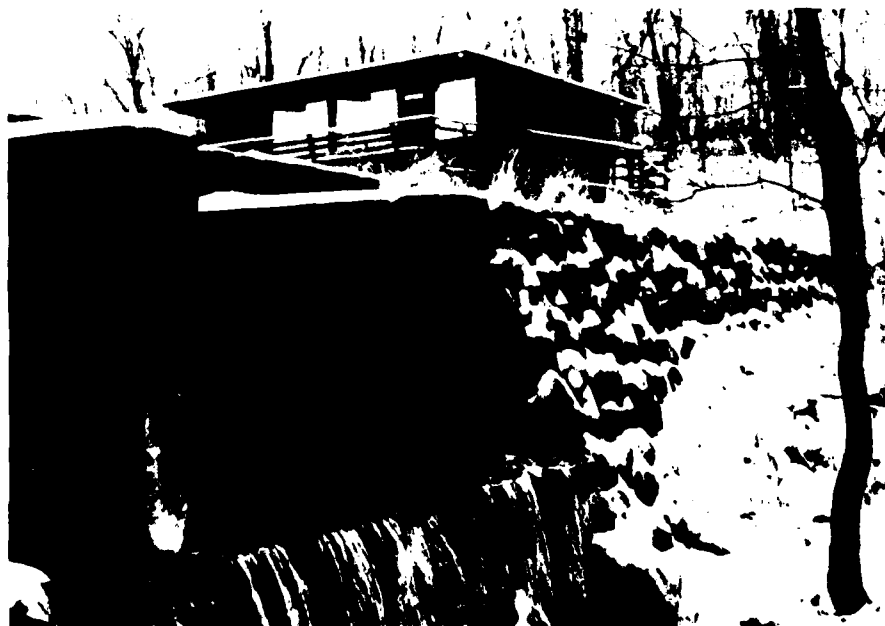
PHOTO 4

The walls forming the upstream and downstream face of embankment appeared to be in satisfactory condition. The crest of dam was uniformly graded and grass covered. An earth slope was observed on the downstream side of the dam extending downward from the toe of the stone rubble wall. The slope, which was covered with trees ranging in size from one inch to six inches, is reportedly part of the original terrain existing before the dam was constructed. At the toe of this slope left of the spillway, two areas of standing water were observed. The standing water could possibly be due to seepage.

DOWNSTREAM SIDE OF SPILLWAY AND
EMBANKMENT - LEFT SECTION

The observed seepage at the left side of the dam at the toe of slope should be monitored on a periodic basis by a professional engineer experienced in the design and construction of dams in order to detect any changes in volume or condition.

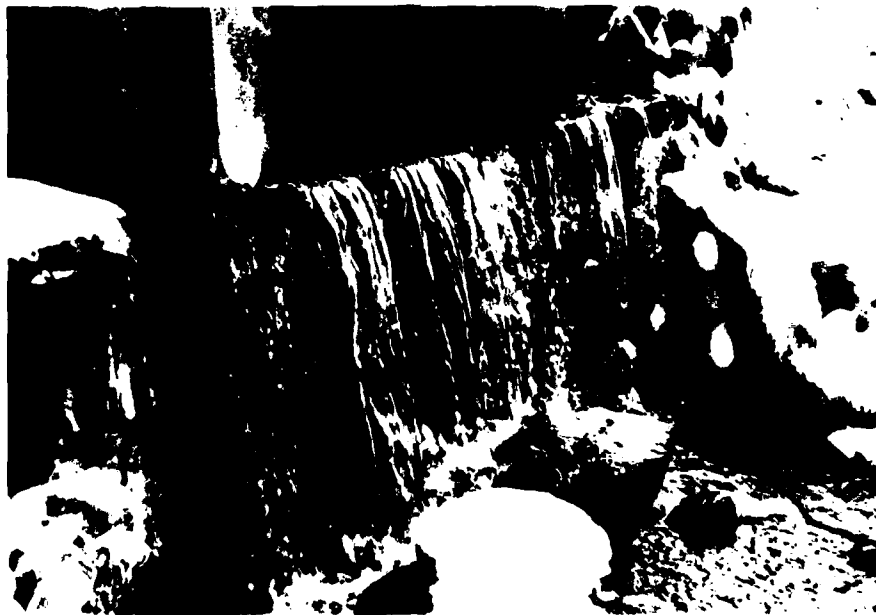
PHOTO 6

SPILOVER AT DOWNSTREAM END OF SPILLWAY
