# COOKS POND DAM

## NJ00810

PHASE 1 INSPECTION REPORT  
NATIONAL DAM SAFETY PROGRAM

REPT. NO.: DAEN/NAP-53842/NJ00810-81/07

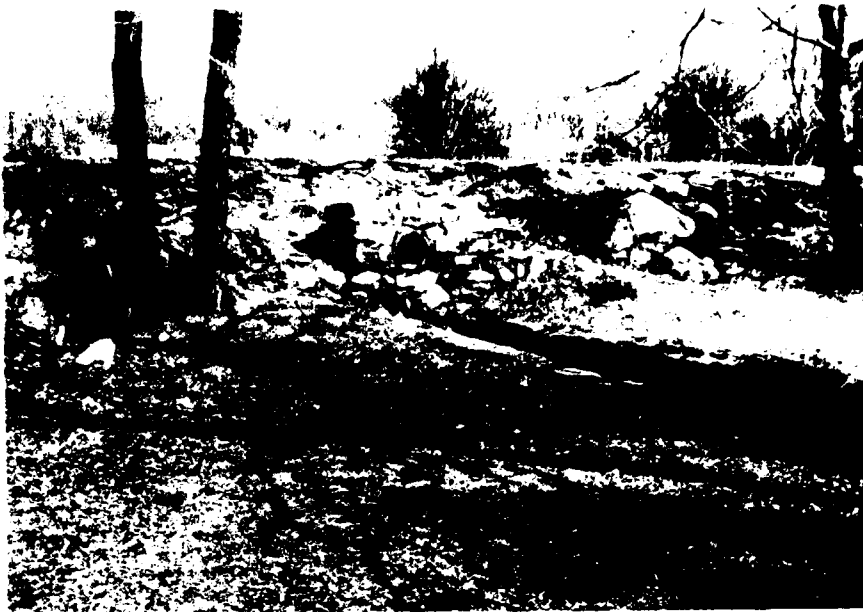
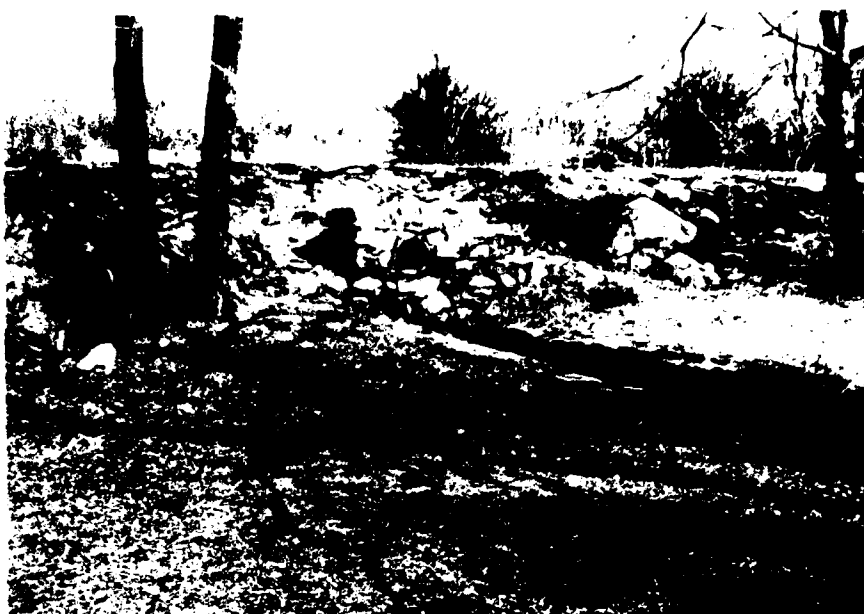
Boulders were observed on the downstream side in the vicinity of the spillway structure. The boulders were haphazardly placed and did not appear to form a uniform slope stabilization. Voids in the soil behind the boulders were observed and sloughing of the embankment in the area of the boulders was noted. Evidence of loss of soil and insufficient compaction was also noted in the vicinity of the spillway.

PHOTO 3  
DOWNSTREAM SIDE OF DAM IN VICINITY OF SPILLWAY

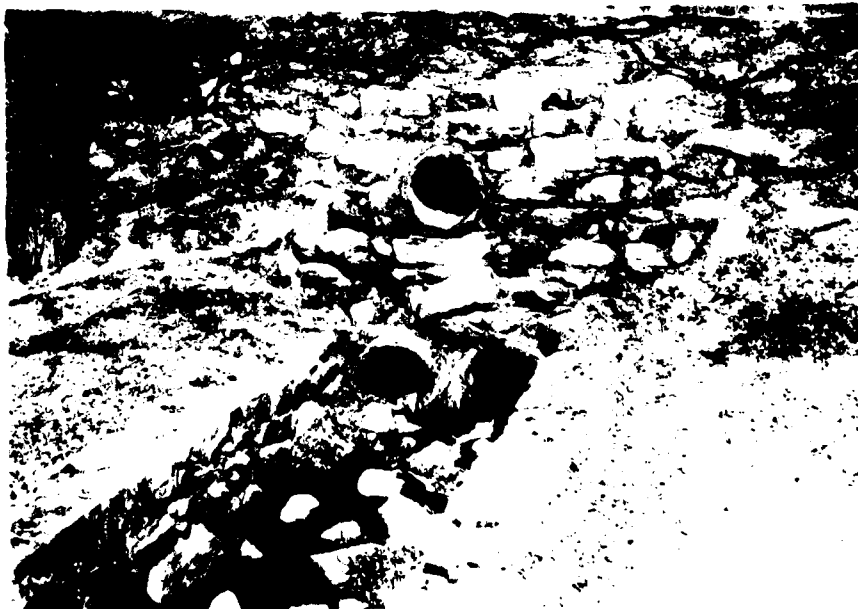
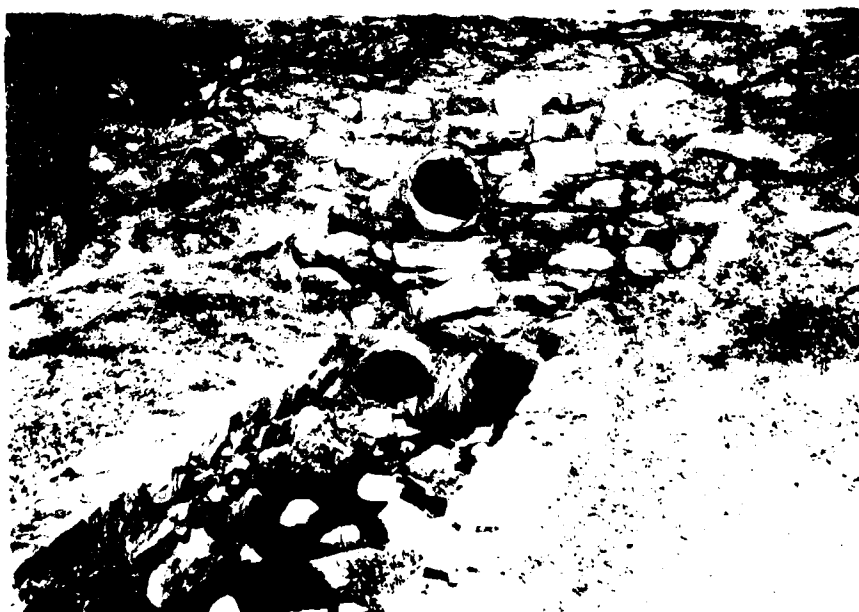
Seepage was observed in the discharge channel. Also, voids in the soil behind the boulders at the downstream end of the spillway discharge culvert were observed. The observed seepage and soil voids however, did not appear to be an indication of immediate structural instability.

PHOTO 4  
DOWNSTREAM END OF SPILLWAY DISCHARGE CULVERTS

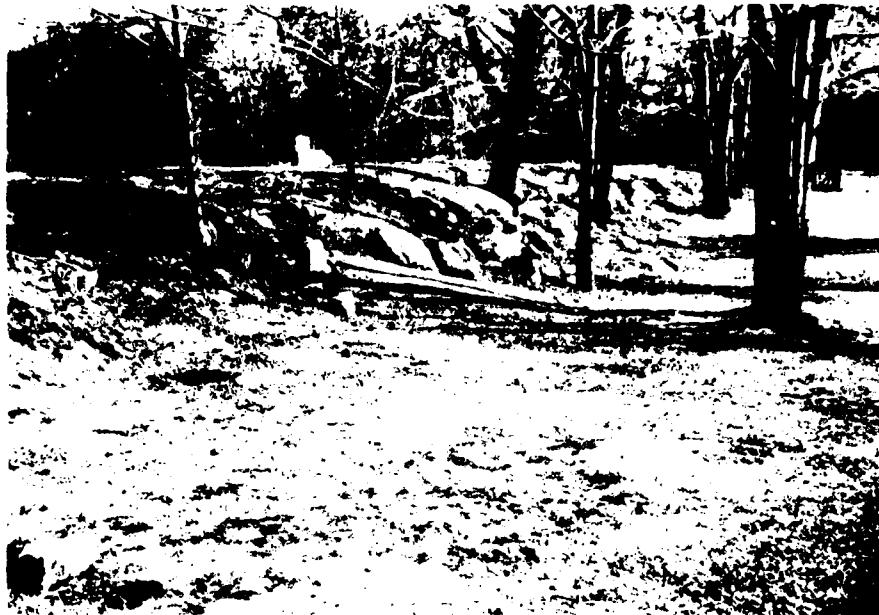
PHOTO 7  
DOWNSTREAM SIDE OF DAM
