PASSAIC RIVER BASIN
INDIA BROOK, MORRIS COUNTY
NEW JERSEY

CHEROKEE LAKE DAM NJ 00785

PHASE 1 INSPECTION REPORT
NATIONAL DAM SAFETY PROGRAM

MAY 1981

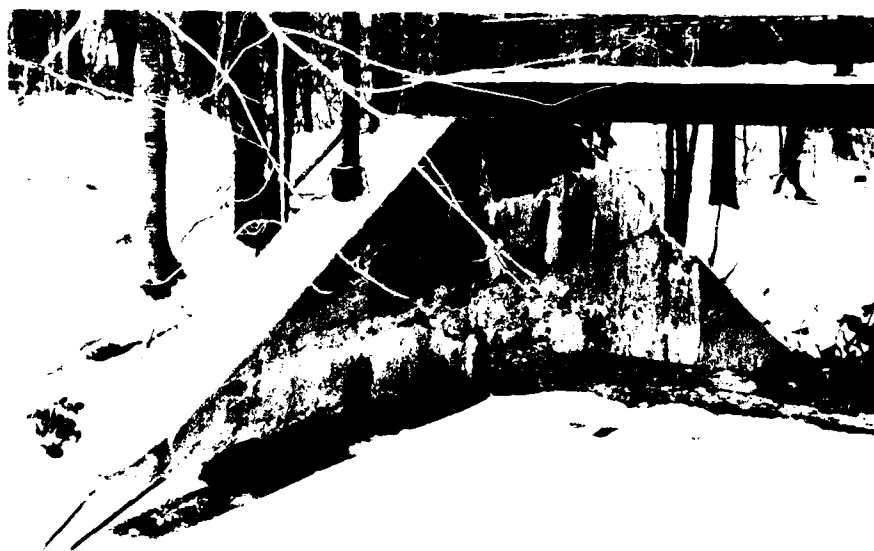
PHOTO 4

LEFT SPILLWAY TRAINING WALL

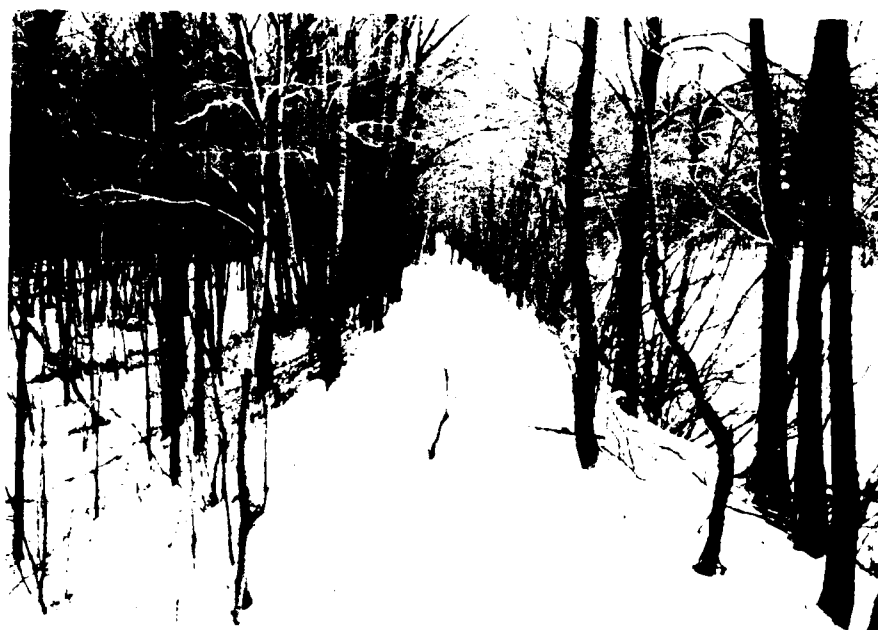
PHOTO 5
CREST OF DAM

The lower portion of the embankment crest appeared to be the same portion noted by the State Water Policy Commission in 1948 as having settled.
