**ICE POND DAM**

NDI ID NO. PA-00566  
DER ID NO. 40-79

**PHASE I INSPECTION REPORT  
NATIONAL DAM INSPECTION PROGRAM**

APRIL 1981

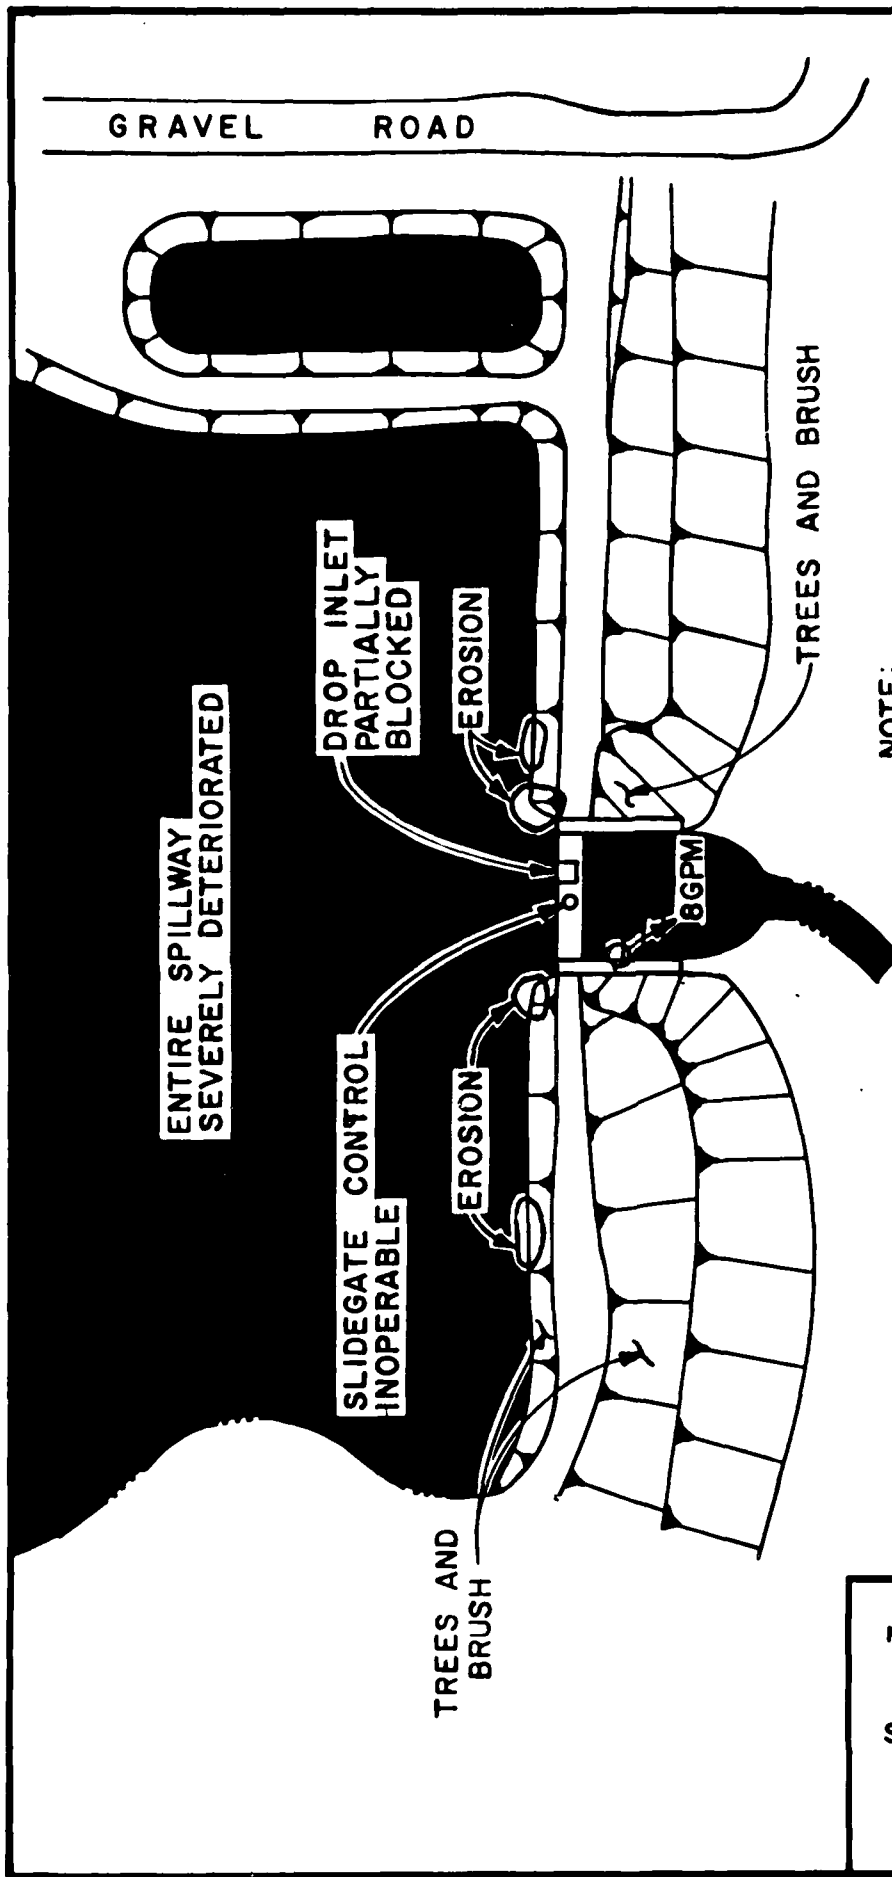
EXHIBIT A-1

NOTE:  
SPILLWAY HAS MAKESHIFT  
BRIDGE - NEAR COLLAPSE

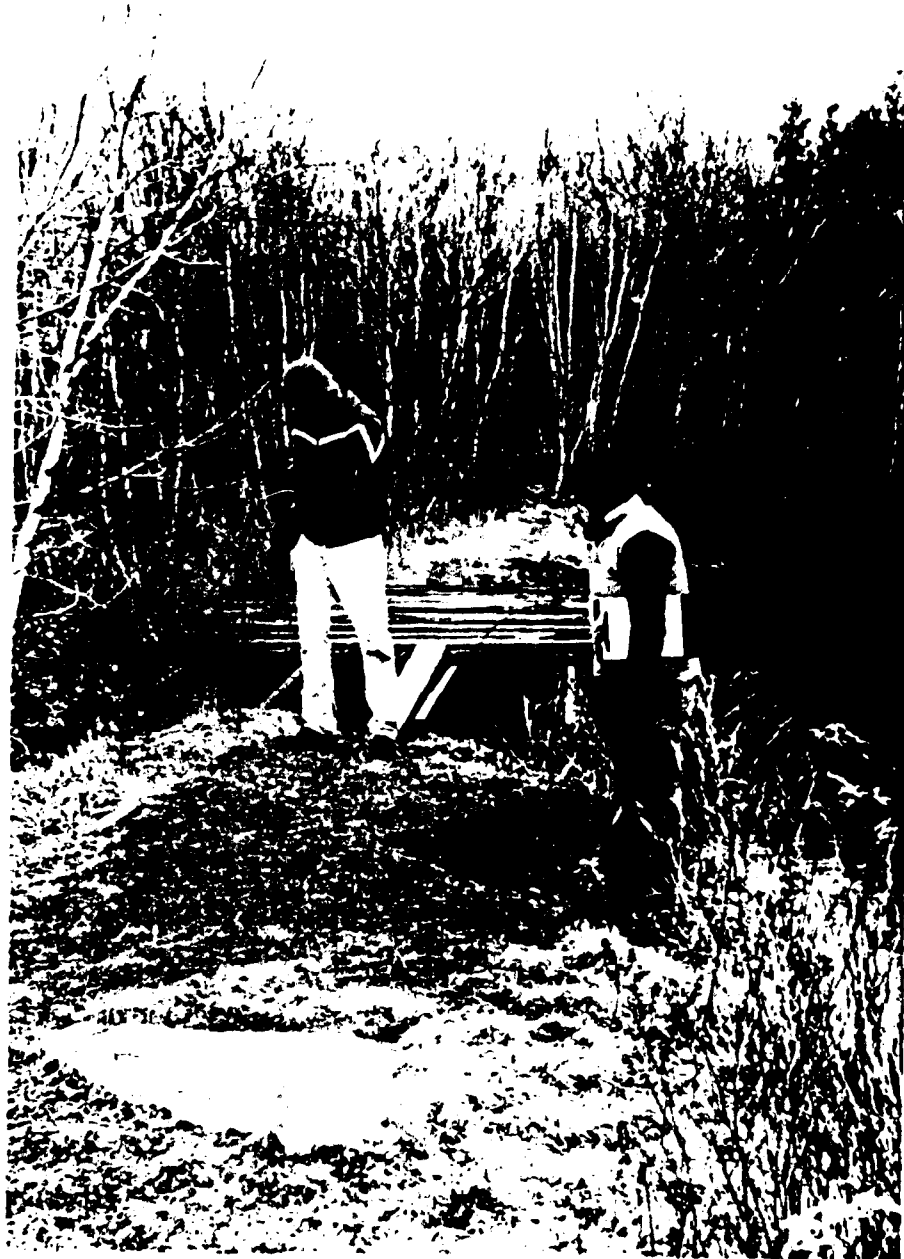
4. Erosion of upstream face and crest.  
Spillway bridge in background.
