INDIAN LAKE DAM

NDI ID NO. PA-01041

**PHASE I INSPECTION REPORT
NATIONAL DAM INSPECTION PROGRAM**

**DEPARTMENT OF THE ARMY
Baltimore District, Corps of Engineers
Baltimore, Maryland 21203**

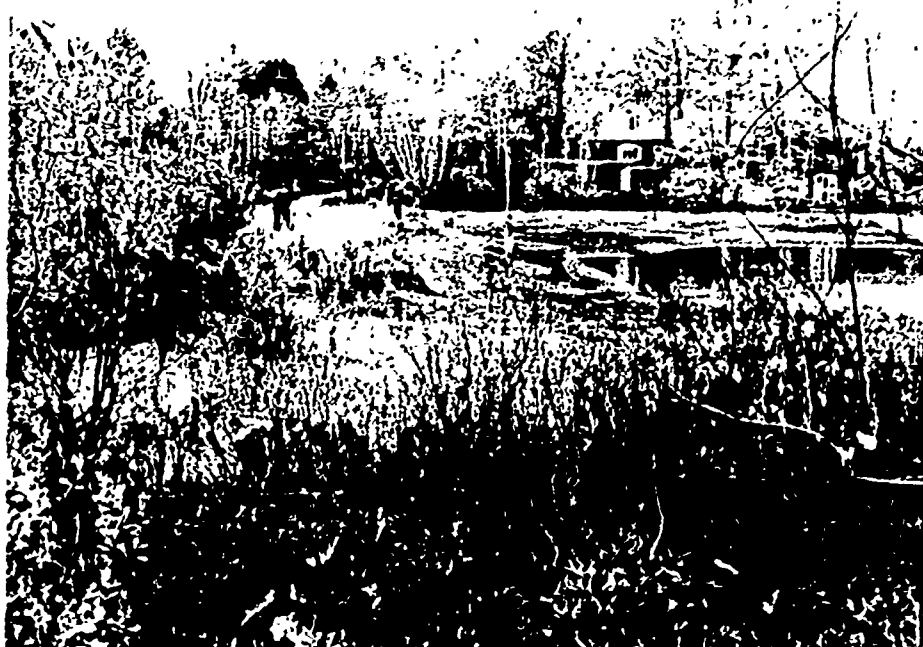
upstream face near the crest. Under this material it can be seen that the upper two feet of the upstream slope does not have riprap, and erosion has caused the slope to become near vertical. Below this point the slope is 1V:5H with riprap. During the review inspection, it was observed that this sod has not been removed and no riprap has been added. The downstream slope is 1V:5H and is covered with a new growth of grass. Approximately 25 feet downstream of the crest is a dirt and gravel roadway. The vertical alignment of the crest is irregular with the low spot occurring at the right abutment contact. No signs of seepage or sloughing were noted.

1. Crest and upstream face (22 Oct 80).

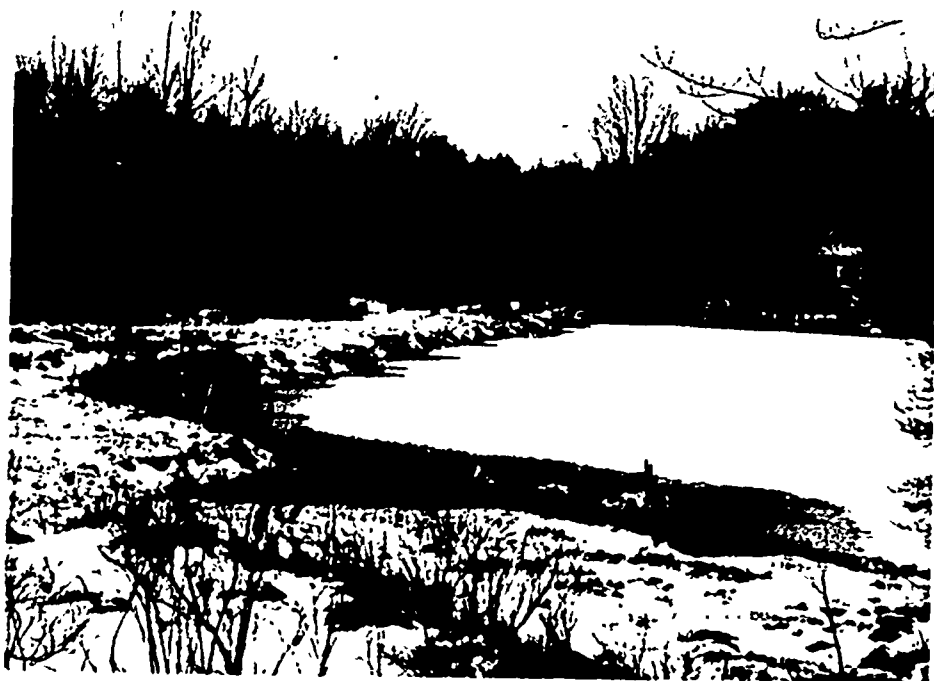
2. Upstream face (10 Mar 81).

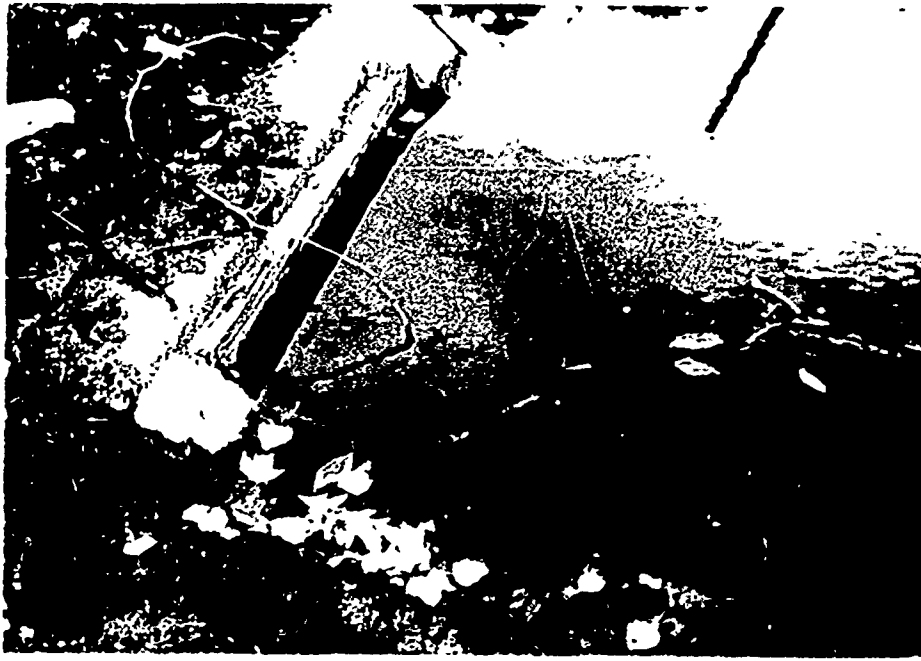
Concrete headwall in good condition. No trash rack

5. Outlet works intake structure (22 Oct 80).

b. A trash rack should be provided on the intake structure and the obstruction should be removed from the discharge end of the outlet works.

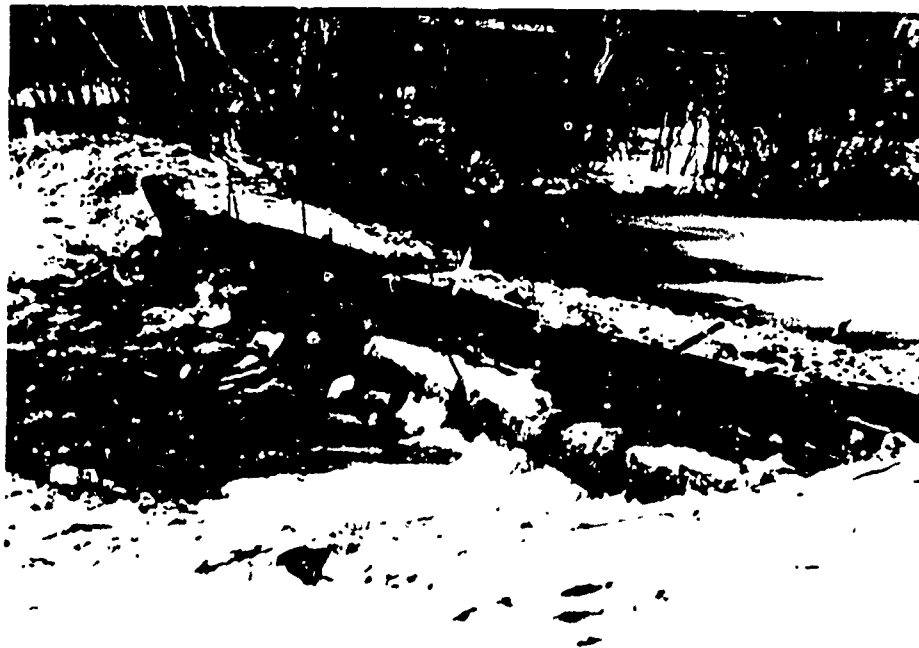
The spillway was originally designed as a five foot deep trapezoidal notch in the corewall with a 40 foot bottom width and 1V:1H sides. As noted in inspection reports by the State of Pennsylvania, lengths of telephone poles and timbers have been placed over and upstream of the corewall to raise the level of normal pool about ten inches above the design elevation. Those present during the initial inspection stated that maintenance was not complete and that the spillway would be cleaned out. However, on the day of the review inspection, the poles and timbers were placed neatly on edge and two high immediately upstream of the corewall. Metal rods were driven behind the corewall to restrain the poles. In addition, earth fill has been placed on the upstream side of this obstruction for a width of about five feet. This obstruction effectively raises the spillway crest level approximately 1.5 feet.

12" concrete corewall covered by large sections of telephone poles in random arrangement. Concrete surface severely spalled. Review inspection - poles stacked on edge, two high, with earth fill behind. Small iron pins immed. u/s of corewall retain poles.

8. Spillway crest (10 Mar 81).

a. The owner should retain a qualified professional engineer to further assess measures required to provide adequate spillway capacity for this facility. As an alternative, the removal of the telephone poles will provide adequate spillway capacity.

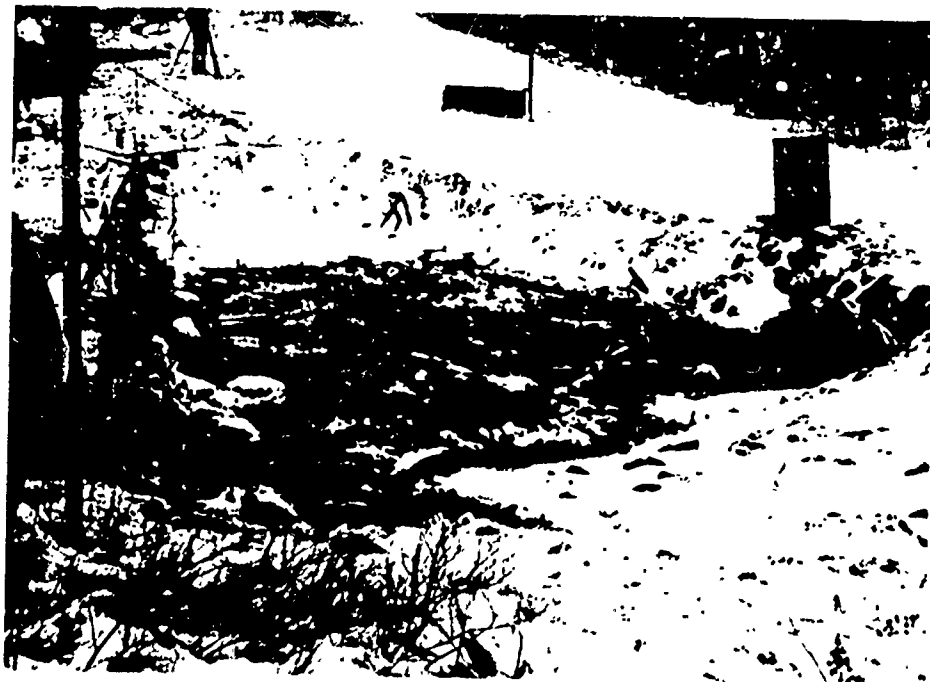
The spillway discharge channel is cut in earth the same width as the weir initially but then narrows to 25 feet wide about 25 feet downstream of the weir. At this point the flow must pass through 2-24 inch corrugated metal pipes and 1-22 inch iron pipe to cross a road. These pipes are in good condition but erosion is occurring under the pipes. However, if these pipes should fail or become obstructed, water would pond and flow over the road. This would not pose a threat to the safety of the dam. The discharge channel downstream of the pipes was recently cut in earth and has adequate dimensions. The entire spillway discharge channel and the embankment adjacent to the spillway weir are unprotected from erosion. Sufficient flows over the spillway could eventually undermine that portion of the corewall.

10. Spillway discharge channel immediately downstream of weir (10 Mar 81).

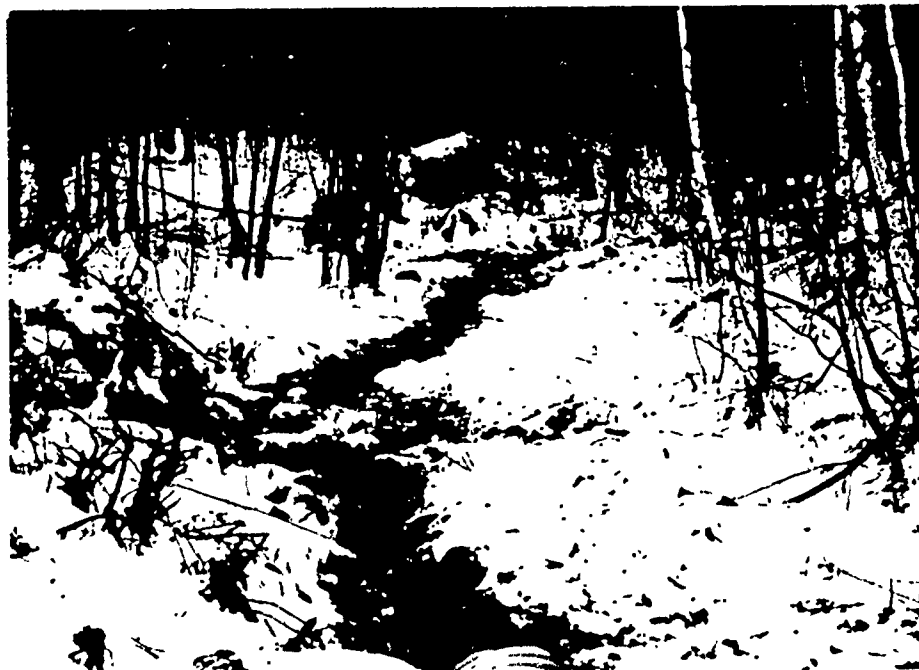
12. Spillway discharge channel downstream of road (10 Mar 81).
