LAKE SOPHIA DAM

NDI I.D. PA-0078  
DER I.D. 058-126  
OWNER: MRS. SOPHIA TUROSKI

PHASE I INSPECTION REPORT  
NATIONAL DAM INSPECTION PROGRAM

NAME OF DAM: Lake Sophia Dam  
STATE LOCATED: Pennsylvania  
COUNTY LOCATED: Susquehanna  
STREAM: Unnamed Creek, tributary of Choconut Creek  
SIZE CLASSIFICATION: Small  
HAZARD CLASSIFICATION: High  
OWNER: Mrs. Sophia Turoski  
DATE OF INSPECTION: March 23, 1981 and April 30, 1981

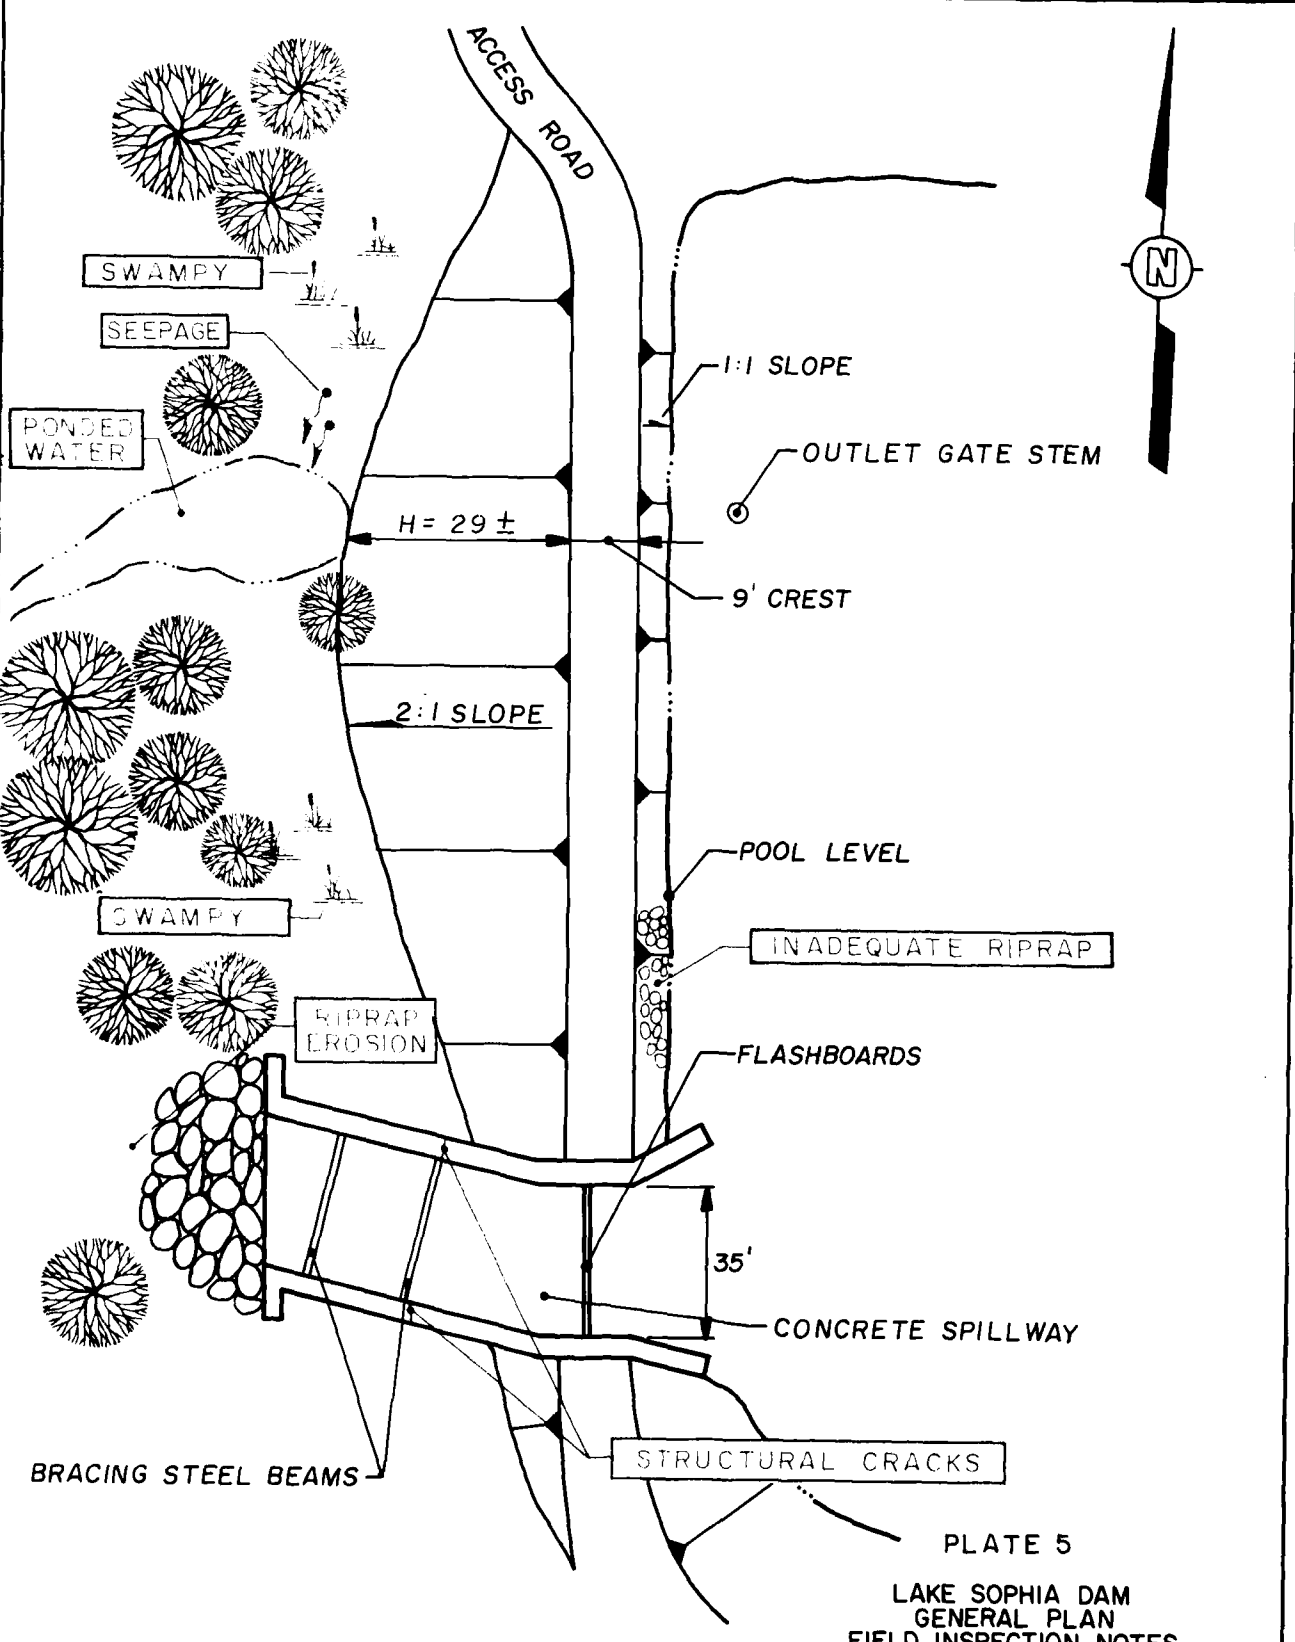
PLATE 5  
 LAKE SOPHIA DAM  
 GENERAL PLAN  
 FIELD INSPECTION NOTES  
 FIELD INSPECTION DATE: MAR. 23, 1981

In general, the condition of the embankment is considered to be fair. No major signs of distress such as slumps or cracks were found. However, extensive swampy areas were observed below the junction of the embankment with the abutments, which raised concern as to the effect of this apparent underseepage on the continued stability of the dam. A seepage in the amount of 10 to 20 gallons per minute was found to be associated with the swampy area on the right abutment. Precipitate was observed in the right abutment seepage. No measurable seepage was observed in the left abutment swampy area. Further, a portion of the toe of the dam was submerged by a pond formed by debris and a beaver dam blocking the outlet pipe discharge channel. This condition precluded inspection of the vicinity of the downstream end of the outlet pipe for possible seepage. Some shoreline erosion was observed along the upstream slope. Riprap on the upstream slope has partially dislocated and is not effective for controlling erosion, due to wave action.

VISUAL EXAMINATION OF	OBSERVATIONS	REMARKS OR RECOMMENDATIONS
JUNCTION OF EMBANKMENT AND ABUTMENT, SPILLWAY AND DAM	No problem observed.	
ANY NOTICEABLE SEEPAGE	Swampy areas below the toe of the dam along both abutments. See Plate 5 for location.	Further investigation of this condition is recommended.
STAFF GAGE AND RECORDER	None	
DRAINS	None observed.

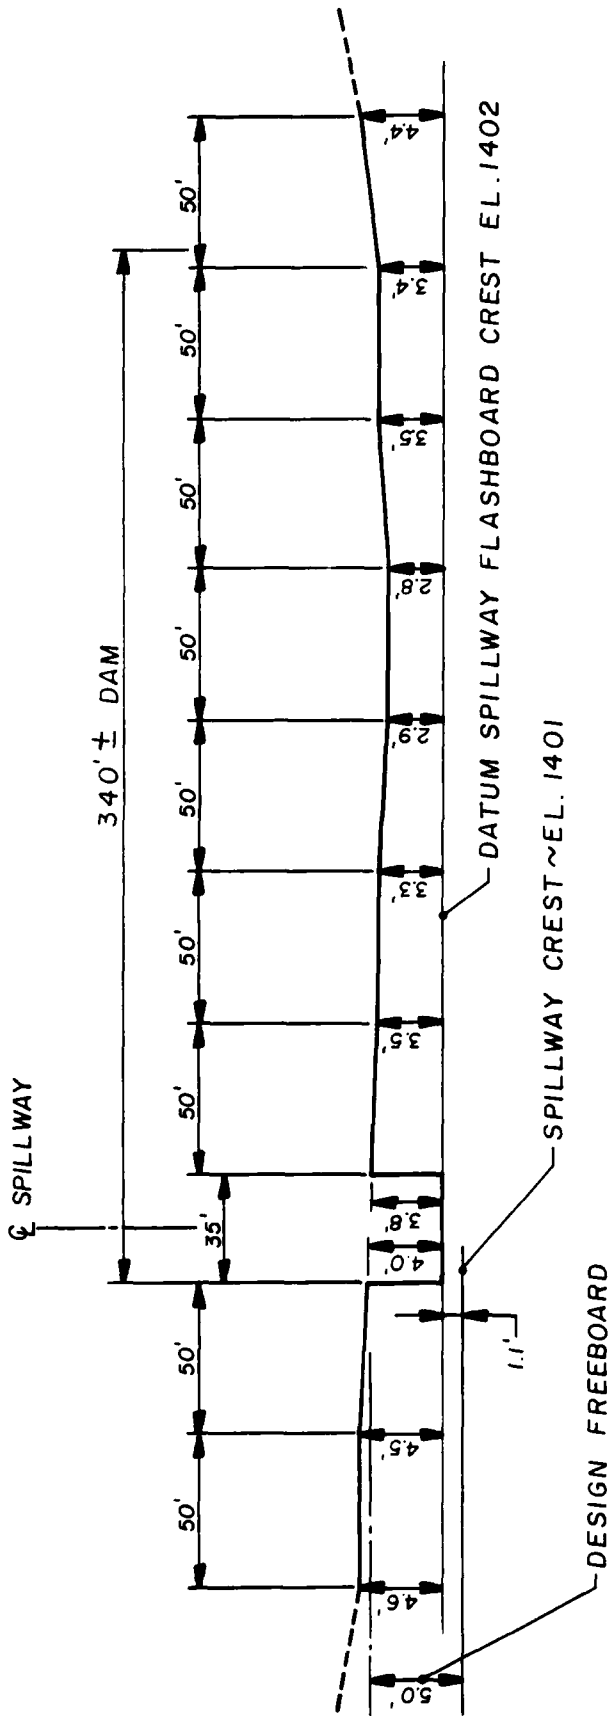
**DAM CREST PROFILE**  
(LOOKING DOWNSTREAM)

The top of the dam was surveyed relative to the spillway crest elevation and the center of the dam was found to have apparently settled. While the design freeboard for the dam was 4 feet, the field survey indicated a freeboard of 2.8 feet between the low spot near the right embankment and the normal pool level.
