BEAVER POND DAM

**NDI No. PA 00133
PennDER No. 64-19
Dam Owner: Marguerite Card**

**PHASE I INSPECTION REPORT
NATIONAL DAM INSPECTION PROGRAM**

Beaver Pond Dam, Wayne County, Pennsylvania
NDI No. PA 00133, PennDER No. 64-19
Unnamed Tributary of Shadigee Creek
Inspected 28 October 1980

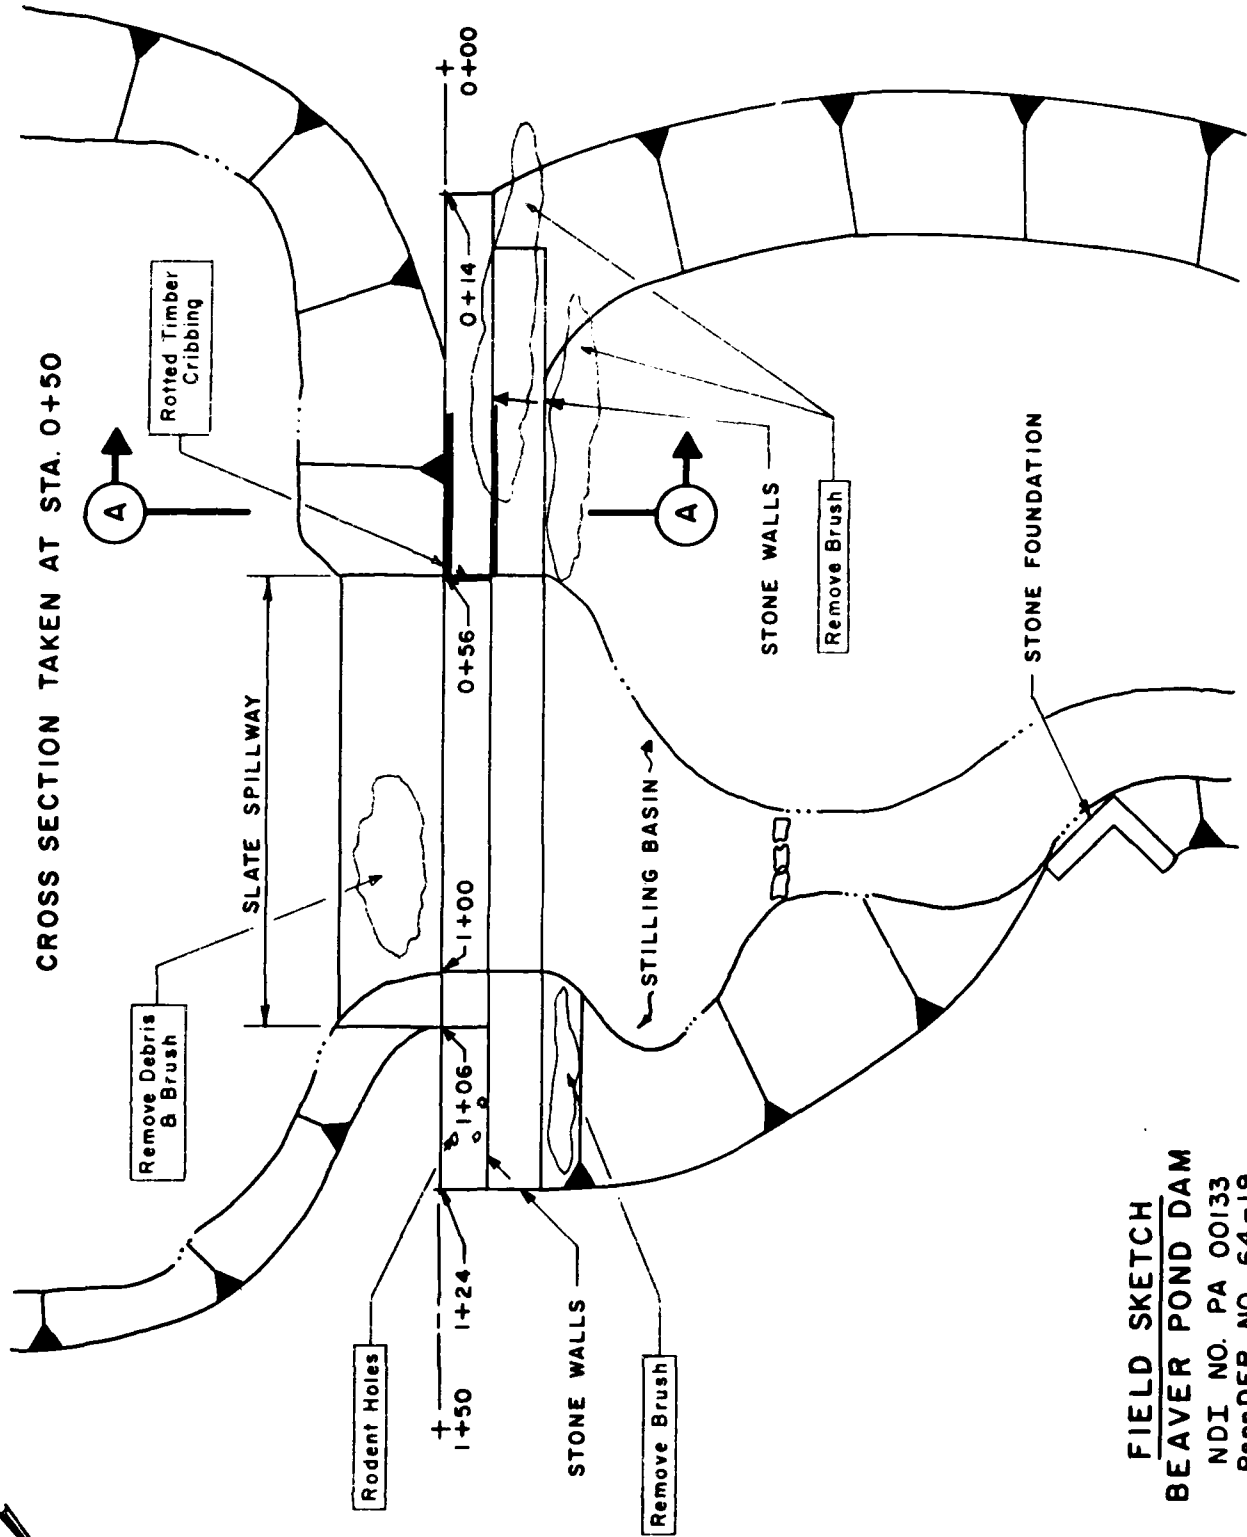
FIELD SKETCH
BEAVER POND DAM
NDI NO. PA 00133
PENNER NO. 64-19
SCHEMATIC - NOT TO SCALE

- a. General - The dam was found to be in poor overall condition at the time of inspection on 28 October 1980. No unusual weather conditions were experienced during the visual inspection. Noteworthy deficiencies observed during the visual inspection of the dam are described briefly in the following paragraphs. The complete visual inspection check list, field sketch, top of dam profile, and typical cross-section are presented in Appendix A.

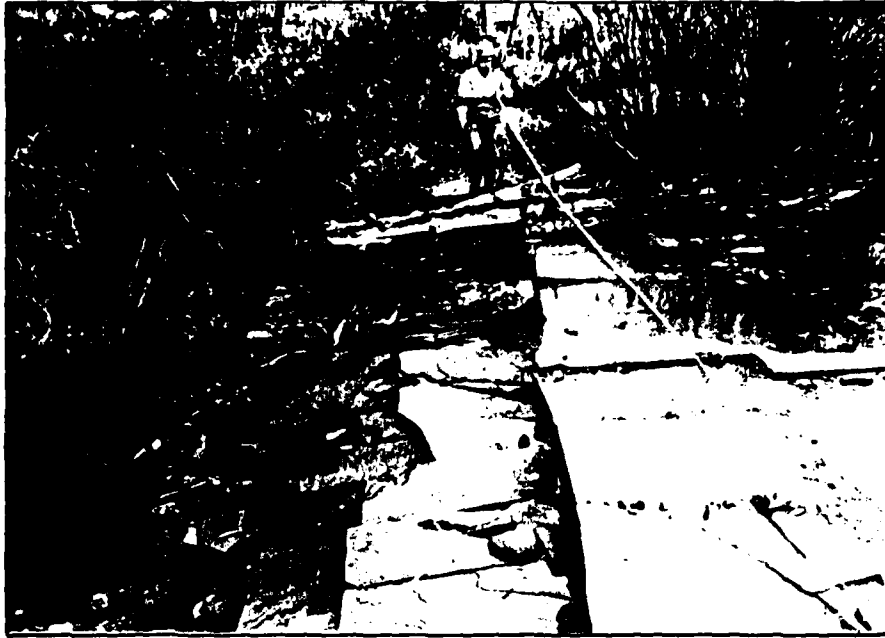
Several rodent holes were observed on the right side of the dam.

PHOTO 3. View Across Dam Towards Right Abutment

- 2) Repair the timber cribbing on the left side of the dam.
- 3) Remove the debris and brush on the spillway.
- 4) Fill the rodent holes on the right side of the dam.
- 5) Cut the brush on the dam and for 10 feet below the toe of the dam.
- 6) Provide means to draw down reservoir during an emergency.
