BRESKIN POND DAM No. 1

NDI No. PA 01141

**PHASE I INSPECTION REPORT
NATIONAL DAM INSPECTION PROGRAM**

Breskin Pond Dam No. 1, Westmoreland County, Pennsylvania
NDI No. PA 01141, PennDER No. 65-141
Unnamed Tributary to Fourmile Run
Inspected 5 December 1980

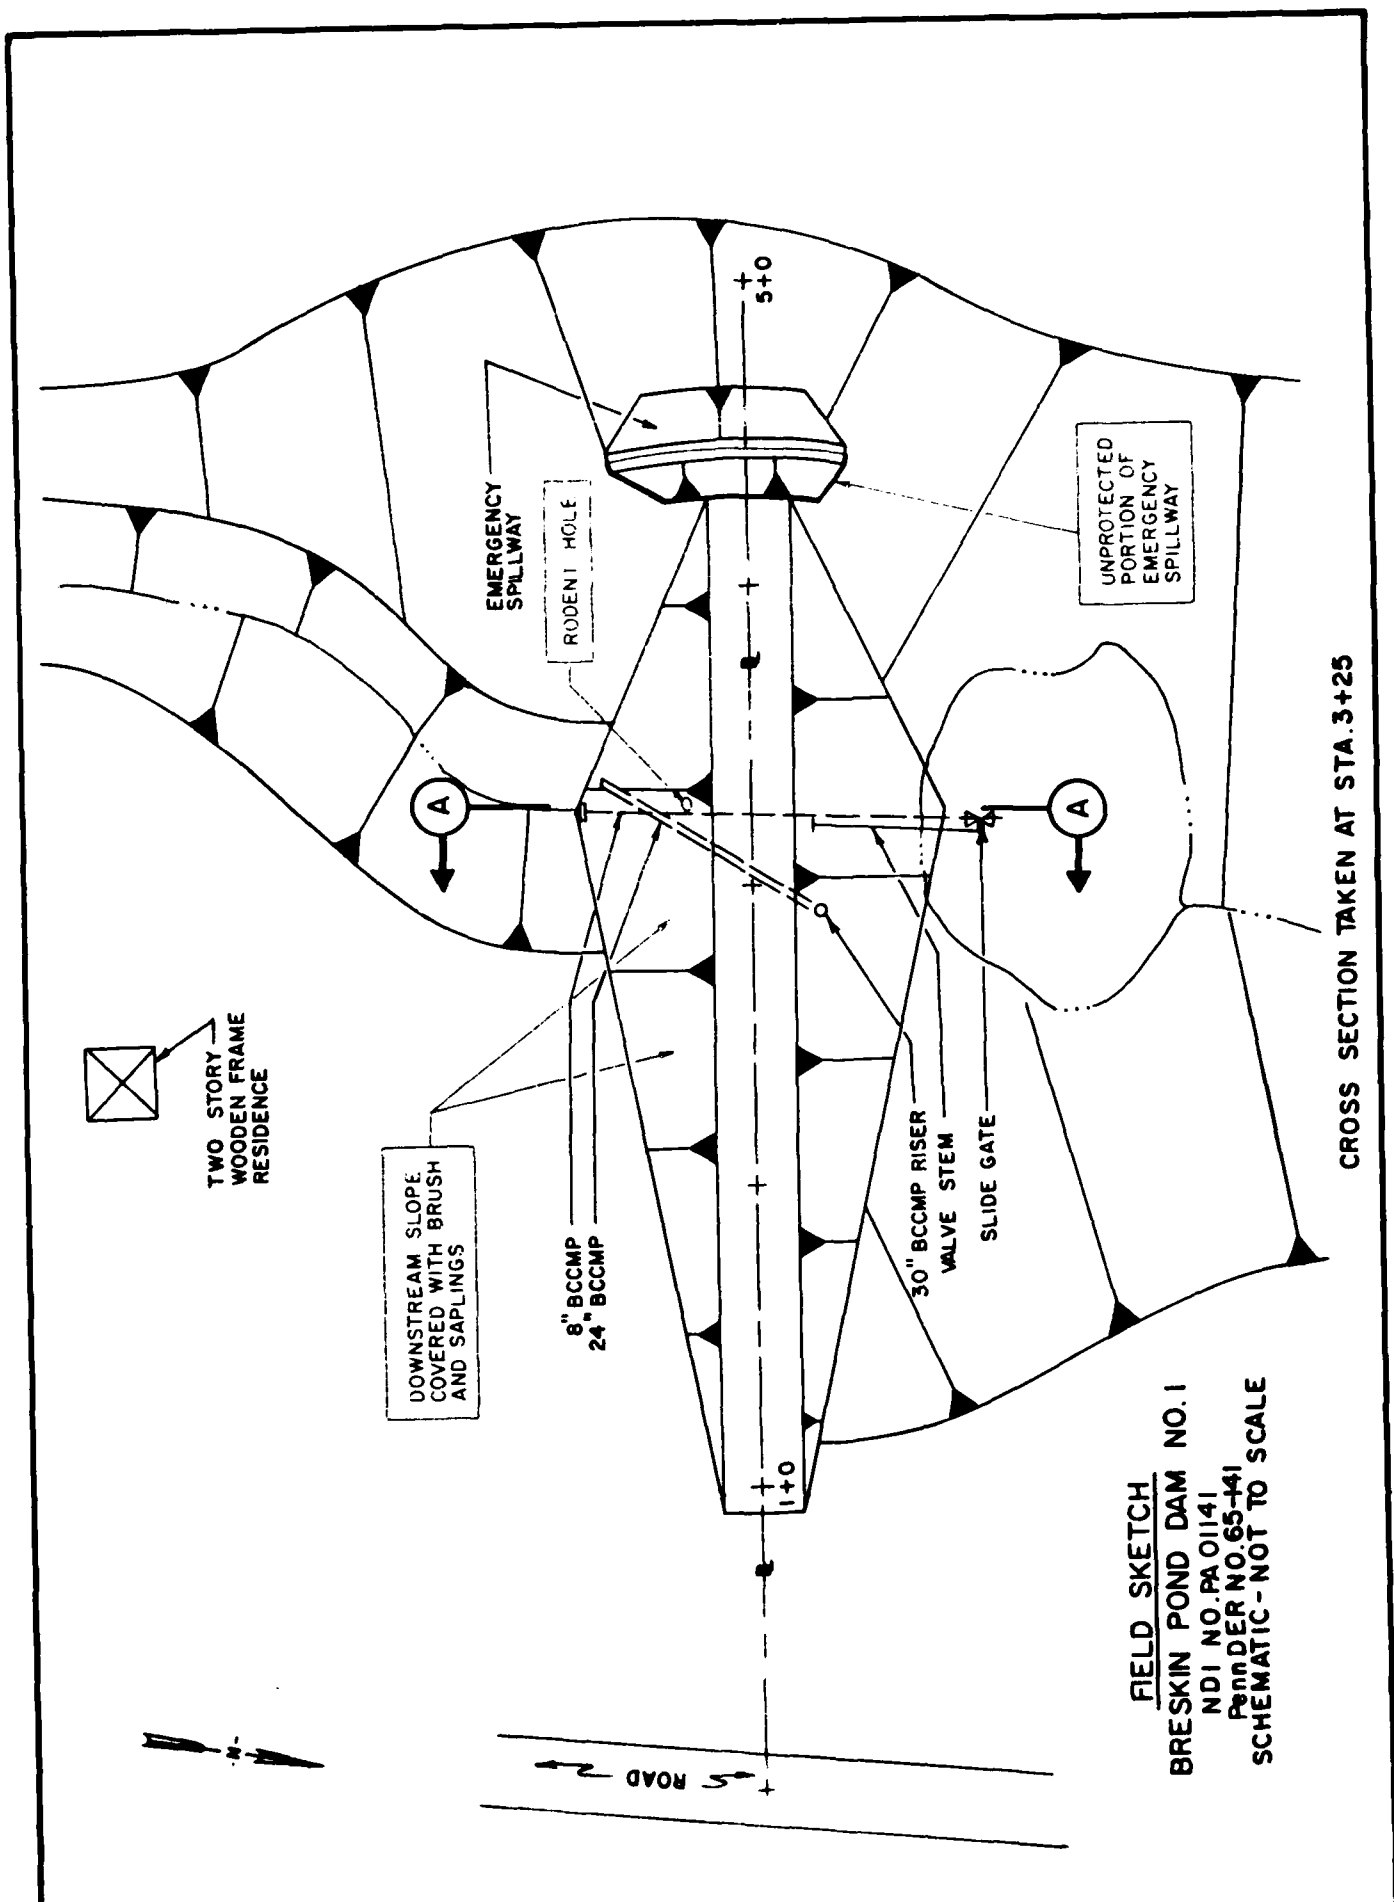
FIELD SKETCH
 BRESKIN POND DAM NO. 1
 NDI NO. PA 01141
 POND NO. 65-41
 SCHEMATIC - NOT TO SCALE

A rodent hole was observed at
approximate station 3+25, approx-
imately 7 ft. below the crest.
