ORSON POND DAM

NDI No. PA 00136

**PHASE I INSPECTION REPORT
NATIONAL DAM INSPECTION PROGRAM**

Orson Pond Dam, Wayne County, Pennsylvania
NDI No. PA 00136, PennDER No. 64-25
Unnamed Tributary of East Branch of Lackawanna River
Inspected 30 October 1980

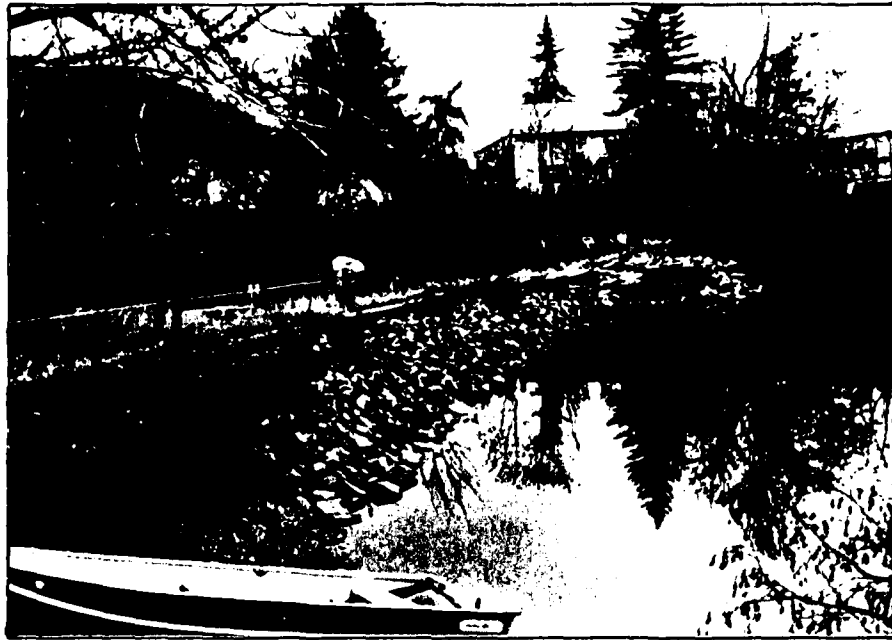
PHOTO 1. View of Upstream Slope from Left Abutment

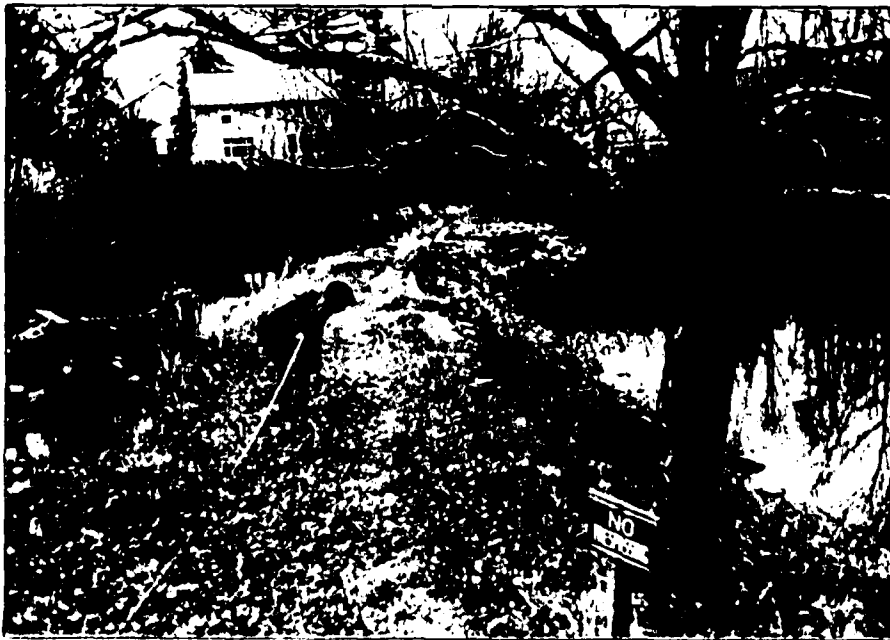
PHOTO 2. View of Dam Crest from Left Abutment

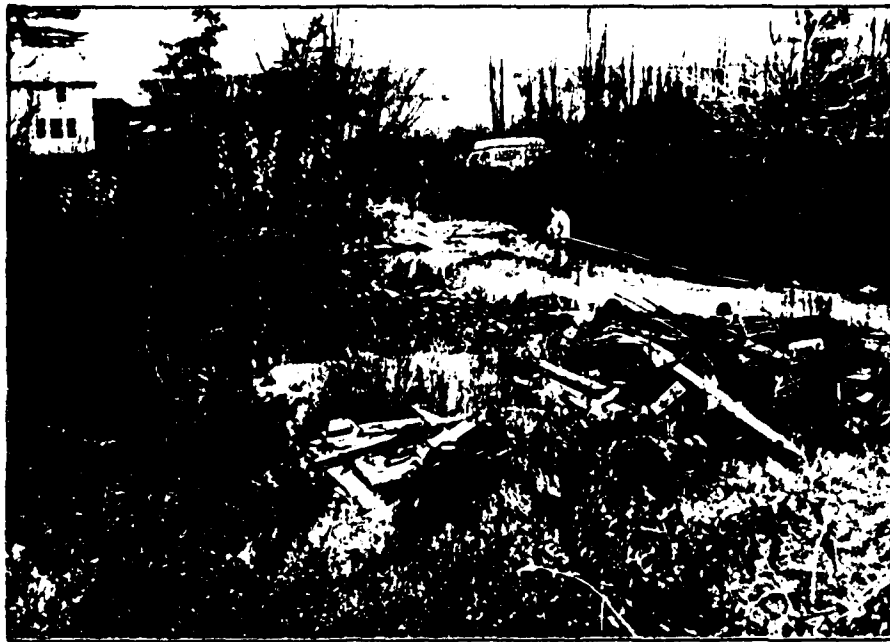
VISUAL EXAMINATION OF	OBSERVATIONS	REMARKS OR RECOMMENDATIONS
SURFACE CRACKS CONCRETE SURFACES	None observed	
STRUCTURAL CRACKING	None observed	
VERTICAL AND HORIZONTAL ALIGNMENT	Good condition	
MONOLITH JOINTS	Not Applicable	
CONSTRUCTION JOINTS	Not Applicable	
VEGETATION	A 7 in. diameter apple tree is located on the left end of the crest. Some brush is located on the right side of the dam and below the toe near the center of the dam.	Cut the brush and the apple tree.

PHOTO 3. View of Downstream Face of Dam from Left Abutment
