NDI No. PA 01073
PENN DER No. 10-63

LAKE SAXONY DAM

PACW 51-81C-0027
PHASE I INSPECTION REPORT

NATIONAL DAM INSPECTION PROGRAM

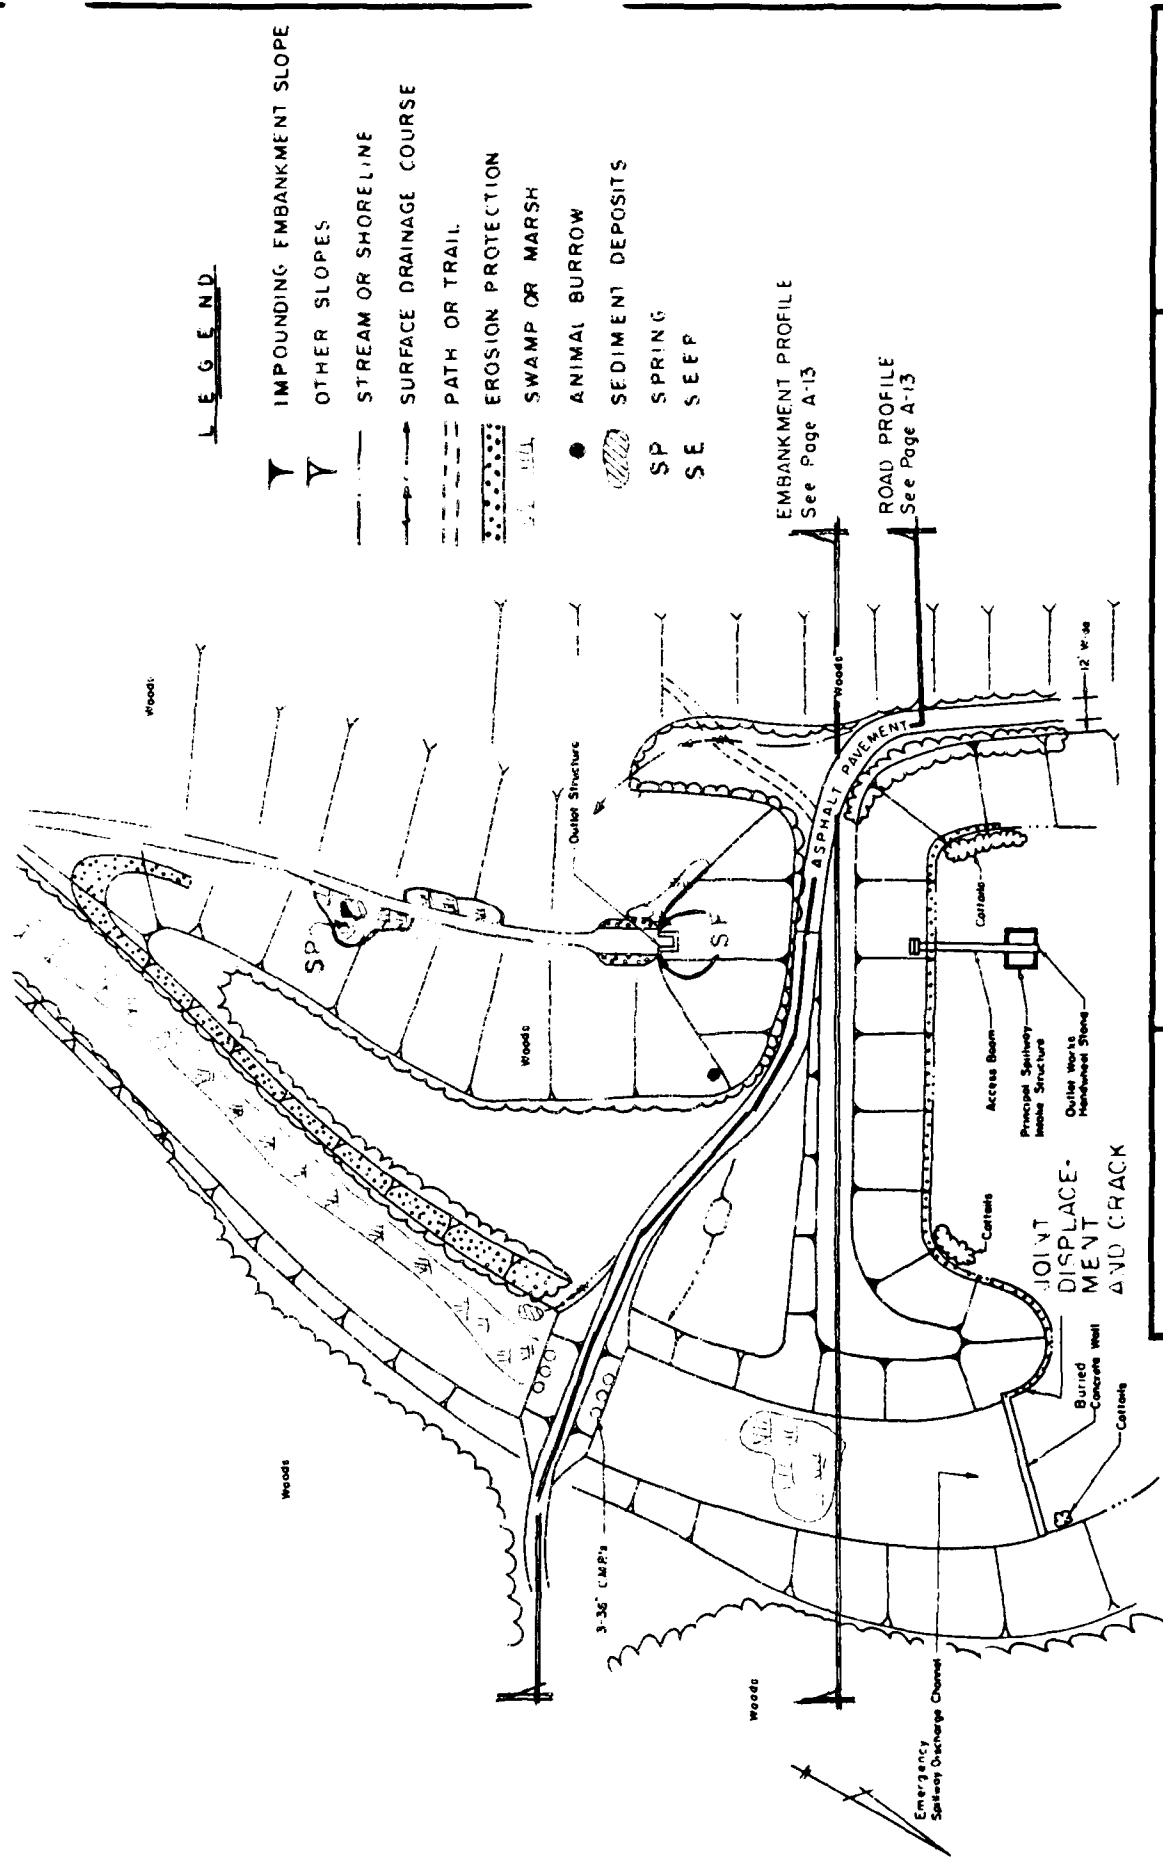
DATE: MAY 1981		LAKE SAXONY	
SCALE: NONE		NATIONAL DAM INSPECTION PROGRAM	
DR: JF	CK: JEB	ACKENHEIL & ASSOCIATES	
DWG. NO. 801380-1		CONSULTING GEO SYSTEMS, INC. ENGINEERS 1000 BANKSVILLE RD. PITTSBURGH, PA. 15216	
		FIELD SKETCH

A swampy zone was observed in the junction between the embankment and the right abutment. The swampy zone extended from approximately mid-height of the embankment down to the stilling pool below the principal spillway outlet structure. Two seeps were flowing from the embankment along the wingwalls of the outlet structure. The seep on the right appeared to have a greater discharge than the seep on the left but flow quantities were too small to estimate. Both seeps were located in a region of significant iron staining.

An animal burrow was observed near the junction of the embankment and the abutment on the left side of the dam just below the road.

(2) Downstream Spring: A spring, discharging an estimated 20 to 25 gallons per minute, was observed on the Sarver Run creek bank, approximately 250 feet below the crest of the embankment. A considerable amount of fine soil sediment was observed below the spring and the area was heavily iron stained. A sediment deposit was observed at the point where the spring flow entered the creek channel. The owner's representative advised that the spring predated the dam.

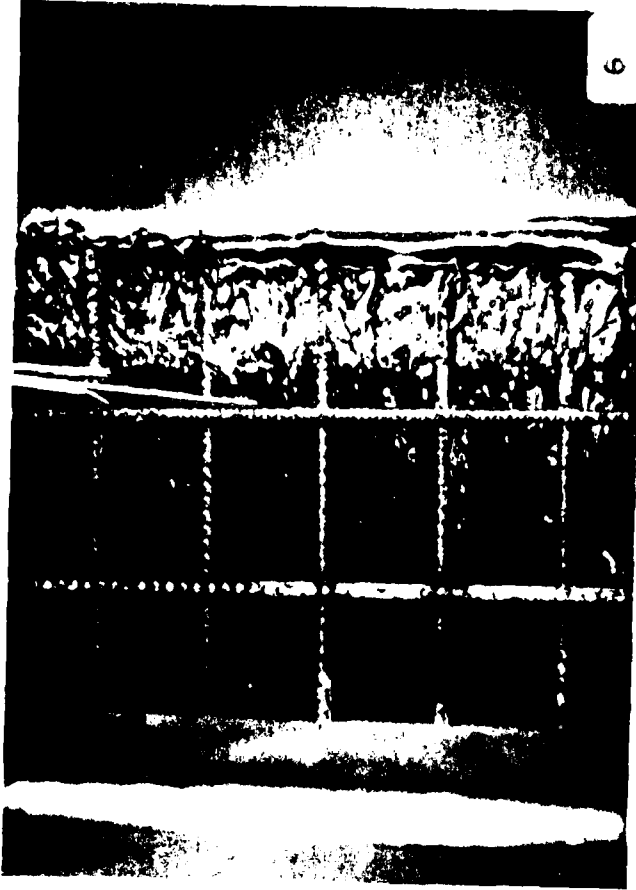
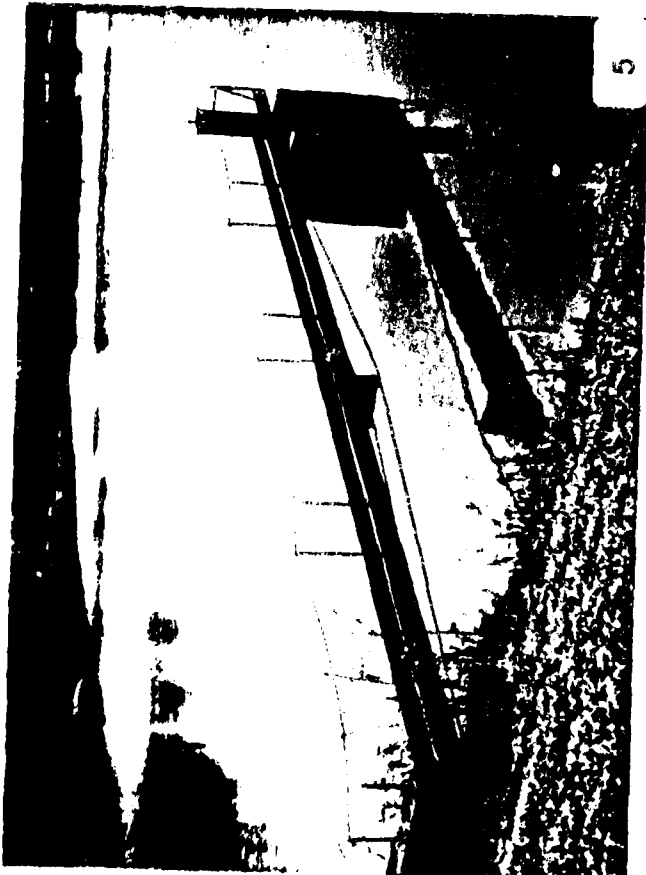
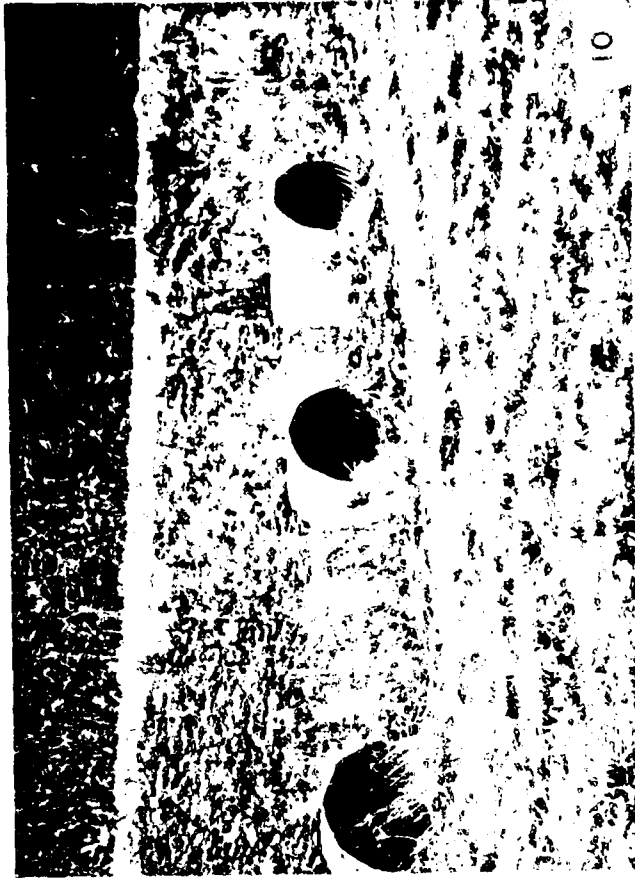
- Photo 1 Reservoir Overview from embankment crest.
- Photo 2 Embankment Crest and Road from right abutment.
- Photo 3 Upstream Slope and Concrete Erosion Protection. Note grass between concrete slabs and principal spillway access bridge (center).
