MILL CREEK DAM

NDI I.D. PA-0038
DER I.D. 008-051
OWNER: CAMP SPRING HILL, INC.

PHASE I INSPECTION REPORT
NATIONAL DAM INSPECTION PROGRAM

MILL CREEK DAM
NDI I.D. PA-00 38
DER I.D. 008-051
NOVEMBER 14, 1980

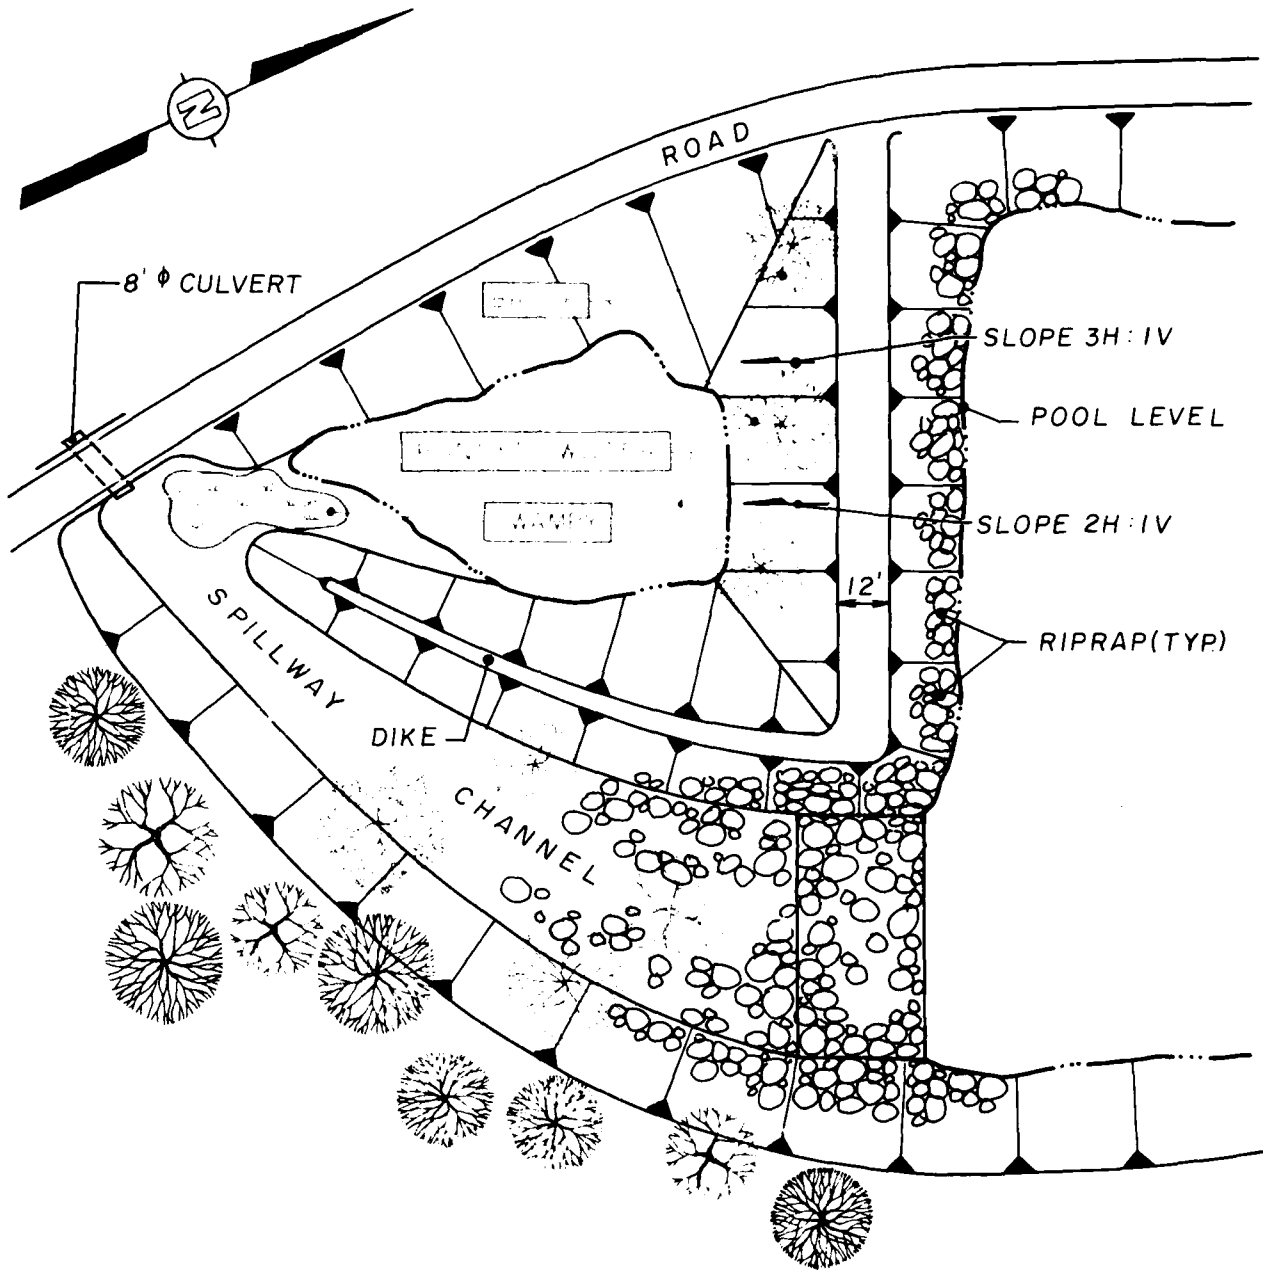
PLATE 4
 MILL CREEK DAM
 GENERAL PLAN
 FIELD INSPECTION NOTES
 FIELD INSPECTION DATE: NOV. 14, 1980

The most significant condition noted was the presence of a pond at the toe of the dam. The pond appeared to be caused by blockage of the outlet pipe discharge channel by debris, approximately 20 feet below the dam. The pond submerges a portion of the downstream slope of the dam, precluding adequate inspection of the toe of the dam for possible seepage.

NOTE:
 POOL LEVEL AT DATE OF INSPECTION:
 ~1 FT. BELOW SPILLWAY CREST

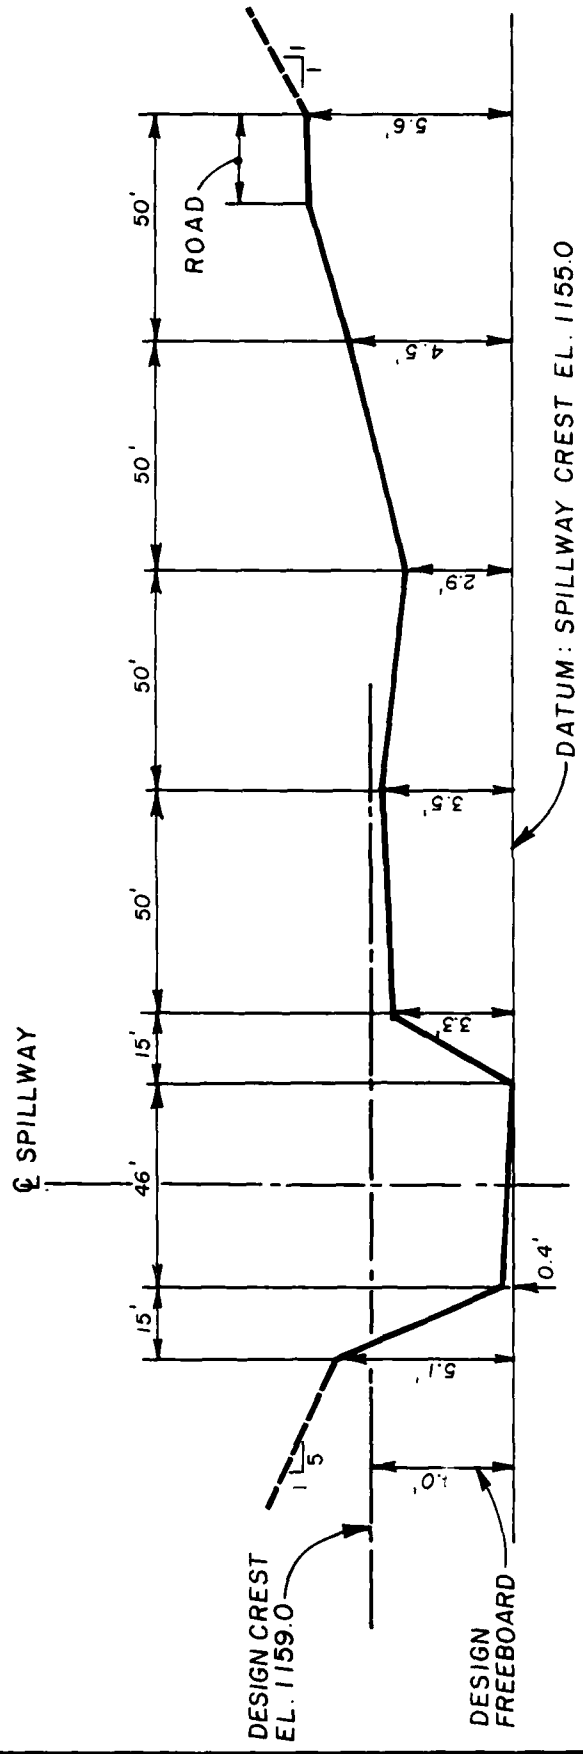
DAM CREST PROFILE
(LOOKING DOWNSTREAM)

The crest of the dam was surveyed relative to the spillway crest elevation and it was found that approximately two-thirds of the embankment is approximately 1.0 foot below the design crest level. The dam crest profile is illustrated in Plate 5. The downstream slope of the dam was surveyed and found to be varying between 3 horizontal to 1 vertical and 2 horizontal to 1 vertical.
