NDI No. PA 01145

MINE No. 60 - POND 6 (NDI Number  
PA 01145, PENN DER Number 63-89)

PHASE I INSPECTION REPORT.

NATIONAL DAM INSPECTION PROGRAM

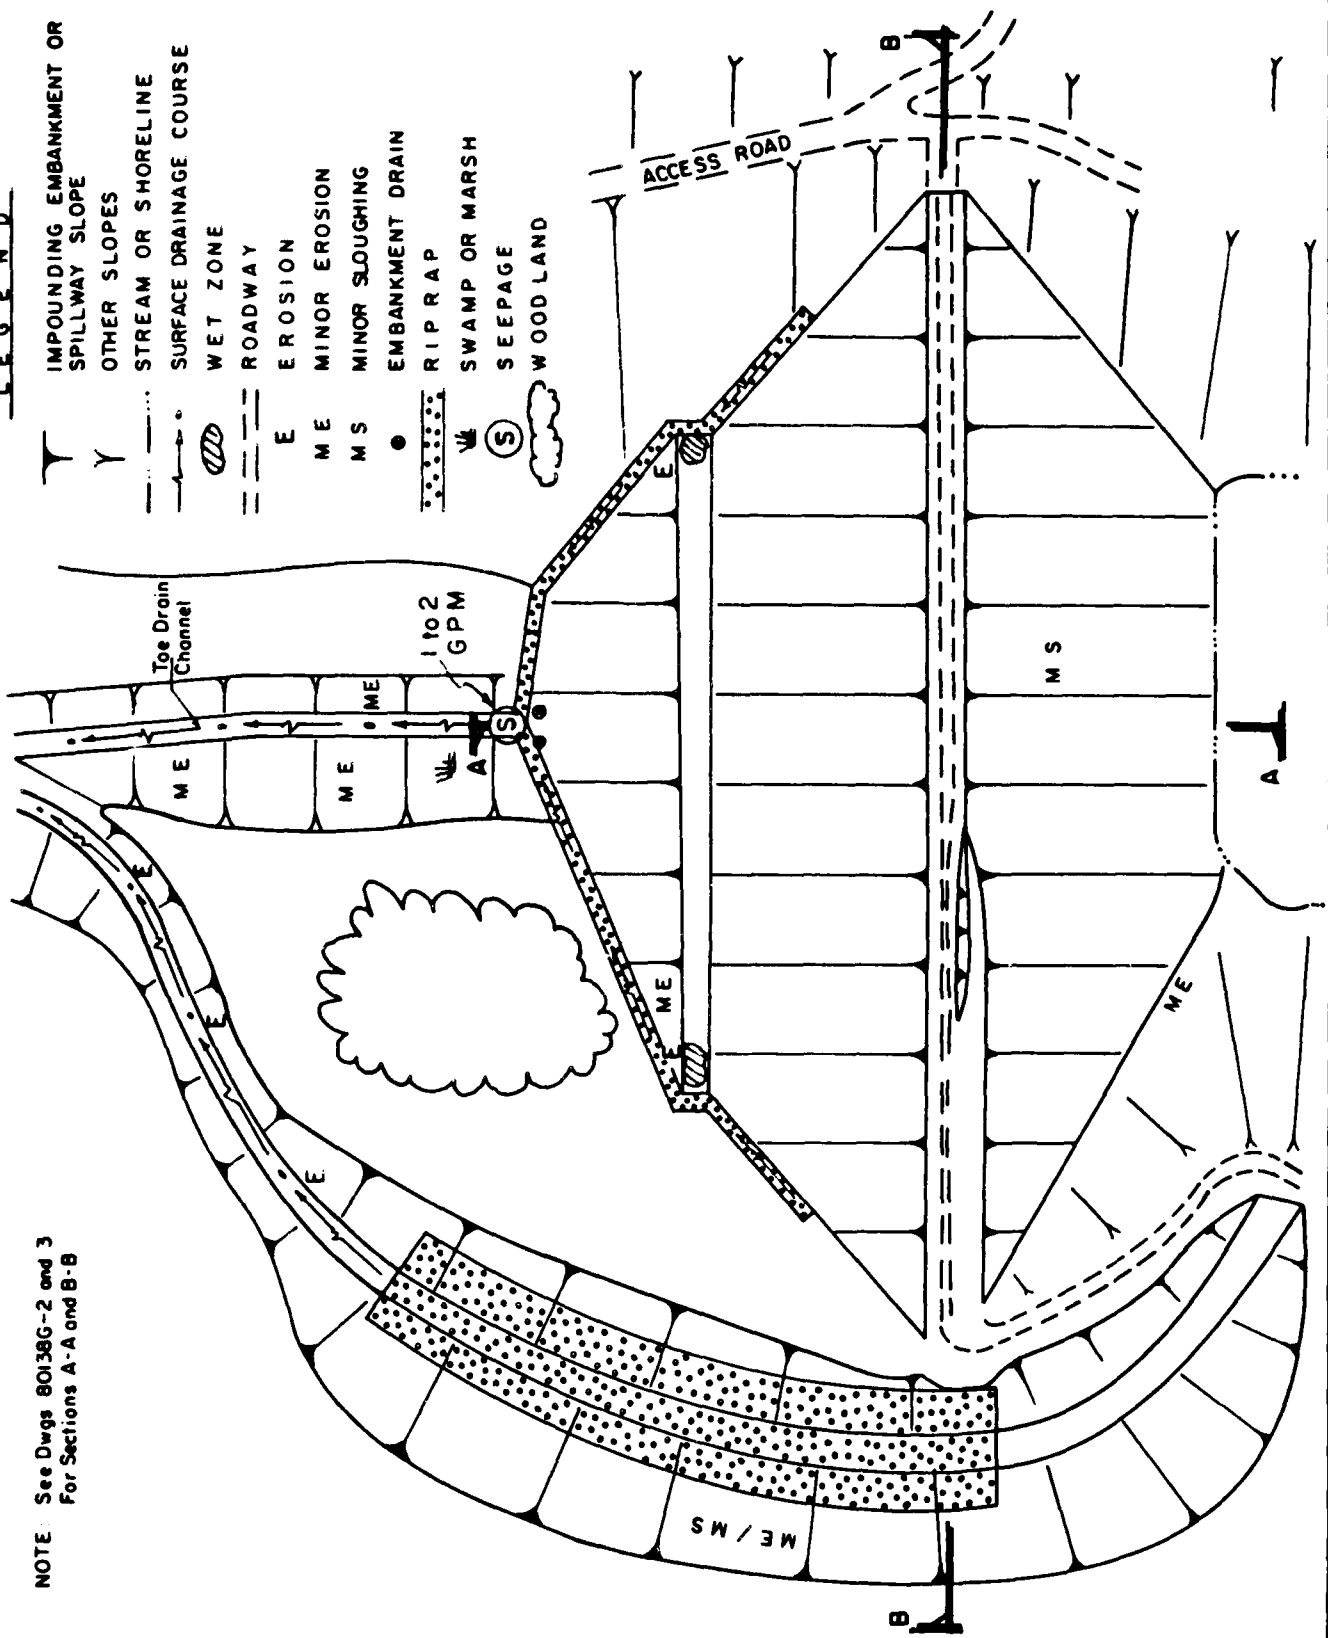
DATE: MAY 1981	MINE No. 60 - POND 6	FIELD SKETCH
SCALE: NONE	NATIONAL DAM INSPECTION PROGRAM	
DR: JF CK: JEB	<b>ACKENHEIL &amp; ASSOCIATES</b> CONSULTING	
DWG. NO. 80138G-1	GEO SYSTEMS, INC. ENGINEERS 1000 BANKSVILLE RD./PITTSBURGH, PA 15216

The downstream slope contains a bench at approximately mid-height which is sloped to drain from the center toward each abutment. Ponded water was observed on the bench at the junctions with both abutments. Some erosion of the embankment slope has occurred below the ponded areas.

(3) Discharge Channel: The spillway discharge channel was riprapped for a distance of approximately 700 feet below the overflow crest. Below the riprap, the channel is an earth cut in original ground. The channel contained an erosional gully caused by surface runoff from above and beyond the dam. The depth of erosion ranged from 6 to 12 inches.
