MINE No. 60 - POND 5

PHASE I INSPECTION REPORT
NATIONAL DAM INSPECTION PROGRAM

MINE NO. 60-POND 5
WASHINGTON COUNTY, COMMONWEALTH OF PENNSYLVANIA
NDI NO. PA 01144
PennDER NO. 63-88

PHASE I INSPECTION REPORT
NATIONAL DAM INSPECTION PROGRAM
MINE NO. 60-POND 5
NATIONAL I. D. NO. PA 01144
PennDER No. 63-88

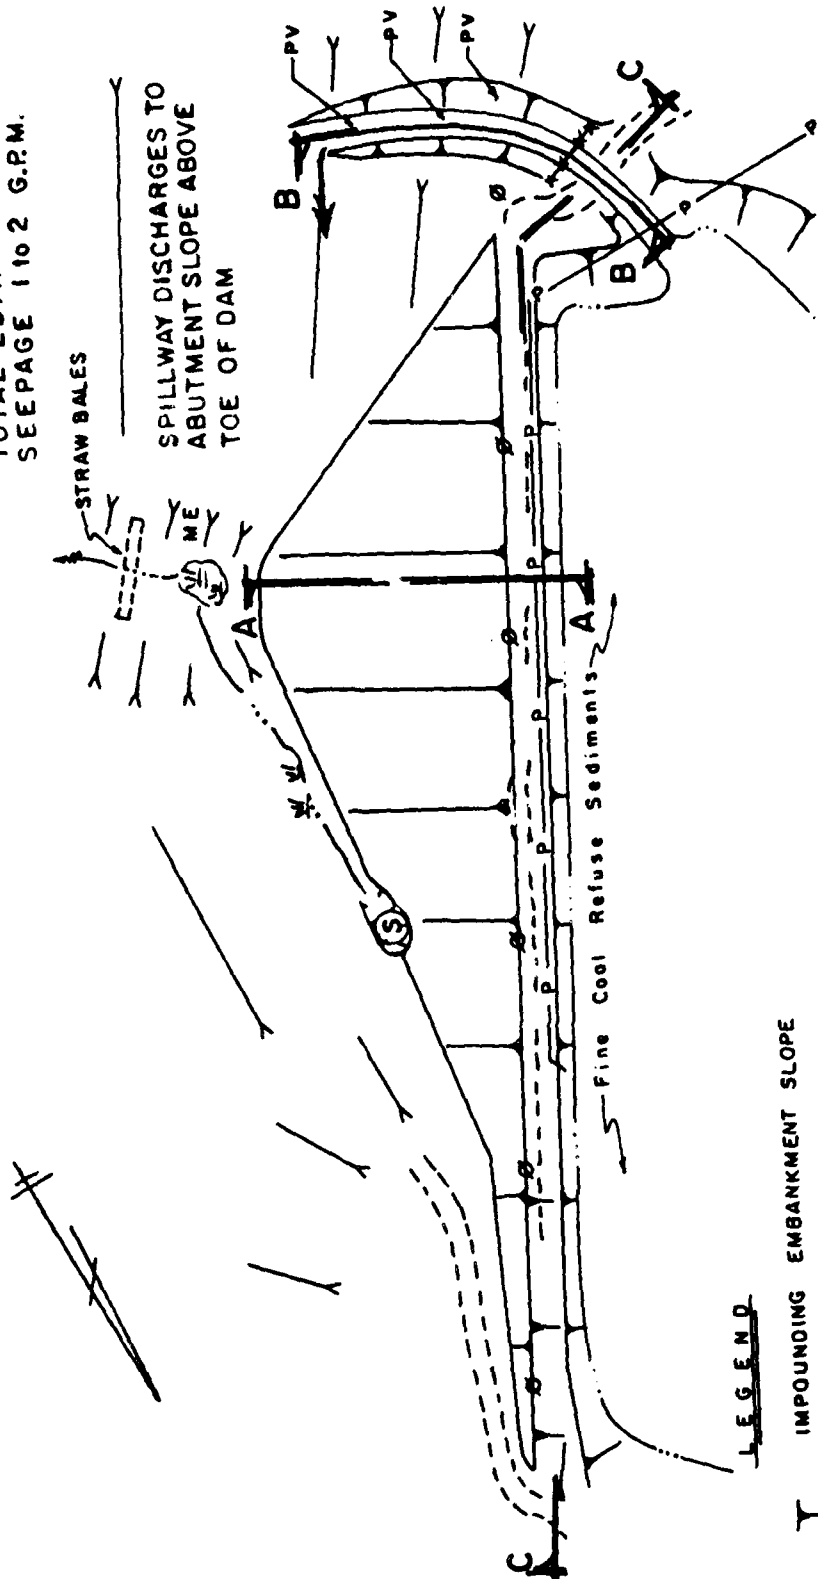
FIELD
SKETCH

b. Principal (and Emergency) Spillway: The spillway was considered to be in poor condition. This is based on the observed silt fence obstruction in the channel and the discharge channel alignment that directs spillway flows into the embankment's right groin.

STRAW BALES
SPILLWAY DISCHARGES TO
ABUTMENT SLOPE ABOVE
TOE OF DAM

b. Removing the silt fence from the spillway channel and realigning the discharge channel to direct flows away from the right groin.

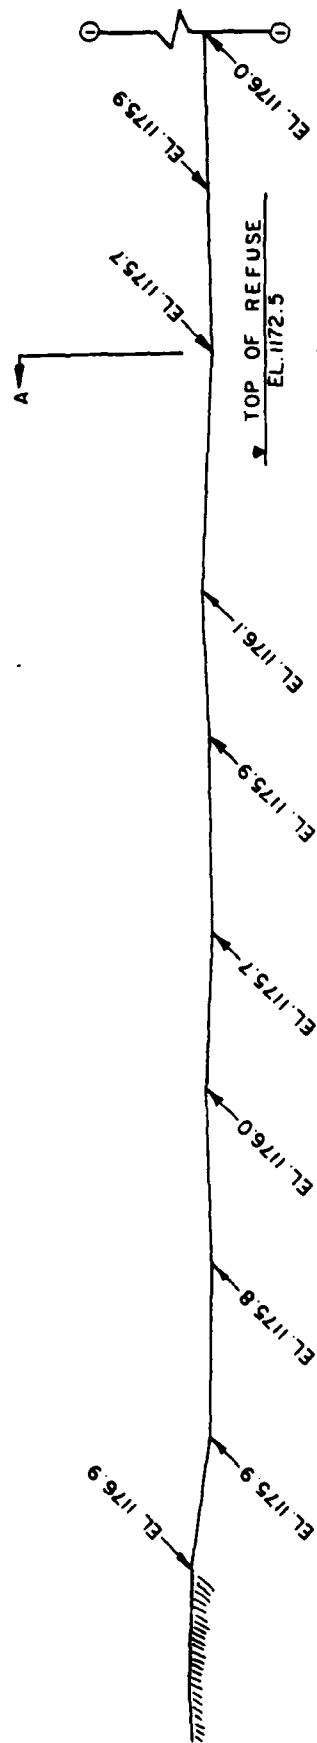
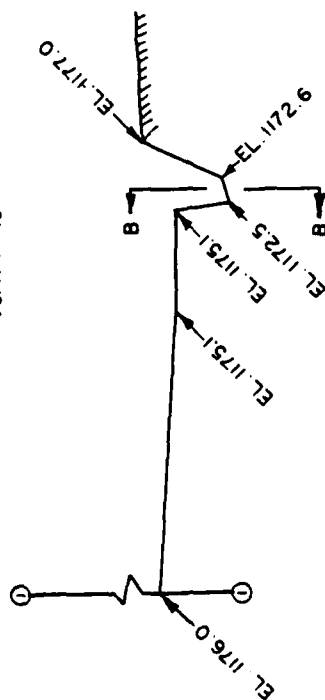
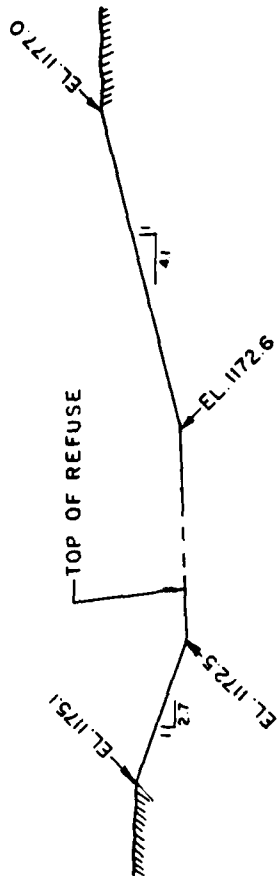
SPILLWAY DETAIL
SCALE 1"=10'

c. Visual Observations: On the date of the field inspection, a silt fence was observed in the overflow crest area of the spillway. The fence appeared capable of obstructing low flows but would probably be destroyed by higher flows. Only a subjective evaluation of its effect could be made. Its existence was not considered in the HEC-1 analysis.
