NDI NO. PA-00948
DER NO. 50-061

PHASE I INSPECTION REPORT.

National Dam Inspection Program.
Negley Dam (NDI Number PA-00948,
DER Number 50-061), Susquehanna River
Basin, Perry County, Pennsylvania.
Phase I Inspection Report,

Name of Dam: NEGLEY DAM
State & State No.: PENNSYLVANIA, 50-61
County: PERRY
Stream: TRIBUTARY TO LITTLE JUNIATA CREEK
Date of Inspection: NOVEMBER 4, 1980

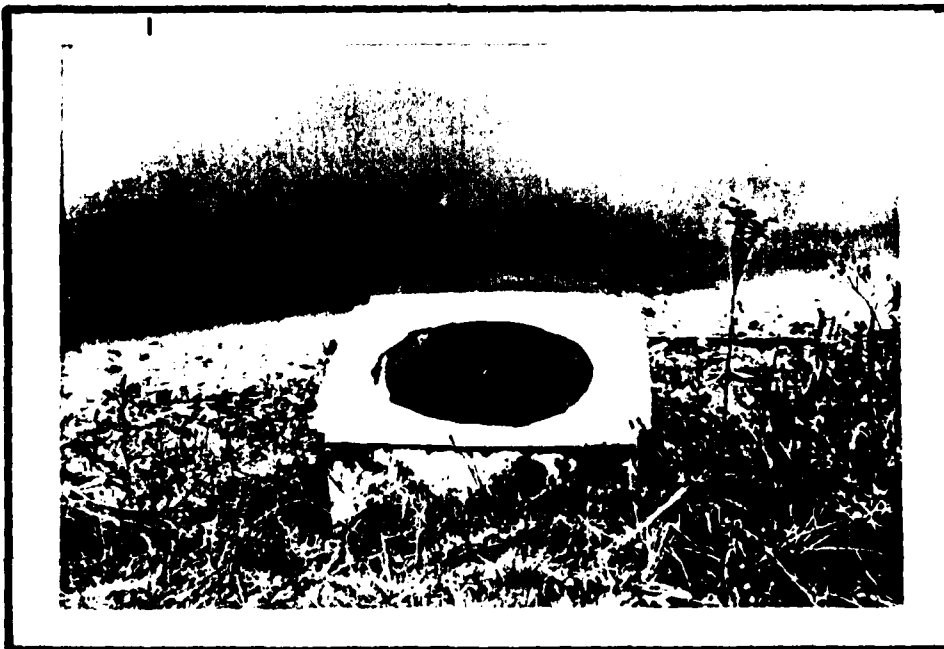
Post construction changes reported by the owner consisted of the replacement of the principal spillway intake. The concrete of the original structure deteriorated badly and was replaced in the fall of 1980 by the present concrete encased CMP.

The principal spillway consists of a 34-inch CMP drop inlet pipe, encased in concrete (Photograph No. 5). Discharge is through an 18-inch CMP which terminates at the downstream toe. A small rock lined plunge pool prevents erosion. The area is overgrown with weeds and briars (Photograph No. 6). The outlet was constructed without a headwall.

The principal spillway appeared to be adequate, and there were no signs of stability problems. The top part of the overflow section was recently replaced.

The only reported post construction change is the replacement of the principal spillway overflow section. The original concrete section was of poor quality and deteriorated due to freeze-thaw cycles. The upper part was replaced with an encased corrugated metal pipe.

PRINCIPAL SPILLWAY - NO. 5
