FAWN LAKE DAM

(NDI I.D. NO. PA-00822
PENNDER I.D. NO. 52-182)

PHASE I INSPECTION REPORT
NATIONAL DAM INSPECTION PROGRAM

JUNE 1981

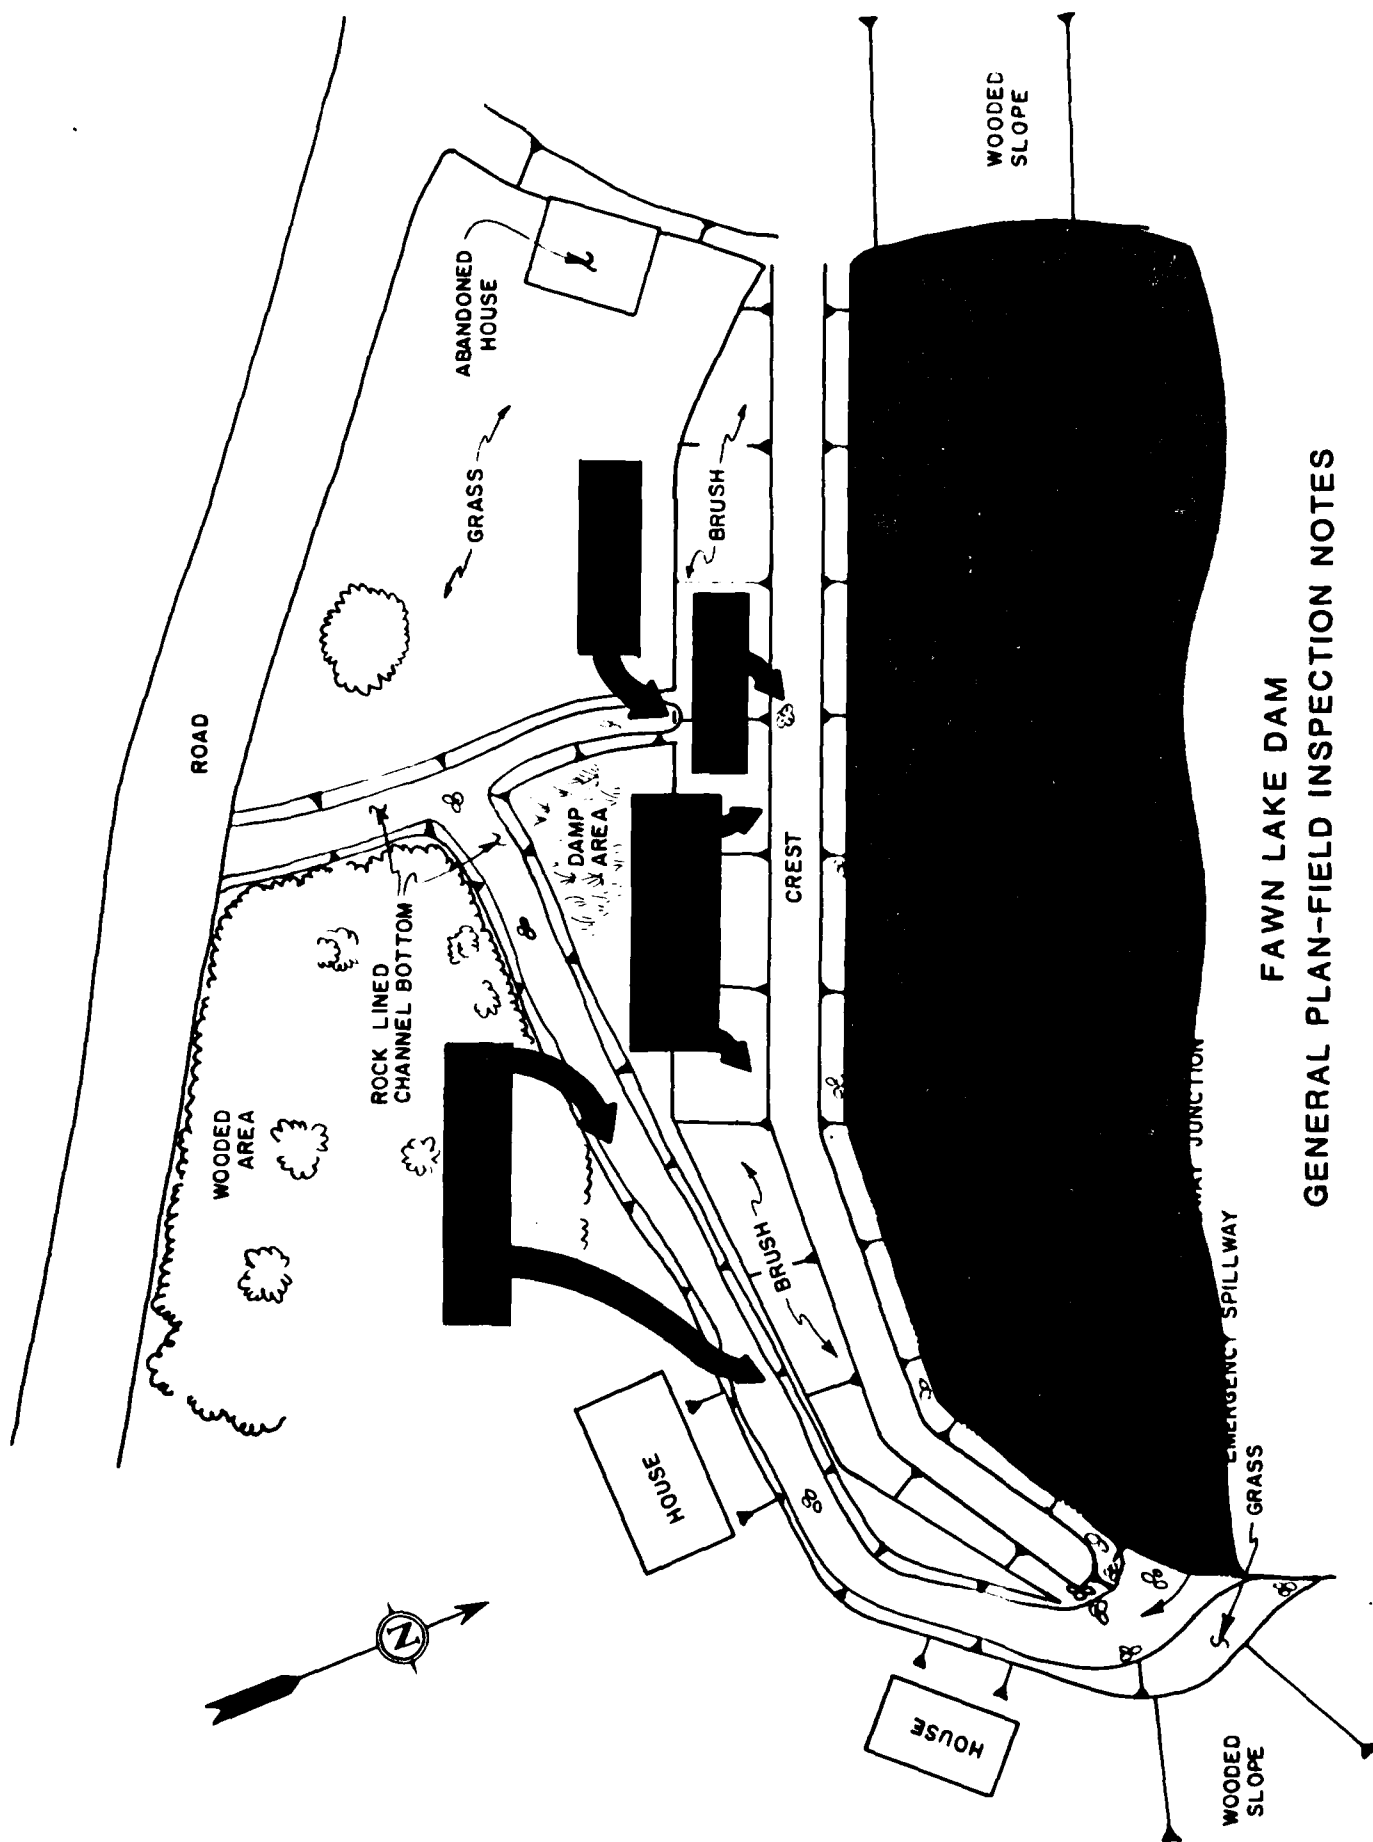
FAWN LAKE DAM GENERAL PLAN-FIELD INSPECTION NOTES

ITEM	OBSERVATIONS/REMARKS/RECOMMENDATIONS	NDI# PA. 00822
SURFACE CRACKS	None observed.	
UNUSUAL MOVEMENT OR CRACKING AT OR BEYOND THE TOE	None observed.	
SLOUGHING OR EROSION OF EMBANKMENT AND ABUTMENT SLOPES	4-foot diameter, rock filled depression located at the downstream edge of the embankment crest directly above the service spillway discharge conduit. Also, erosion evident along the sidewalls of the spillway discharge channel where the channel parallels the downstream embankment toe.	
VERTICAL AND HORIZONTAL ALIGNMENT OF THE CREST	Horizontal - good. Vertical - see "Profile of Dam Crest from Field Survey", Appendix A.	
RIPRAP FAILURES	Partially covered with vegetation. Riprap size is relatively small below the pool level and much larger at and above the water line. No erosion apparent. Embankment soil appears very rocky.	
JUNCTION OF EMBANKMENT AND ABUTMENT, SPILLWAY AND DAM	Good condition.
