BEAVER LAKE LODGE DAM

NDI I.D. NO. PA-00300  
PENNDER I.D. NO. 52-93

PHASE I INSPECTION REPORT  
NATIONAL DAM INSPECTION PROGRAM

JUNE 1981

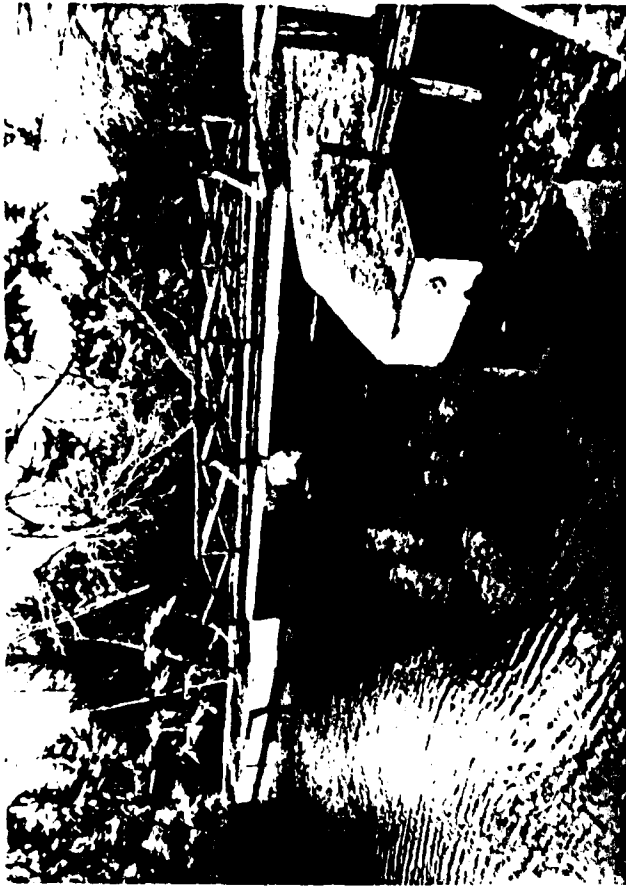
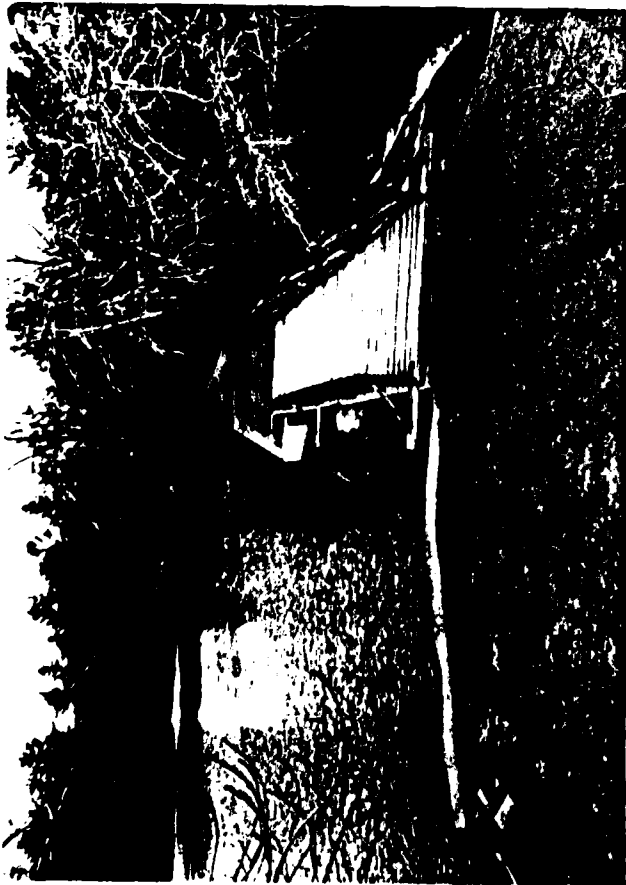
PHOTOGRAPH 3 View of the service spillway looking upstream. Note the broken bottom slab.

PHOTOGRAPH 4 View of the service spillway showing deterioration of concrete pier and sidewall.

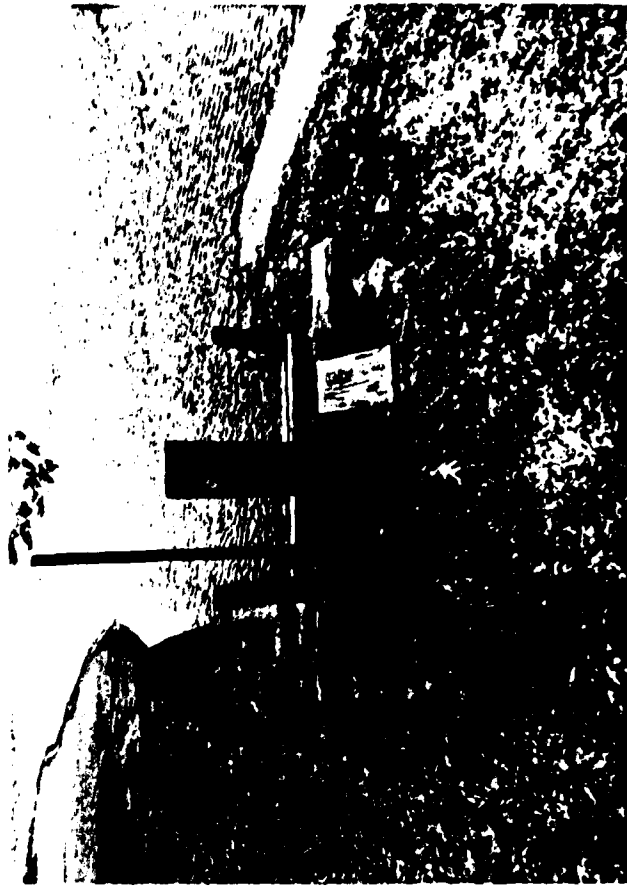
3. Outlet Works. The only visible section of the outlet works is the intake structure and the control mechanism located at the right abutment (see Photographs 7 and 8). The intake structure is dilapidated and currently non-functional. The lever and gear mechanism designed to operate the sluice gate is broken.

PHOTOGRAPH 8 View of the sluice gate lever and gear mechanism (inoperable).

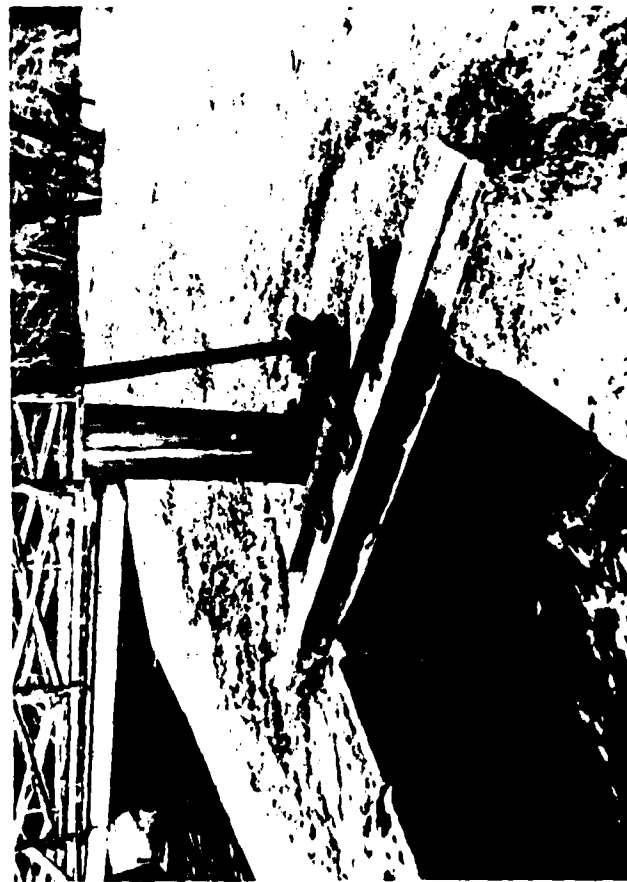
PHOTOGRAPH 7 View of intake structure (inoperable sluice gate). Note broken concrete wall.
