WHITNEY LAKE DAM

NDI ID NO PA-00142
DER ID NO 64-133

PHASE I INSPECTION REPORT

NATIONAL DAM INSPECTION PROGRAM

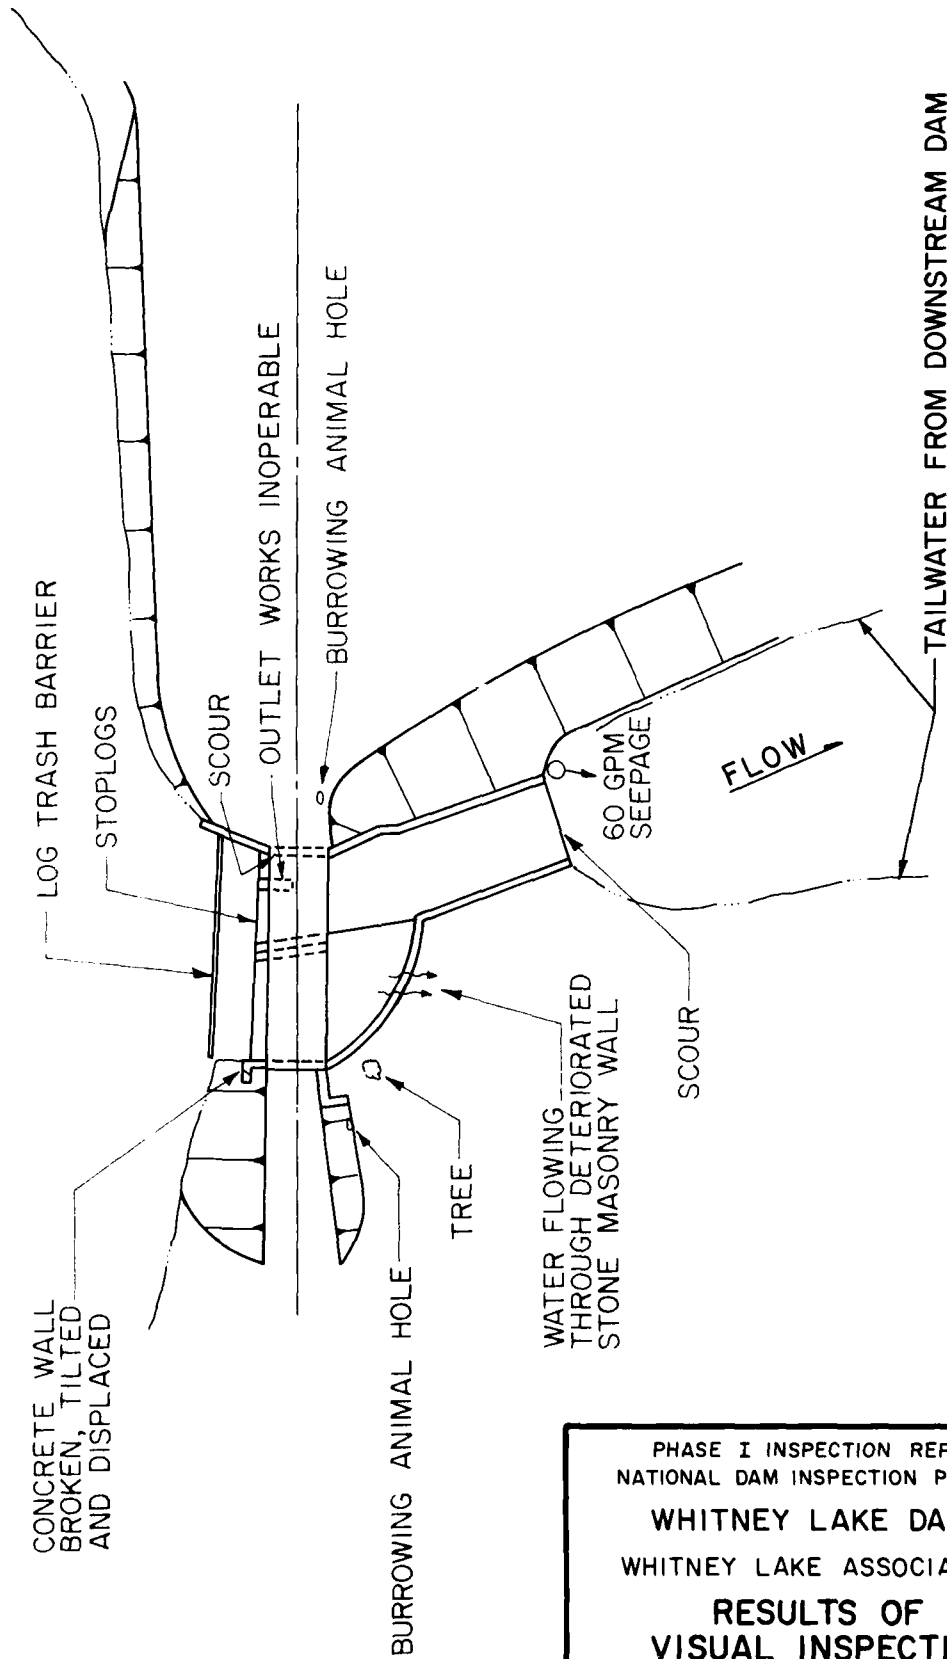
PHASE I INSPECTION REPORT
NATIONAL DAM INSPECTION PROGRAM
WHITNEY LAKE DAM
WHITNEY LAKE ASSOCIATION
**RESULTS OF
VISUAL INSPECTION**
MAY 1981 EXHIBIT B-1

DATE OF INSPECTION: 13 APRIL 81
POOL ELEVATION: 1379.0
