GORSON DAM

NDI ID NO PA-01084

PHASE I INSPECTION REPORT

NATIONAL DAM INSPECTION PROGRAM

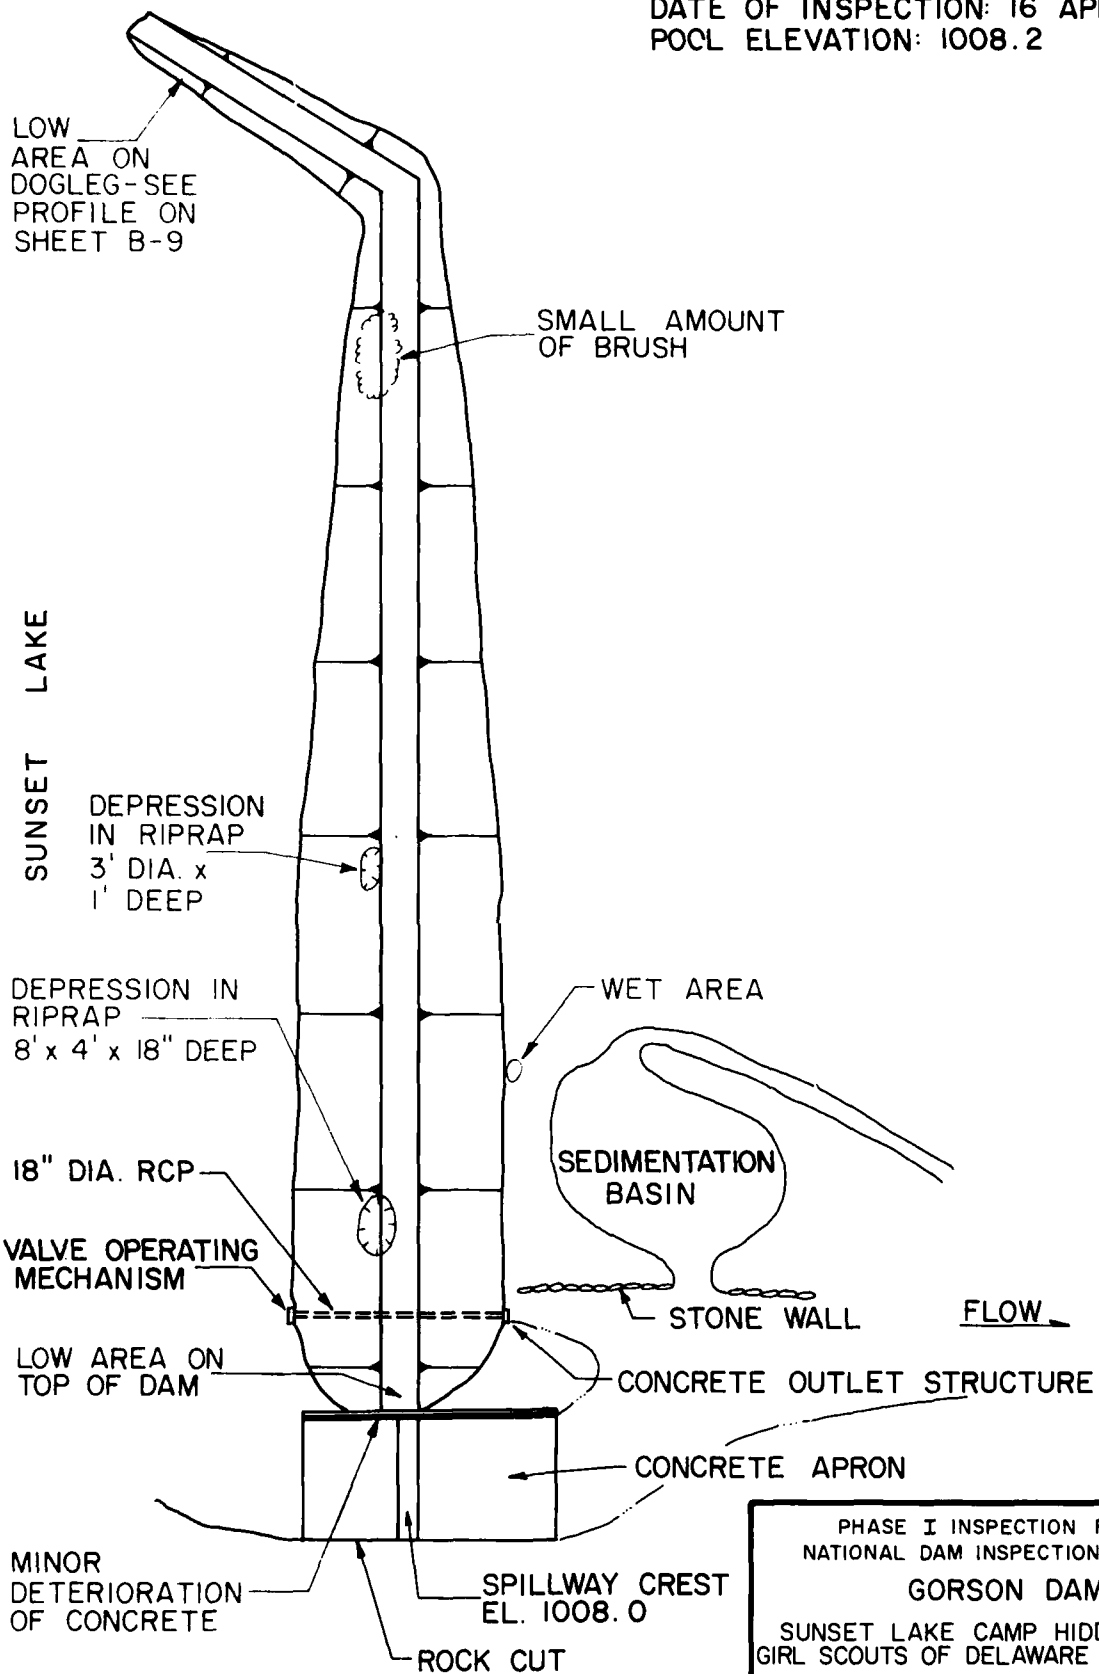
DATE OF INSPECTION: 16 APRIL 1981
POOL ELEVATION: 1008.2

a. General. The overall appearance of the dam and appurtenant structures is good. Some minor deficiencies were observed as noted below. A sketch of the dam with the locations of the deficiencies is presented on Exhibit B-1 in Appendix B. Survey information acquired for this Report is summarized in Appendix B. Datum used for the survey was the spillway crest, Elevation 1008.0, as estimated from USGS contour mapping. On the day of the inspection, the pool elevation was 0.2 foot above the spillway crest level.

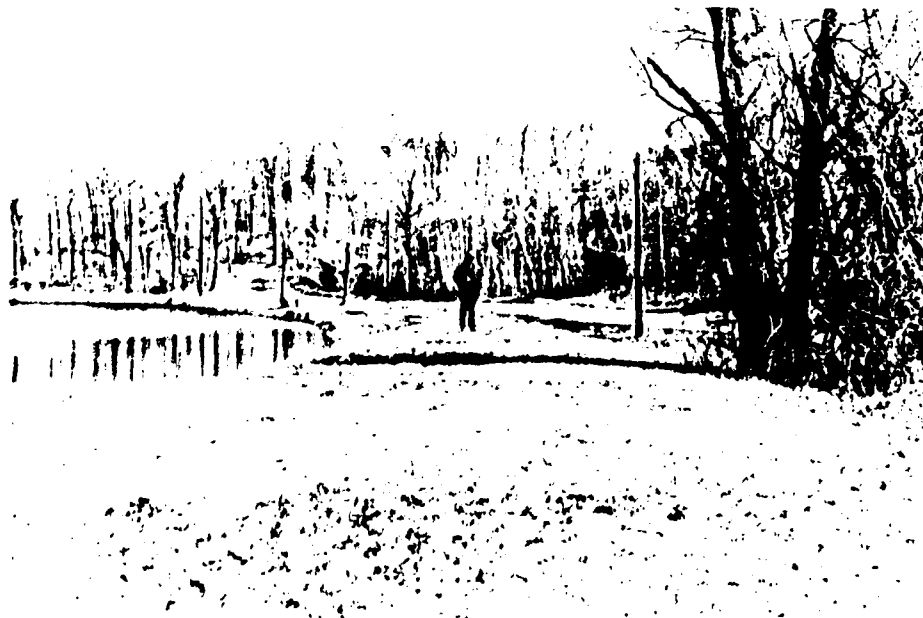
b. Embankment. The embankment is generally in good condition. There are low areas along the top of both the main embankment and the dogleg. The lowest area is along the dogleg and it is 1.1 feet below the design elevation of the top of the dam.

B. Dogleg along left side of reservoir

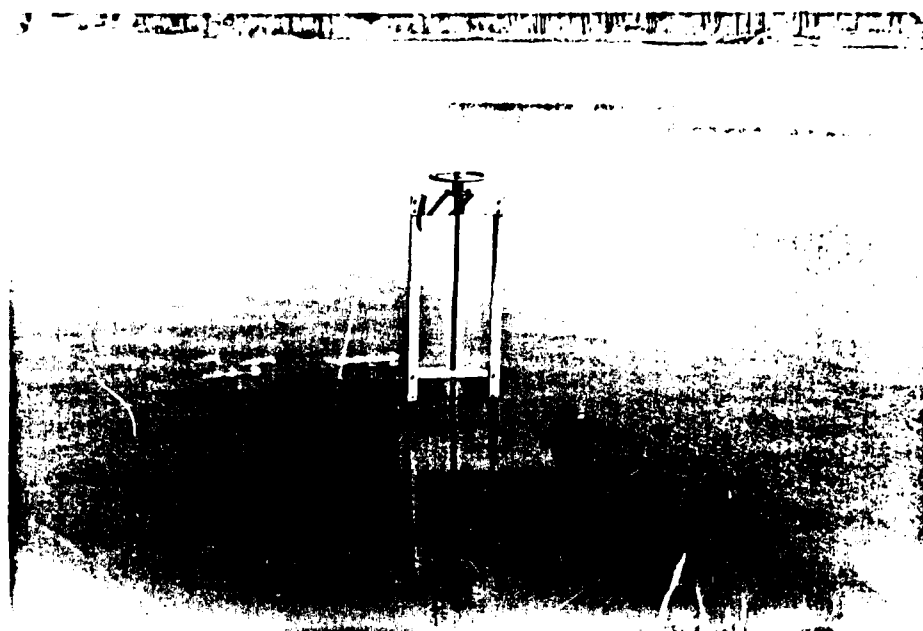
c. Appurtenant Structures. The outlet works is in good condition. The caretaker reported that the valve is operated annually to draw down the reservoir slightly to facilitate flashboard removal.

G. Gate operating mechanism
