National Dam Inspection Program.
Duck Harbor Pond Dam (NDI ID Number
PA-00144, DER ID Number 64-54), Dela-
ware River Basin, Little Equinunk Creek,
Wayne County, Pennsylvania. Phase I
Inspection Report.

DUCK HARBOR POND DAM

NDI ID No. PA-00144

PHASE I INSPECTION REPORT
NATIONAL DAM INSPECTION PROGRAM

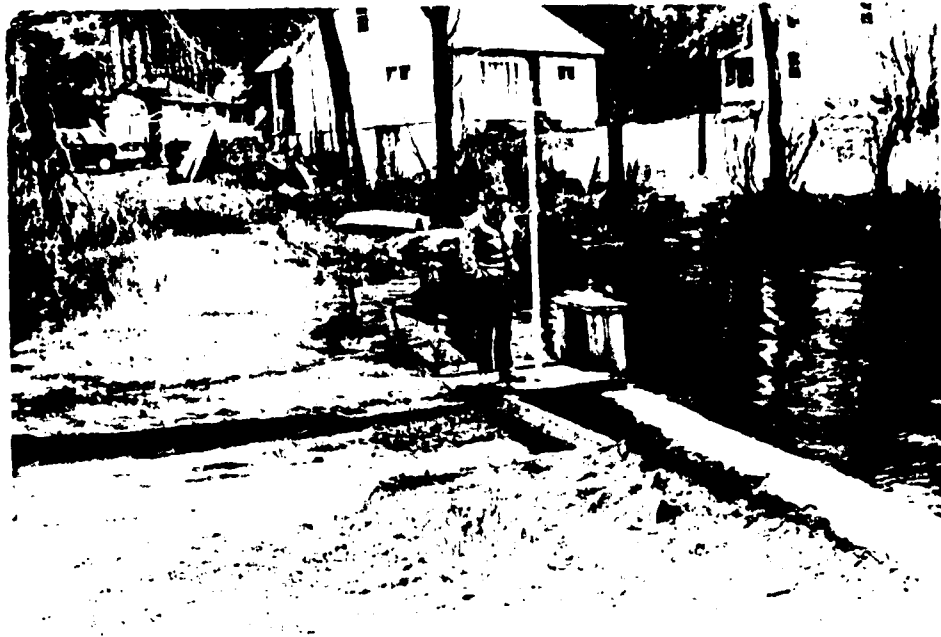
C. Top of Dam

(1) As part of the regular maintenance program, remove trees growing along the toe of the dam and replace the missing stones at the top of the dam.

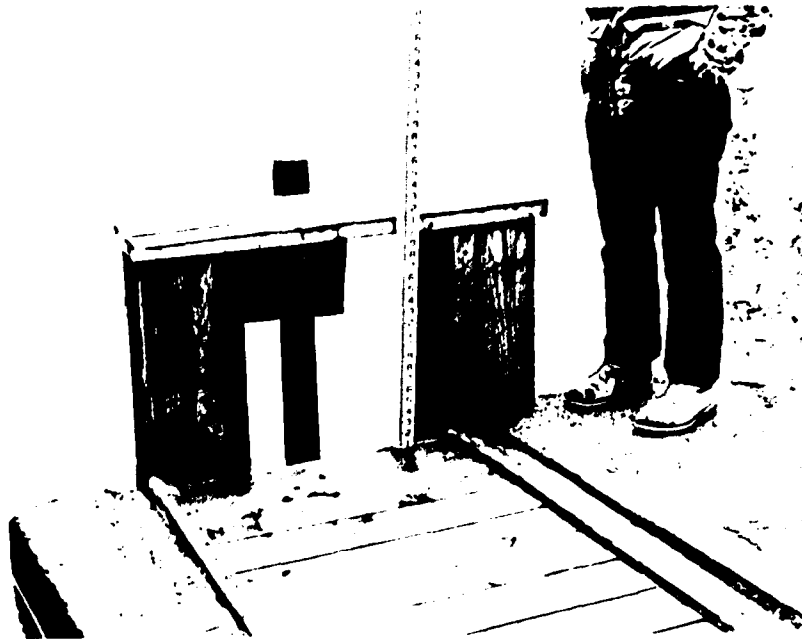
The outlet works is in excellent condition (Photograph E). It was noted that some of the outlet works discharge passing over the top outlet works stoplog was flowing into the dry masonry.

E. Outlet Works
