WILDWOOD LAKE DAM

NDI ID NO. PA-00157

PHASE I INSPECTION REPORT

NATIONAL DAM INSPECTION PROGRAM

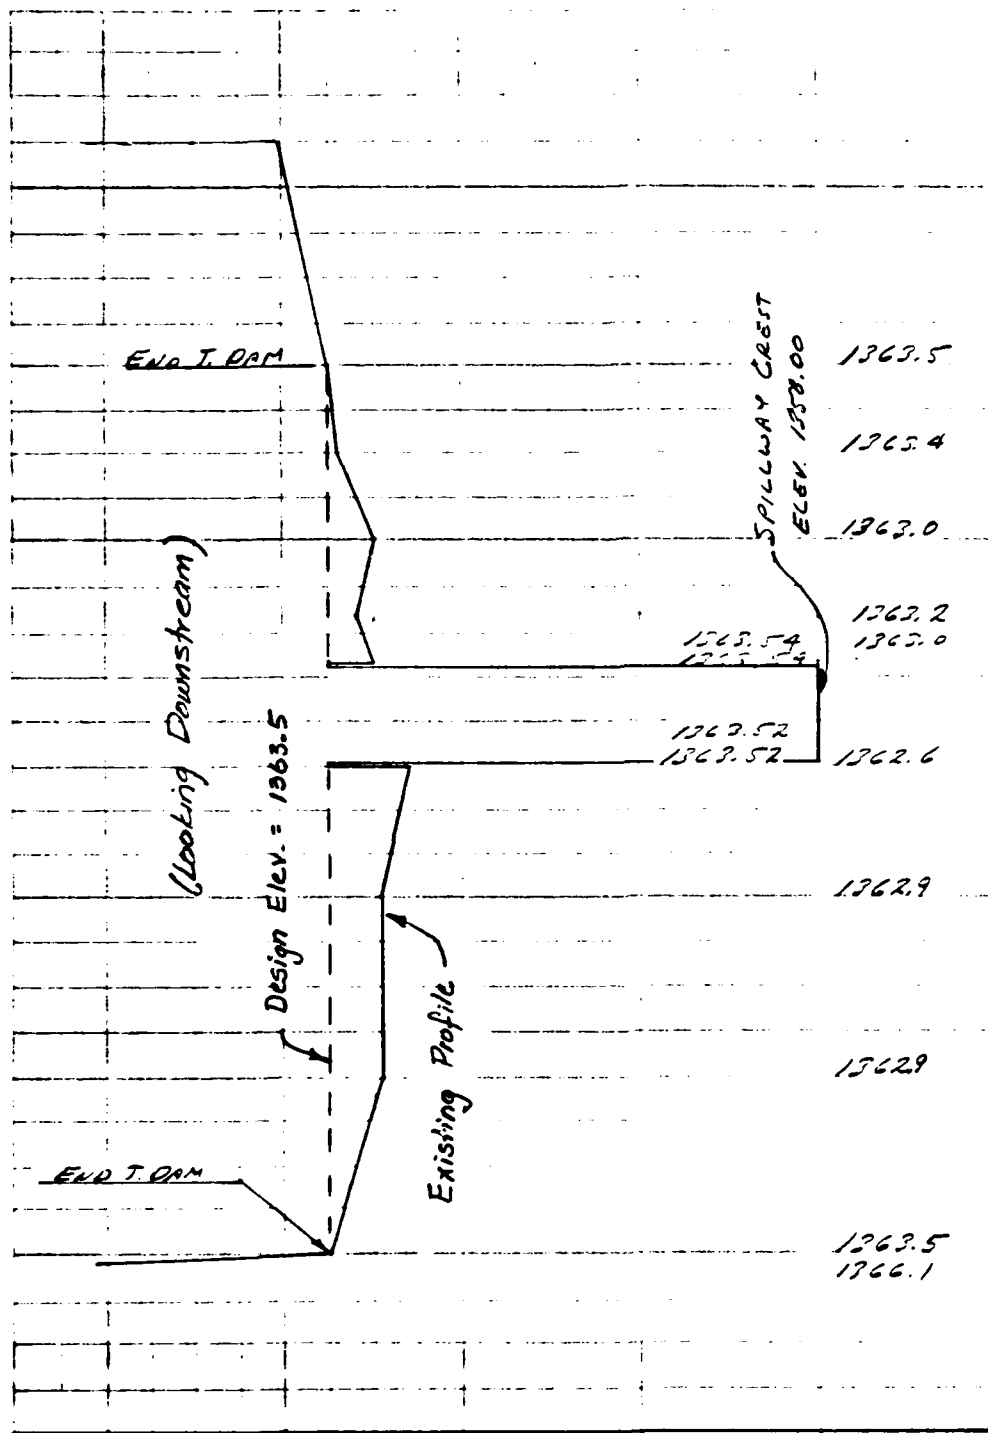
WILLOWOOD LAKE DAM
 Profile - Top of Dam
 Scales: 1" = 100' Hor
 1" = 2' Ver

VISUAL EXAMINATION OF	OBSERVATIONS	REMARKS OR RECOMMENDATIONS
JUNCTION OF EMBANKMENT WITH: Abutment Spillway Other Features	<i>Abutments - no deficiencies. Spillway - low areas as shown on profile on Sheet B-9.</i>	
ANY NOTICEABLE SEEPAGE	<i>None.</i>	
STAFF GAGE AND RECORDER	<i>None.</i>	
DRAINS	<i>None apparent.</i>	
TREES AND BRUSH	<i>Upstream and downstream slopes covered with brush and many trees.</i>	<i>Average size of trees 3" - 4' diameter. Maximum size about 8" diameter.</i>

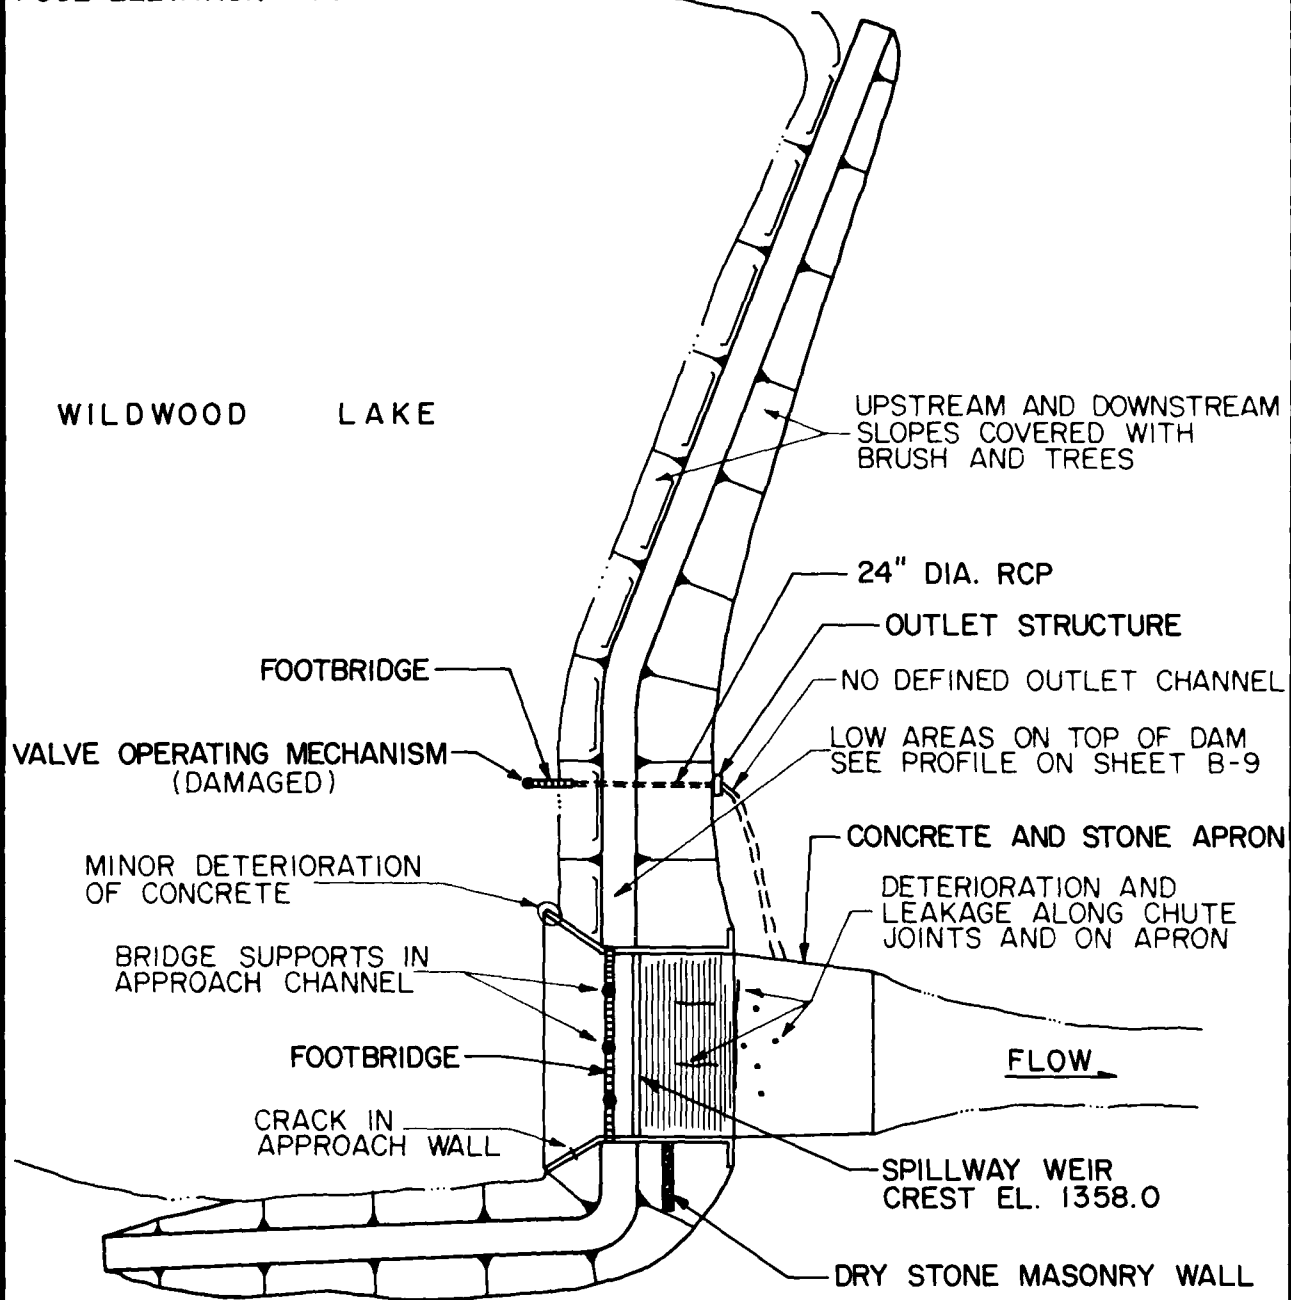
PHASE I INSPECTION REPORT
NATIONAL DAM INSPECTION PROGRAM
WILDWOOD LAKE DAM
WILDWOOD PARK OUTING CLUB, INC.
**RESULTS OF
VISUAL INSPECTION**
MARCH 1981 EXHIBIT B-1

a. General. The overall appearance of the dam is fair. Some deficiencies were observed as noted below. A sketch of the dam with the locations of deficiencies is presented on Exhibit B-1 in Appendix B. Survey information acquired for this Report is summarized in Appendix B. Datum used for the survey was the spillway crest level, Elevation 1358.0. On the day of the inspection, the pool was at the spillway crest level.
