BUNNELL'S POND DAM

NDI ID NO. PA-00170
DER ID NO. 64-29

PHASE I INSPECTION REPORT
NATIONAL DAM INSPECTION PROGRAM

MARCH 1981

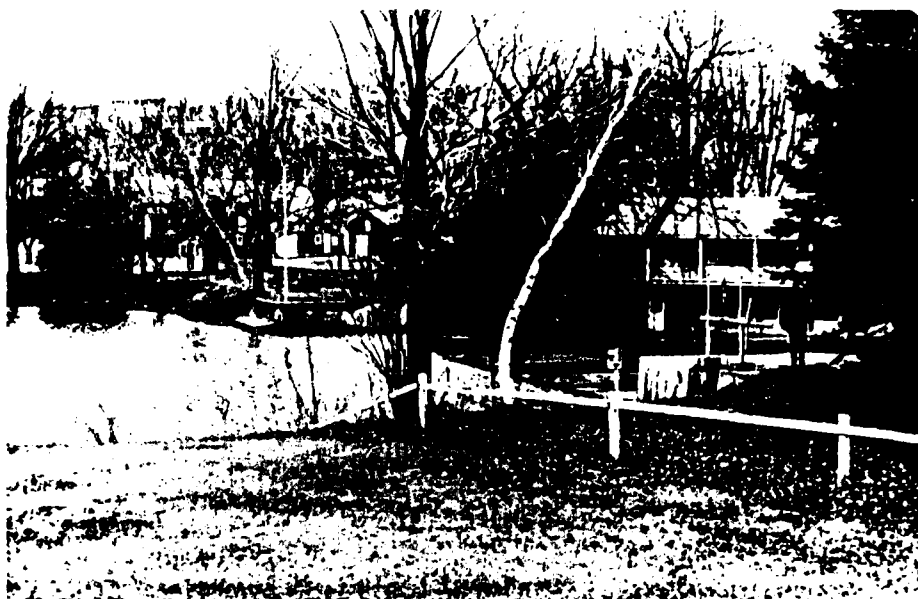
A. Upstream Side of Dam

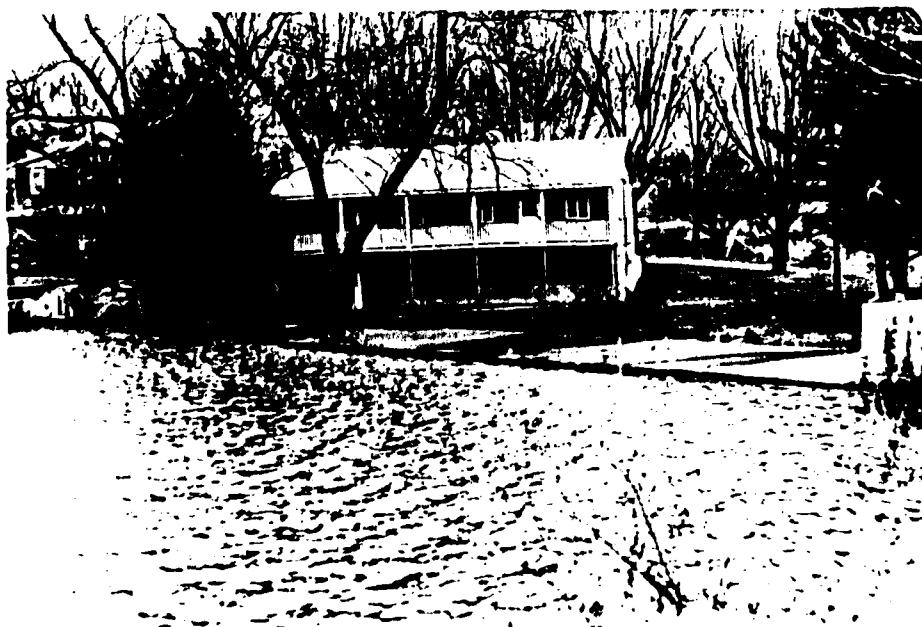
B. Upstream Side of Spillway

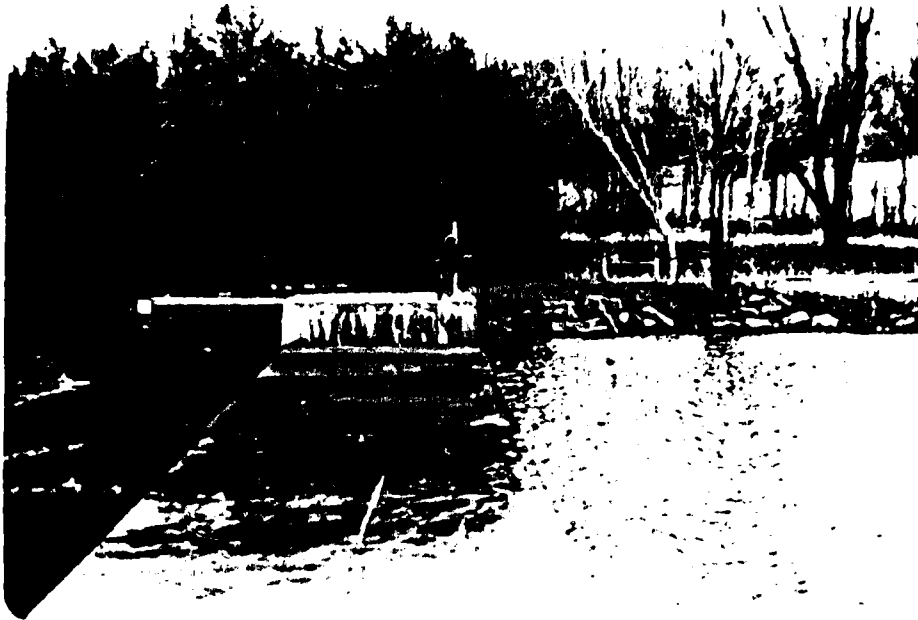
C. Spillway-Looking Toward Right Abutment
