STONE LAKE DAM

(NDI.D. PA-0055,  
DER ID. 058-129), Susquehanna

~~OWNER: SUSQUEHANNA RIVER BASIN~~  
River Basin, Stonestreet Creek, Susquehanna County,  
Pennsylvania. PHASE I INSPECTION REPORT,

NATIONAL DAM INSPECTION PROGRAM

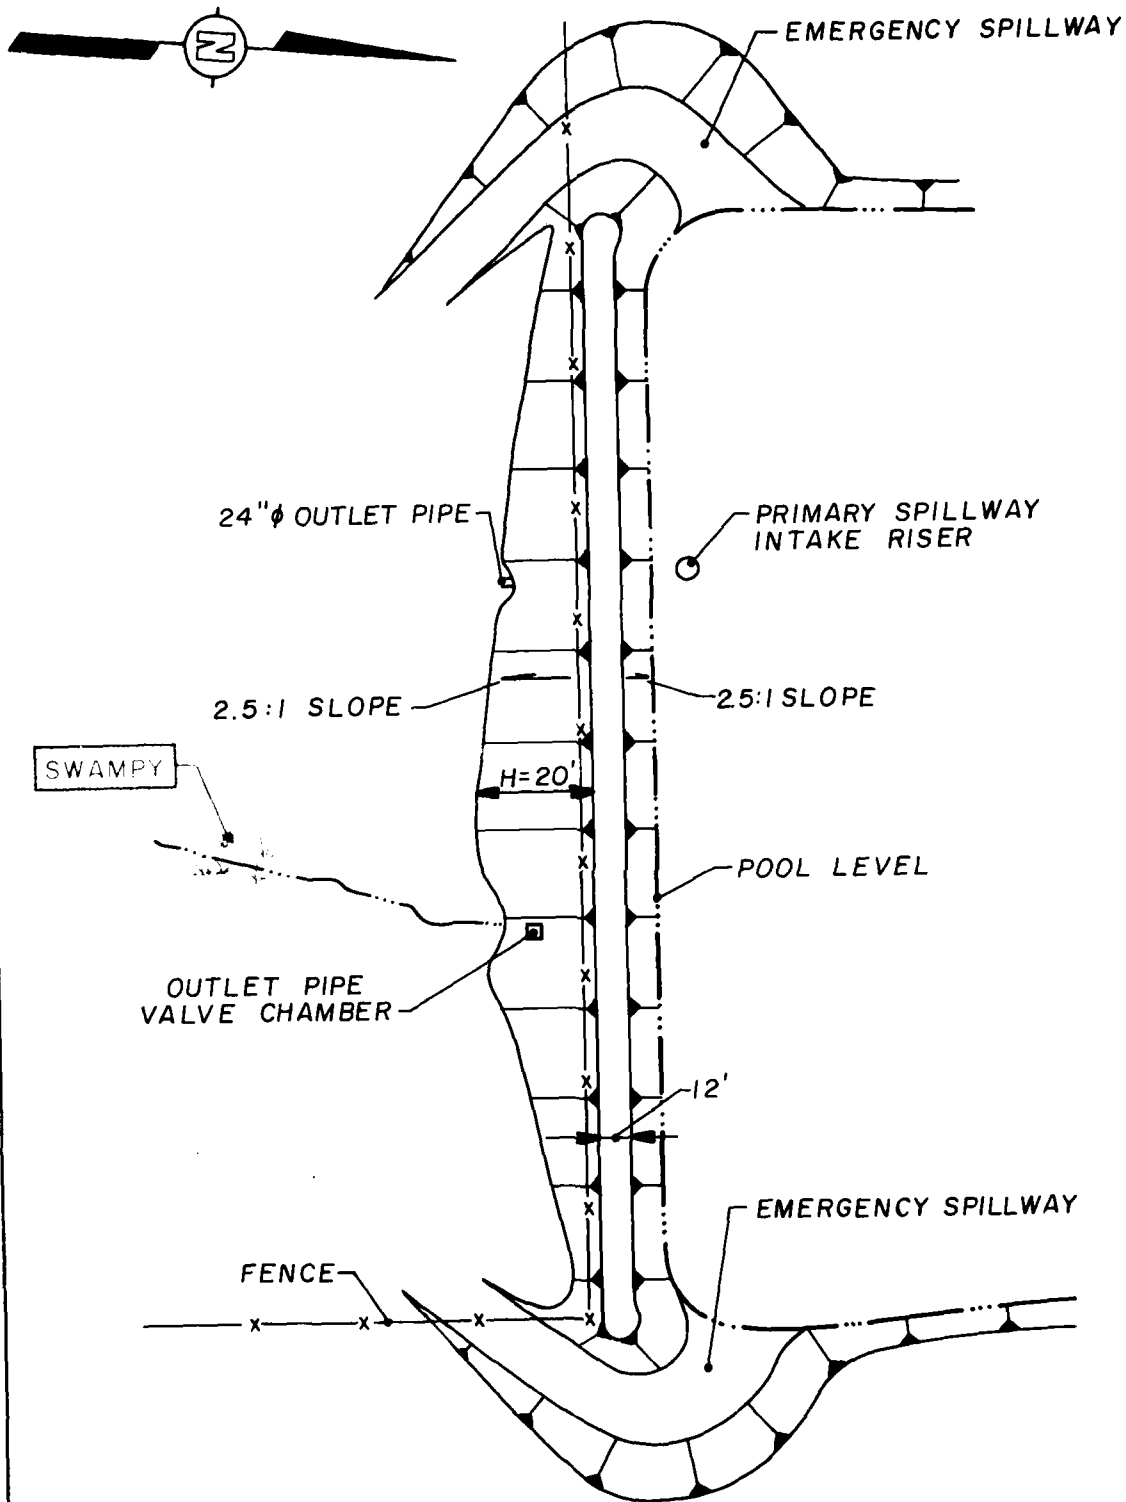
In general, the condition of the dam is considered to be good. One wet area was observed at the toe of the dam in an area which appears to be the original streambed. No seepage flow appeared to be associated with this area. The downstream face and the crest are covered with grass and found to be adequately maintained.

VISUAL EXAMINATION OF	OBSERVATIONS	REMARKS OR RECOMMENDATIONS
JUNCTION OF EMBANKMENT AND ABUTMENT, SPILLWAY AND DAM	No problems observed.	
ANY NOTICEABLE SEEPAGE	None. A swampy area is located below the toe of the dam. See Plate 4 for location.	This area should be periodically observed to determine if seepage conditions are developing.
STAFF GAGE AND RECORDER	None	
DRAINS	None

1. The owner should confirm the operational condition of the outlet pipe valve and perform maintenance, if required. The need for providing an upstream control to the outlet pipe should be evaluated.
2. The swampy area below the toe of the dam should be periodically observed and necessary remedial work should be performed if seepage conditions develop.
3. The barbed wire fence across the right abutment emergency spillway should be relocated sufficiently away from the flow control section to prevent possible blockage of the channel by debris.
4. Around-the-clock surveillance should be provided during unusually heavy runoff and a formal warning system should be developed to alert the downstream residents in the event of an emergency.
5. The dam and appurtenant structures should be inspected regularly and necessary maintenance should be performed.

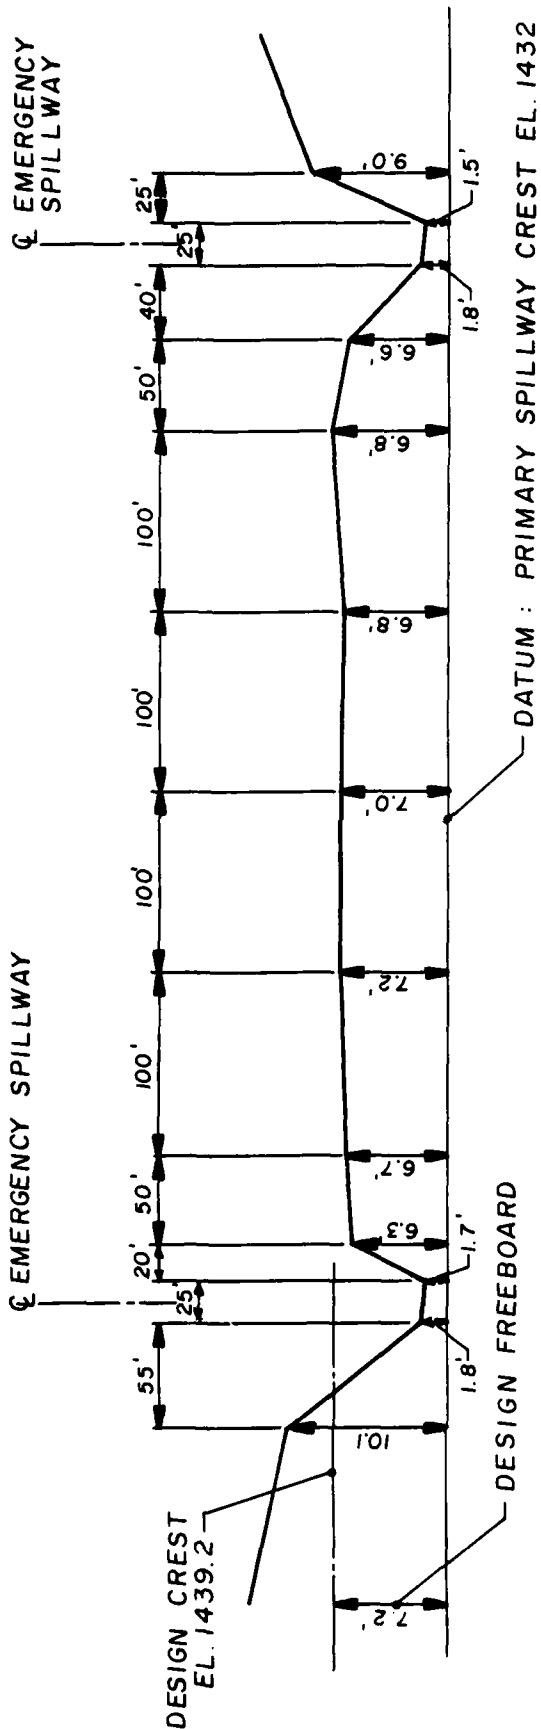
DAM CREST PROFILE  
(LOOKING DOWNSTREAM)

The dam crest was surveyed relative to the primary spillway crest elevation and was found to have some vertical irregularities. Although the design freeboard for the dam is 7.2 feet, the field survey indicated freeboards ranging from 6.3 feet to 7.2 feet. The lowest area occurred in a section adjacent to the left emergency spillway. The dam crest profile, according to field measurements, is illustrated in Plate 5.
