MINKLER LAKE DAM

NDI I.D. PA-0052

PHASE I INSPECTION REPORT  
NATIONAL DAM INSPECTION PROGRAM

NAME OF DAM: Minkler Lake Dam  
 STATE LOCATED: Pennsylvania  
 COUNTY LOCATED: Susquehanna  
 STREAM: Apalachin Creek  
 SIZE CLASSIFICATION: Small  
 HAZARD CLASSIFICATION: Significant  
 OWNER: Mr. Mario Roma and Mr. Asa B. Chilson  
 DATE OF INSPECTION: March 24, 1981 and April 30, 1981

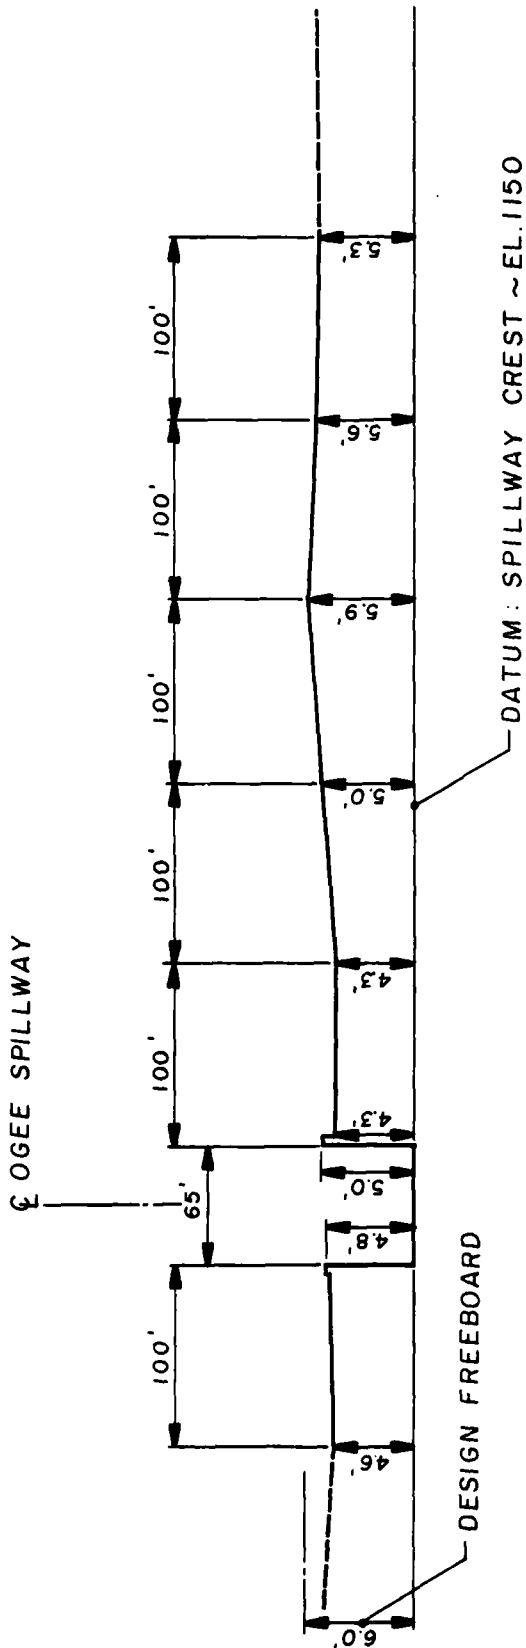
DAM CREST PROFILE  
(LOOKING DOWNSTREAM)

The top of the dam was surveyed relative to the spillway crest elevation and was found to have some vertical irregularities. While the design freeboard for the dam was six feet, the field survey indicated a freeboard of 4.3 feet between the low spot of the embankment and the spillway crest. Plate 6 shows the dam crest profile.
