PERRINS MARSH DAM

NDI I.D. PA-0886,
DER I.D. 066-005
OWNER: MR. ELMER REESE

PHASE I INSPECTION REPORT
NATIONAL DAM INSPECTION PROGRAM

PERRINS MARSH DAM
NDI I.D. PA-0886
DER I.D. 066-005
NOVEMBER 10, 1980

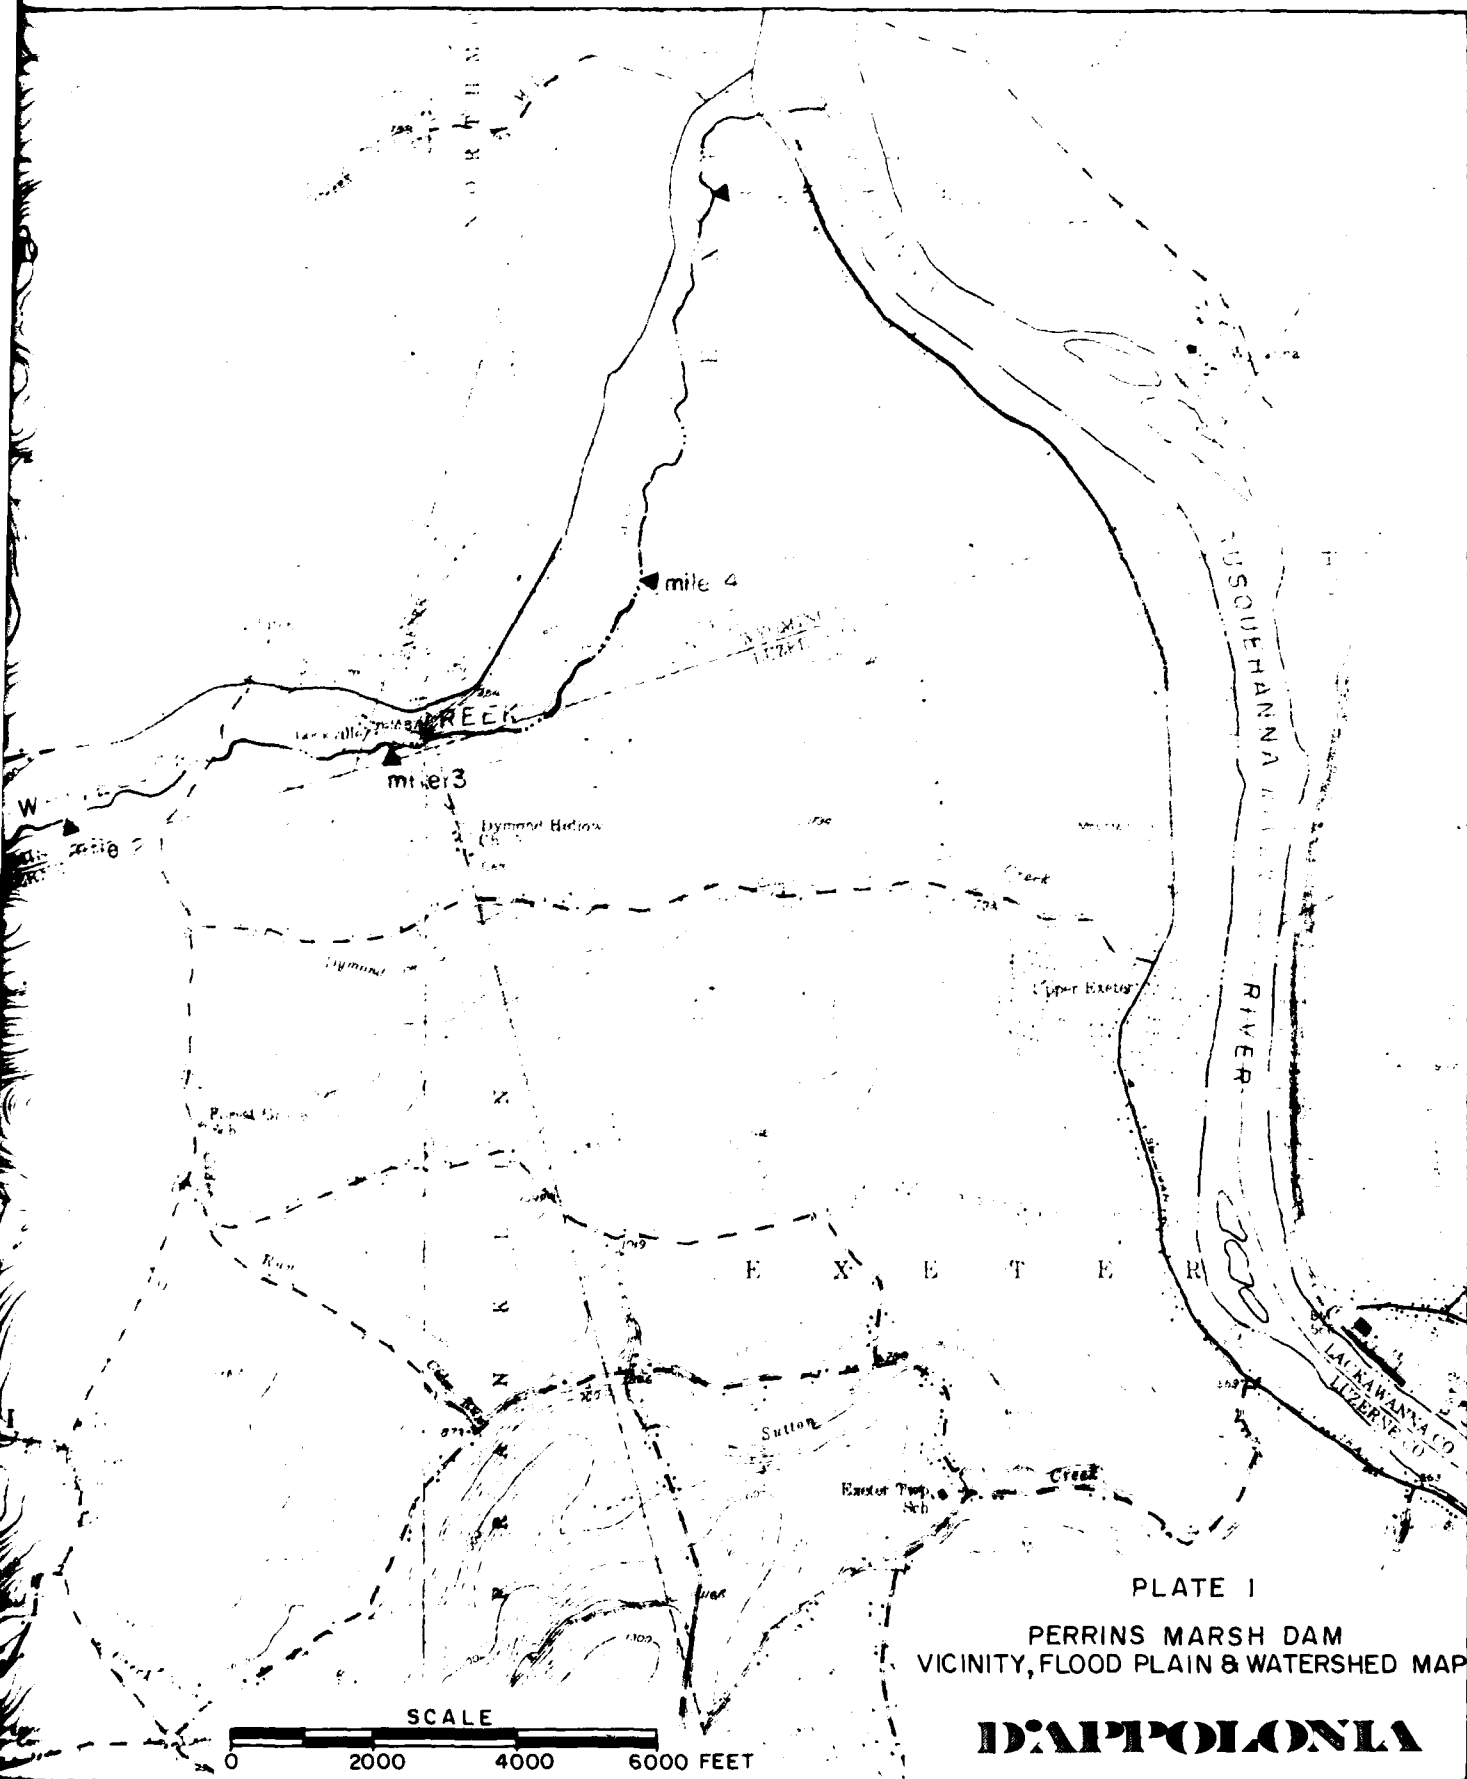
The specific observations are illustrated in Plate 2.

VISUAL EXAMINATION OF	OBSERVATIONS	REMARKS OR RECOMMENDATIONS
JUNCTION OF EMBANKMENT AND ABUTMENT, SPILLWAY AND DAM	An erosion ditch at left abutment dam junction. See Plate 2 for location.	Erosion ditch should be filled. Adequate erosion protection (such as riprap) should be provided at the junction of embankment with both abutments.
ANY NOTICEABLE SEEPAGE	None	
STAFF GAGE AND RECORDER	None	
DRAINS	None

immediately retain the services of a professional engineer for rehabilitation and restoration of the dam. Filling of the erosion scar on the left abutment and restoration of the concrete work and stone wall is recommended. The need for providing riprap at the junction of the overflow section and the abutments should be evaluated.

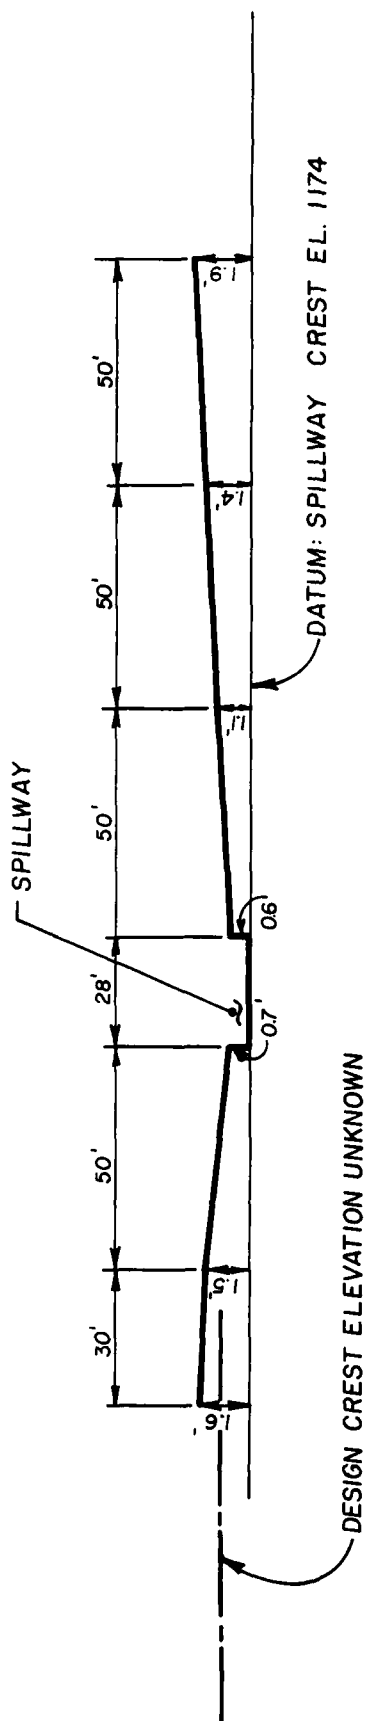
DAM CREST PROFILE (LOOKING DOWNSTREAM)

The top of the dam and the abutment sections were surveyed relative to the overflow section of the dam. The profile is illustrated in Plate 3.
