DEL AWARE RIVER BASIN
MILL DAM
COMMONWEALTH OF PENNSYLVANIA
WERNERSVILLE STATE HOSPITAL

NDI NO. PA-00711
DER NO. 6-295
BERKS COUNTY, PENNSYLVANIA

PHASE I INSPECTION REPORT
NATIONAL DAM INSPECTION PROGRAM

JUNE 1981

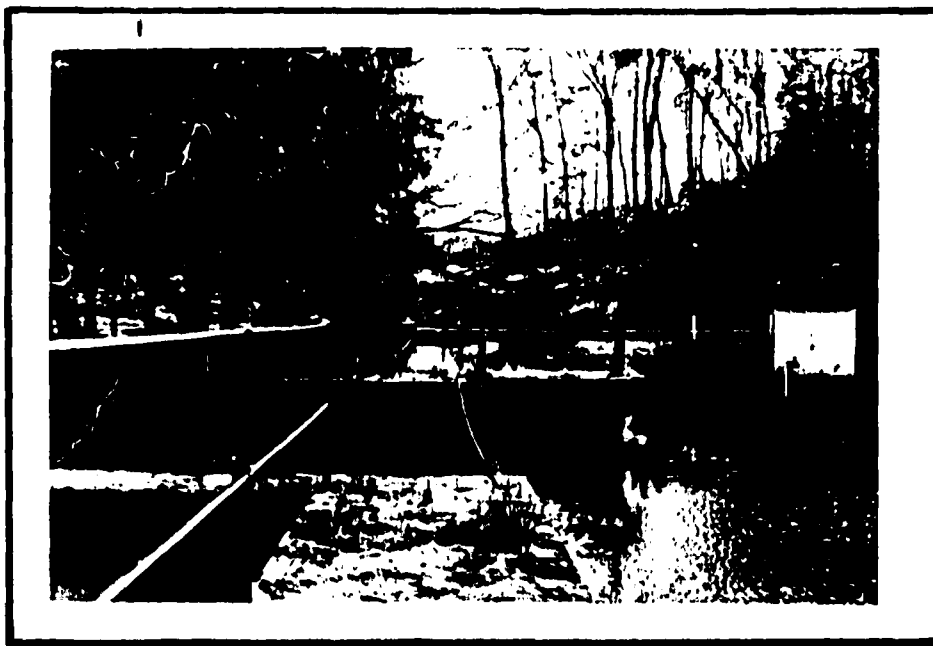
TOP VIEW FROM LEFT END - NO. 2

The concrete gravity section is faced with masonry and has an excellent appearance. The crest is four feet wide and is provided with a pipe railing and an entrance gate (Photograph No. 1). The right abutment ties into the right hillside, which has been excavated for a roadway (Photograph No. 2). The left abutment ties into a steep wooded slope. Both abutments appear to be solid.
