**QUAKAKE DAM**

NDI ID NO. PA-00613  
DER ID NO. 13-11

**HAZLETON CITY WATER AUTHORITY**

**PHASE I INSPECTION REPORT  
NATIONAL DAM INSPECTION PROGRAM**

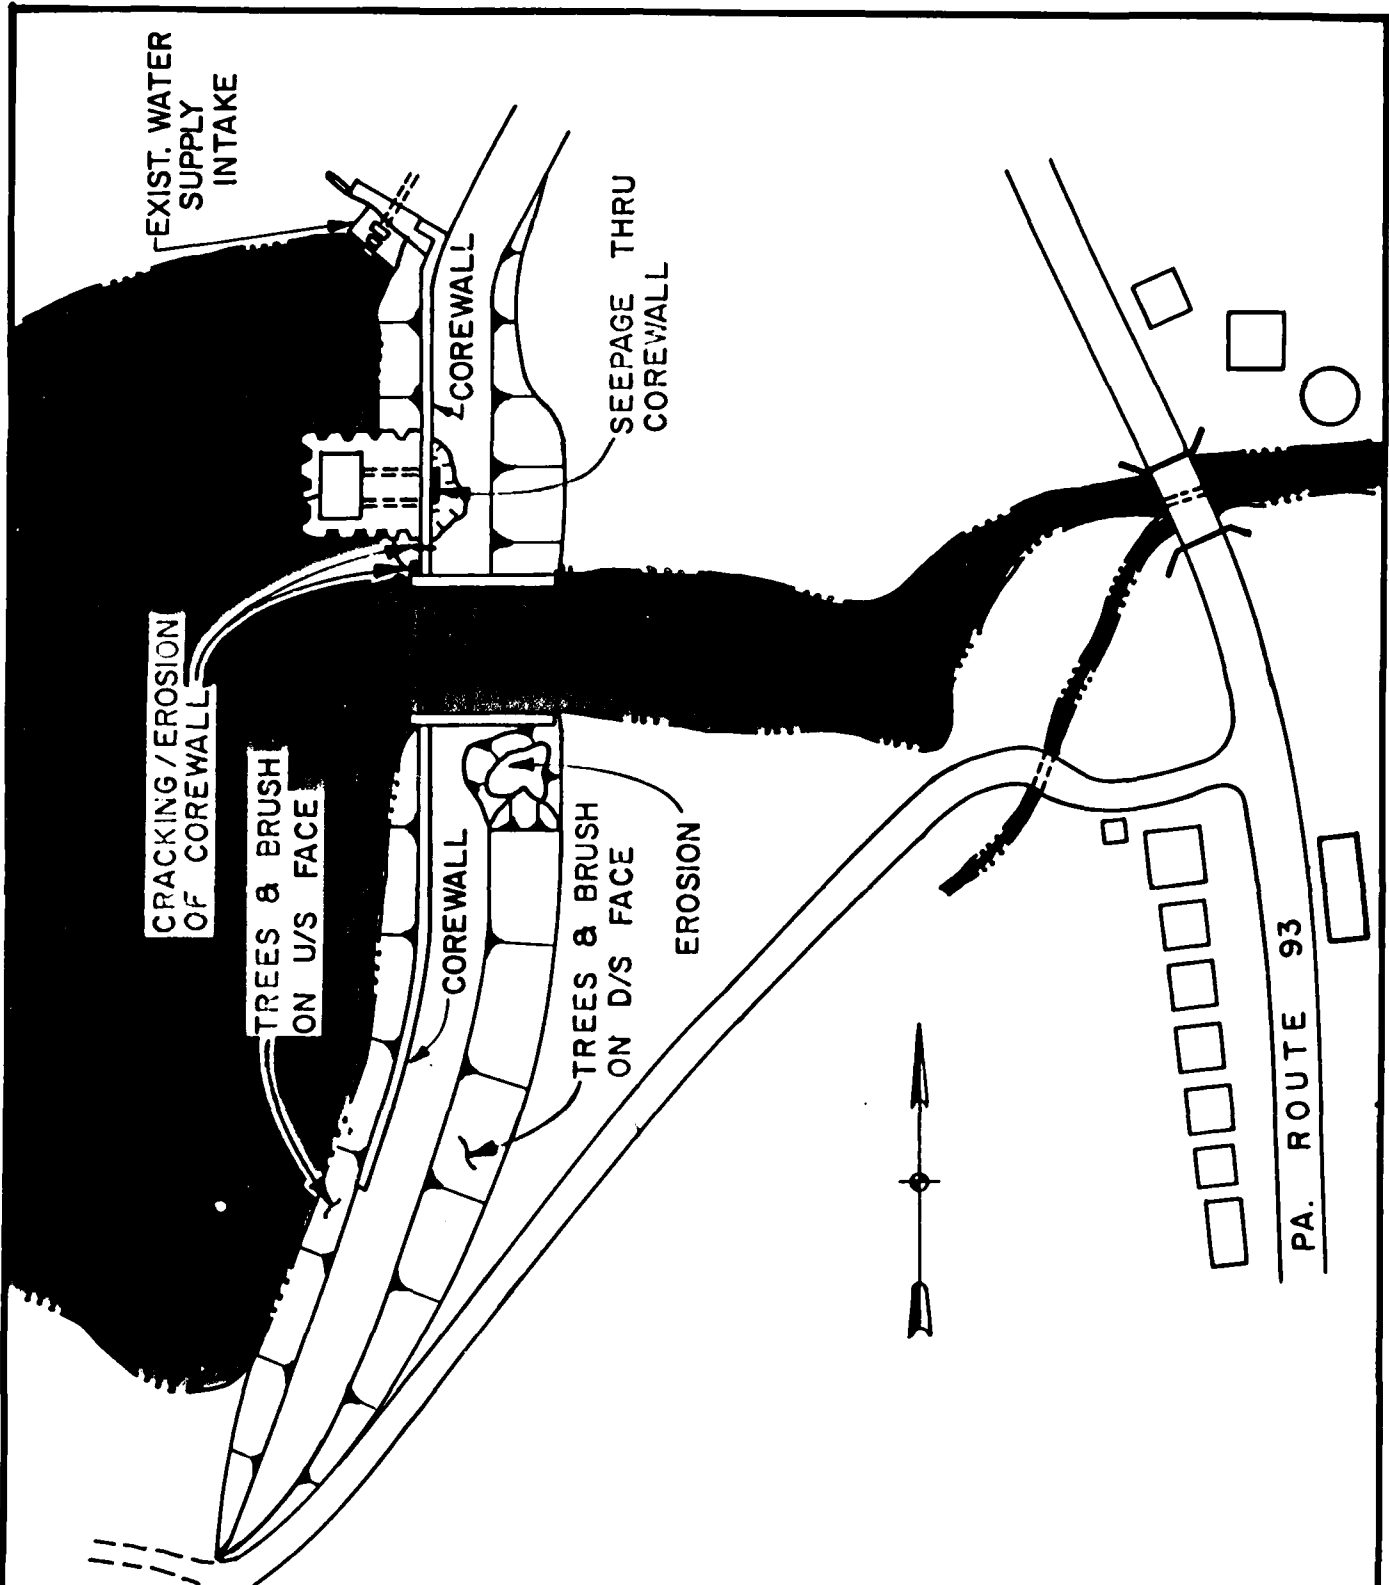
FIELD SKETCH

CRACKING / EROSION  
OF COREWALL

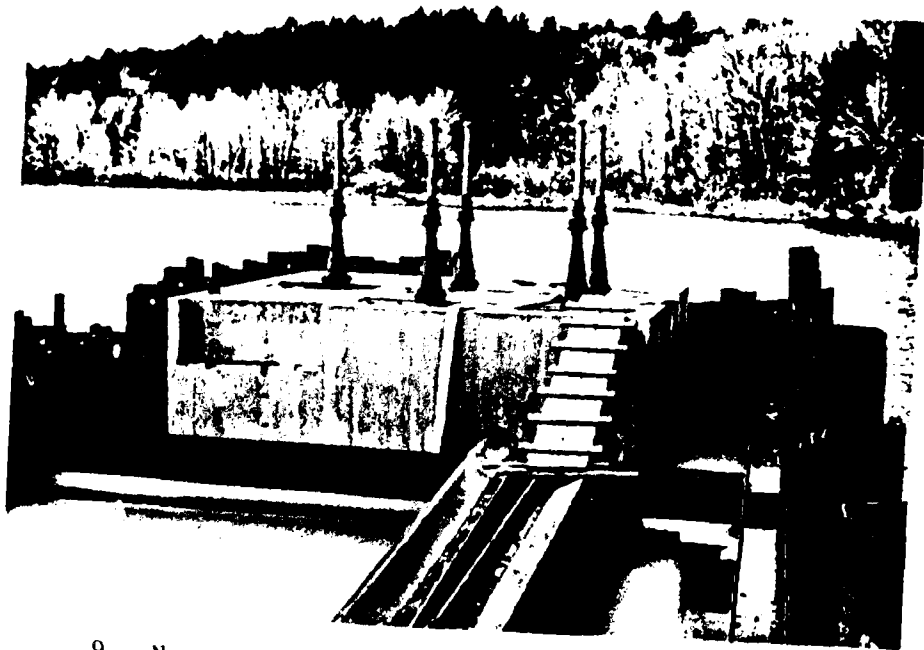
9. New water supply and pond drain intake structure (10 Mar 81)

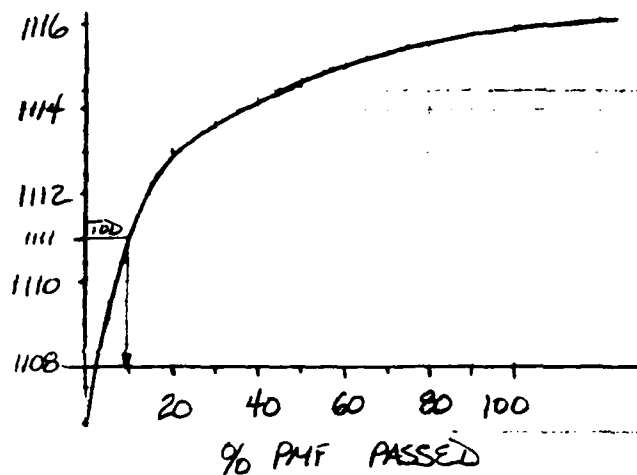
LAKE QUAKAKE DAM  
CAN PASS 9% OF THE  
PMF PRIOR TO OVERTOPPING  
THE EMBANKMENT

THIS FACILITY CAN HANDLE 9% OF THE PMF. AT THE SDF ( $\frac{1}{2}$  PMF), THE DAM IS OVERTOPPED TO A MAXIMUM HEIGHT OF 3.60 FEET FOR A TOTAL DURATION OF ~93 HOURS. SINCE IT IS FELT THAT AT 50% OF THE PMF THE DAM WOULD FAIL DUE TO OVERTOPPING, A BREACH ANALYSIS IS REQUIRED.
