SUSQUEHANNA RIVER BASIN
UPPER MT. HOLLY DAM
EATON - DIKEMAN OF KNOWLTON BROS.

NDI NO. PA-00583
DER NO. 21-001

CUMBERLAND COUNTY, PENNSYLVANIA
PHASE I INSPECTION REPORT
NATIONAL DAM INSPECTION PROGRAM

JUNE 1981

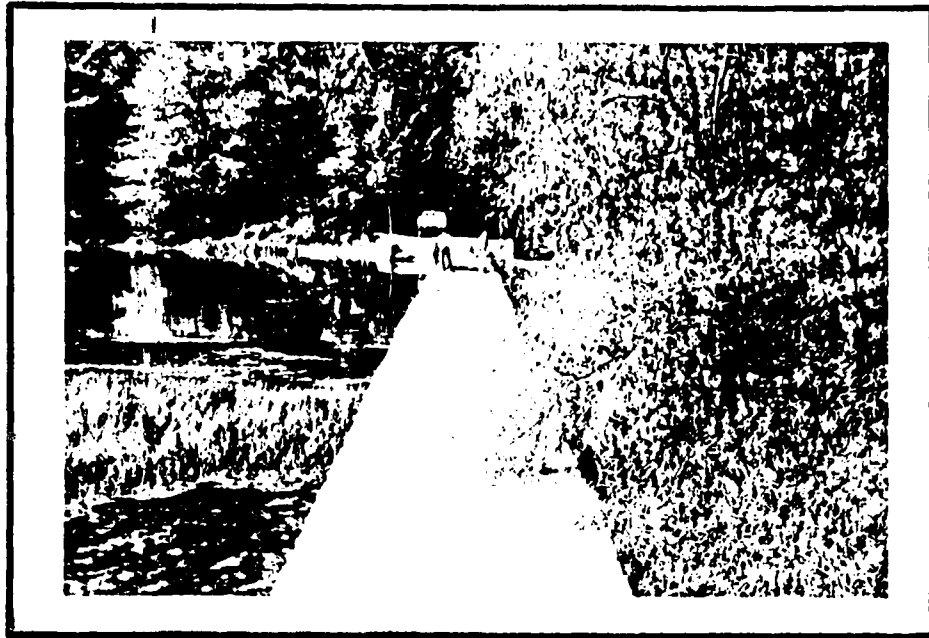
OVERVIEW OF SPILLWAY FROM RIGHT ABUTMENT - NO. 2

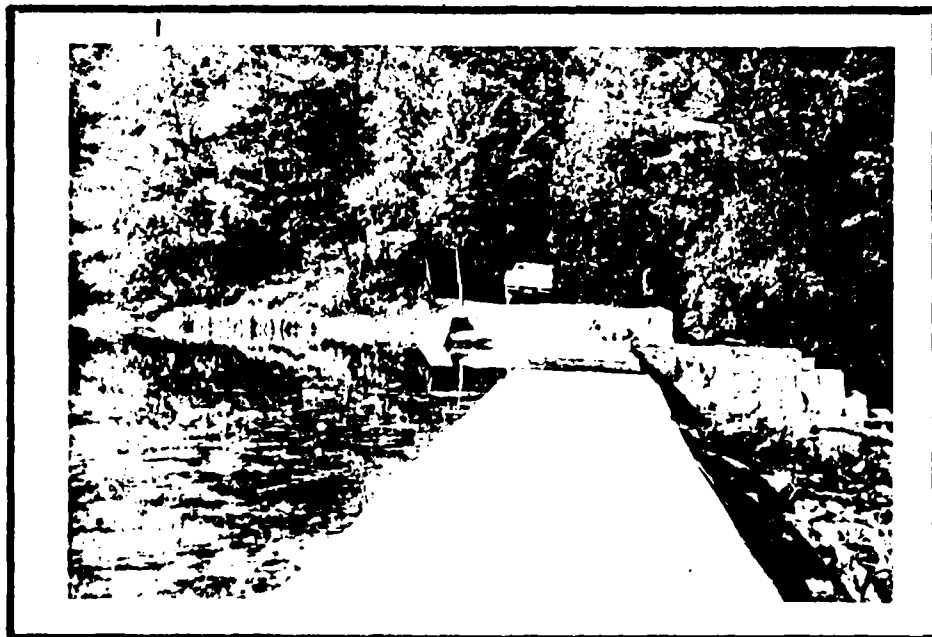
LEFT SPILLWAY ABUTMENT - NO. 3

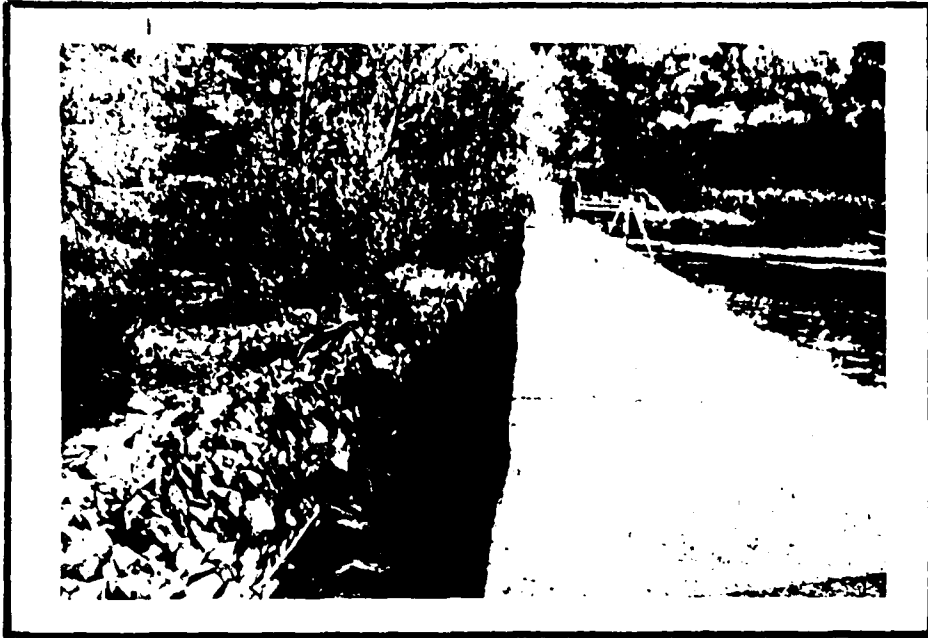
The downstream side of the spillway is protected with hand laid riprap (Photograph No. 4). Several voids have developed in this surface and several trees are growing on this surface. Both conditions could cause further erosion of this protection.

DOWNSTREAM ROCK PROTECTION OF SPILLWAY - NO. 4

After this clearing, the embankment should be inspected for seepage and signs of instability. The embankment should be made level and should be protected against erosion with a good grass mat. The riprap at the downstream side of the spillway should be repaired. <

The spillway weir appears to be stable. The gunite surface has cracked and some seepage through the gravity section is occurring. To prevent future erosion, the trees in the downstream slope should be removed and the voids should be filled.

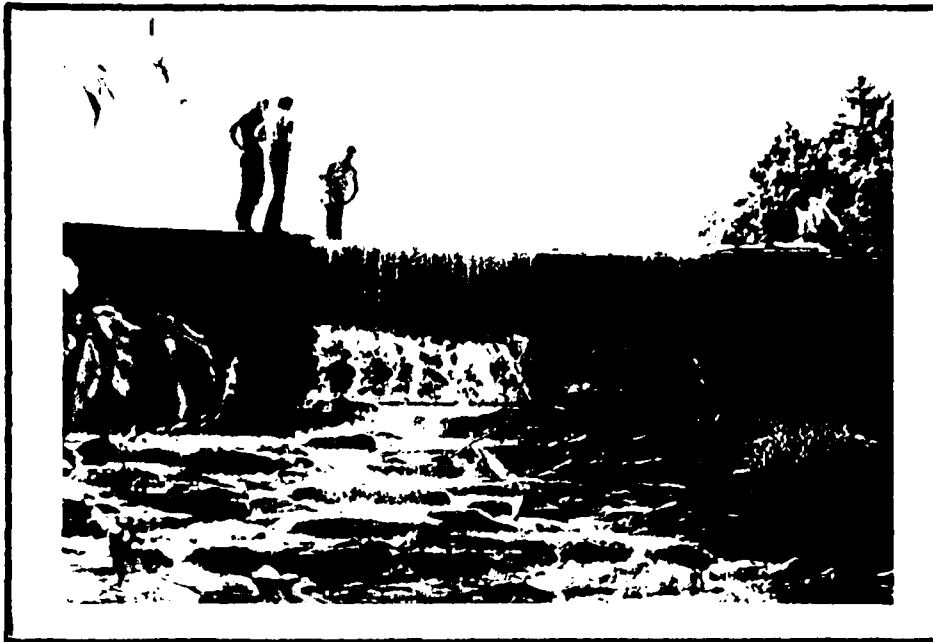
LOW FLOW SECTION OF SPILLWAY - NO. 6

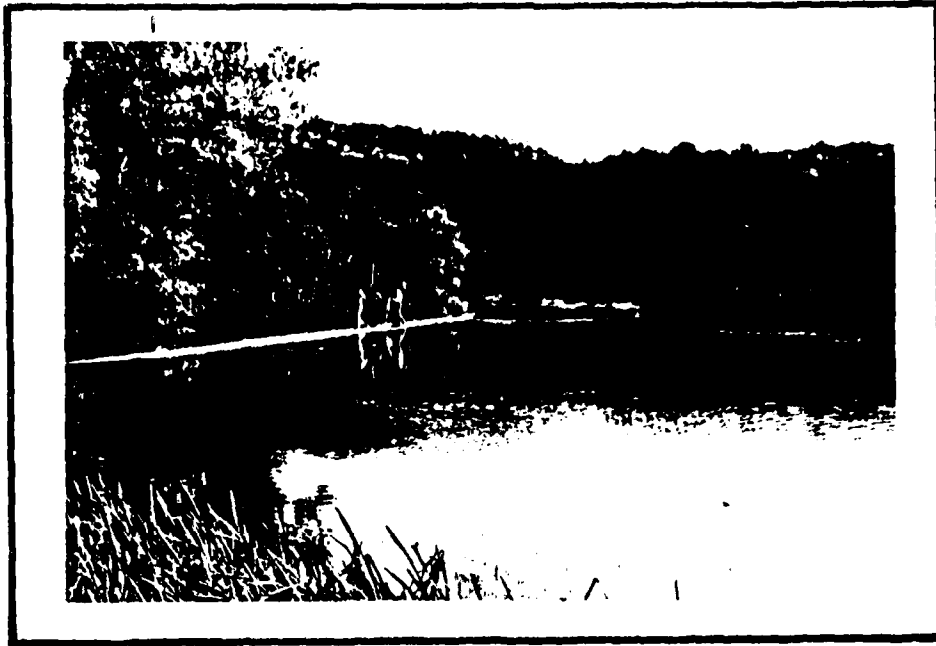
OVERVIEW SPILLWAY FROM LEFT RESERVOIR BANK - NO. 8
