DELAWARE RIVER BASIN
GREEN VALLEY FARMS DAM
MRS. ELEANOR M. REYNOLDS

NDI NO. PA-01101
DER NO. 15-307

CHESTER COUNTY, PENNSYLVANIA
PHASE I INSPECTION REPORT
NATIONAL DAM INSPECTION PROGRAM

JUNE 1981

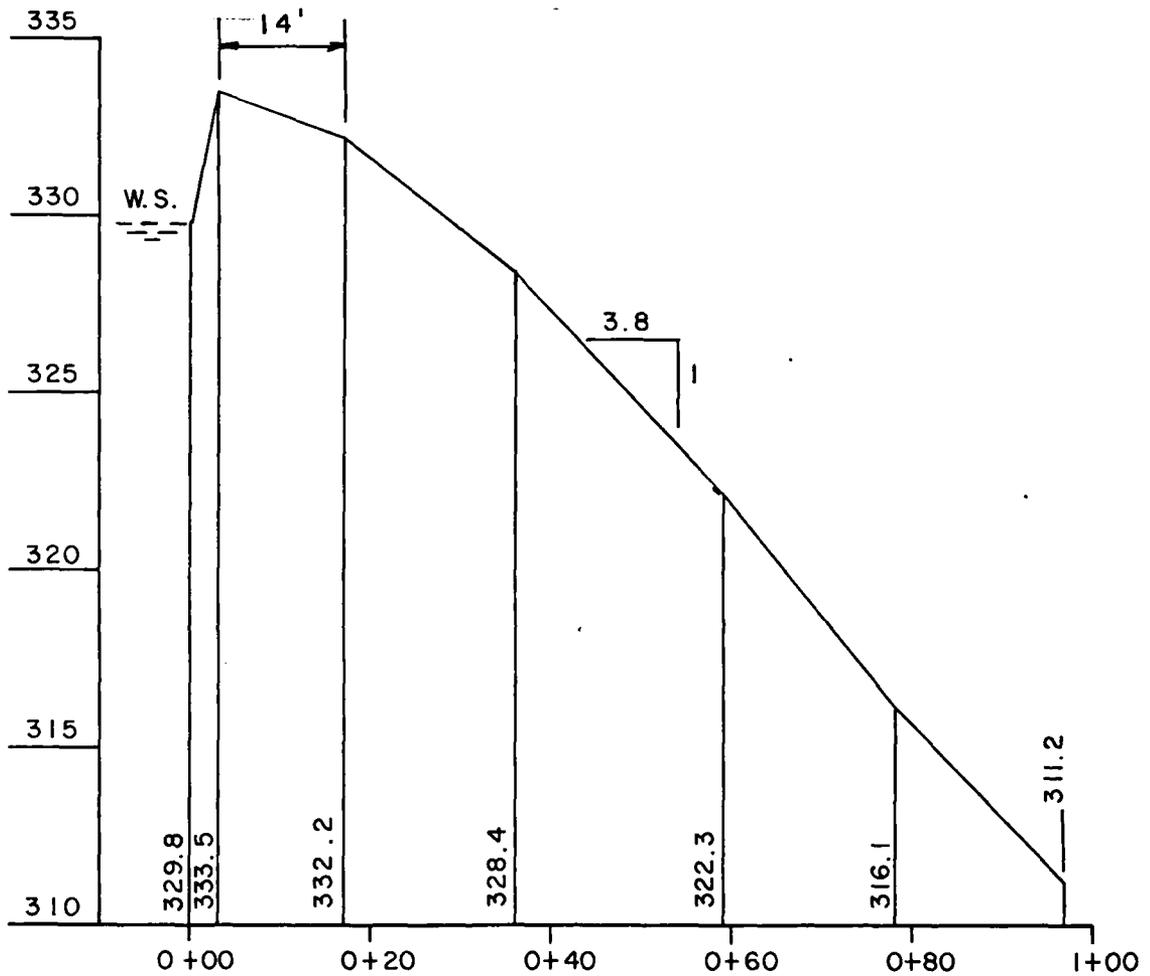
EMBANKMENT SECTION - STA. 5+30

The downstream slope varies over the length of the embankment. The right end of the embankment has a slope of about at 2.5H to 1V. Near the center of the dam at station 5+30 (Plate A-III) the average slope is 3.8H to 1V. The slope has a good grass mat cover. There were no signs of sloughage or seepage. A 30-inch diameter observation well is located near the downstream toe. Two drainpipes, estimated at 6-inch diameter, enter this well. One drain was active. Another pipe discharges the collected water from the well to the downstream area.

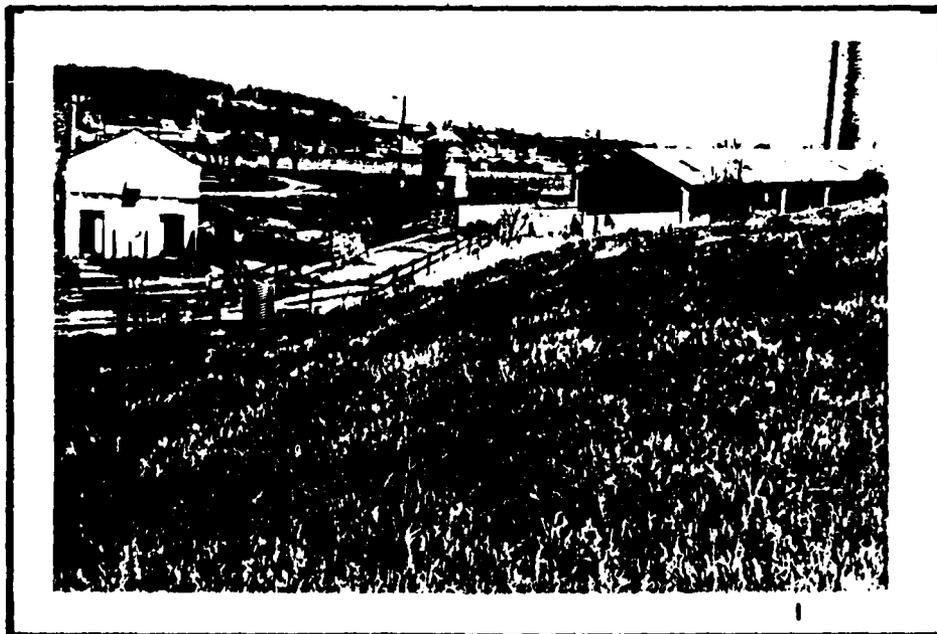
DOWNSTREAM SLOPE - NO. 7
NOTE: OBSERVATION WELL AND BARN
