NDI ID PA 00571  
PA DER 45-258

# HEMLOCK LAKE DAM

PHASE I INSPECTION REPORT  
NATIONAL DAM INSPECTION PROGRAM

APRIL 1981

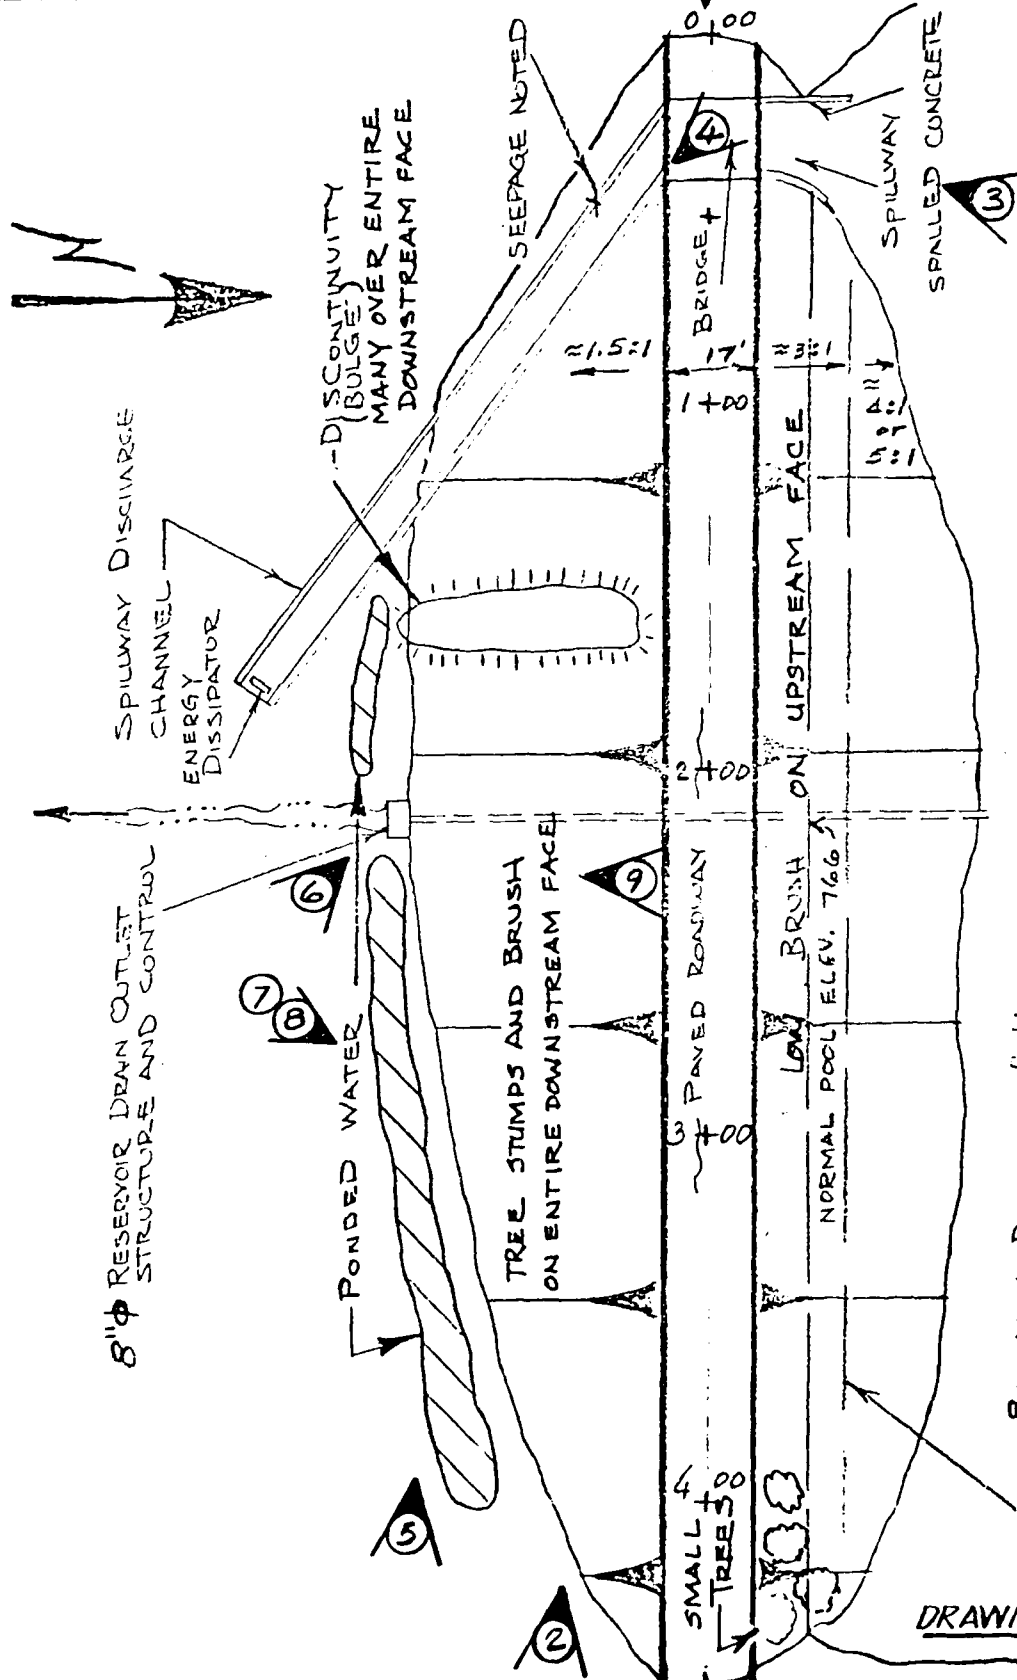
SUBJECT	HEMLOCK LAKE DAM	SHEET	A	BY	REL	DATE	2-10-81	JOB NO.	1841-014
---------	------------------	-------	---	----	-----	------	---------	---------	----------

SEEPAGE NOTED

BREAK IN PROFILE OF UPSTREAM SLOPE  
(APPARENTLY DUE TO THE PLACEMENT OF A CLAY "BLANKET" AFTER INITIAL CONSTRUCTION WAS COMPLETED)

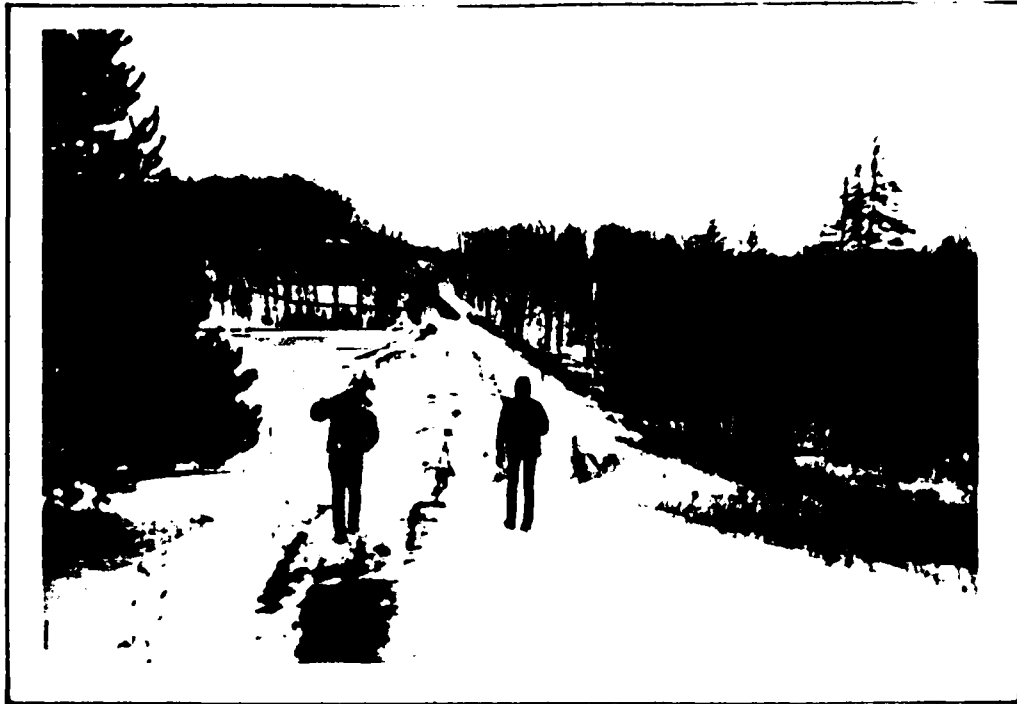
1. VIEW ALONG THE TOP OF THE DAM FROM THE RIGHT ABUTMENT.  
(12/20/80)

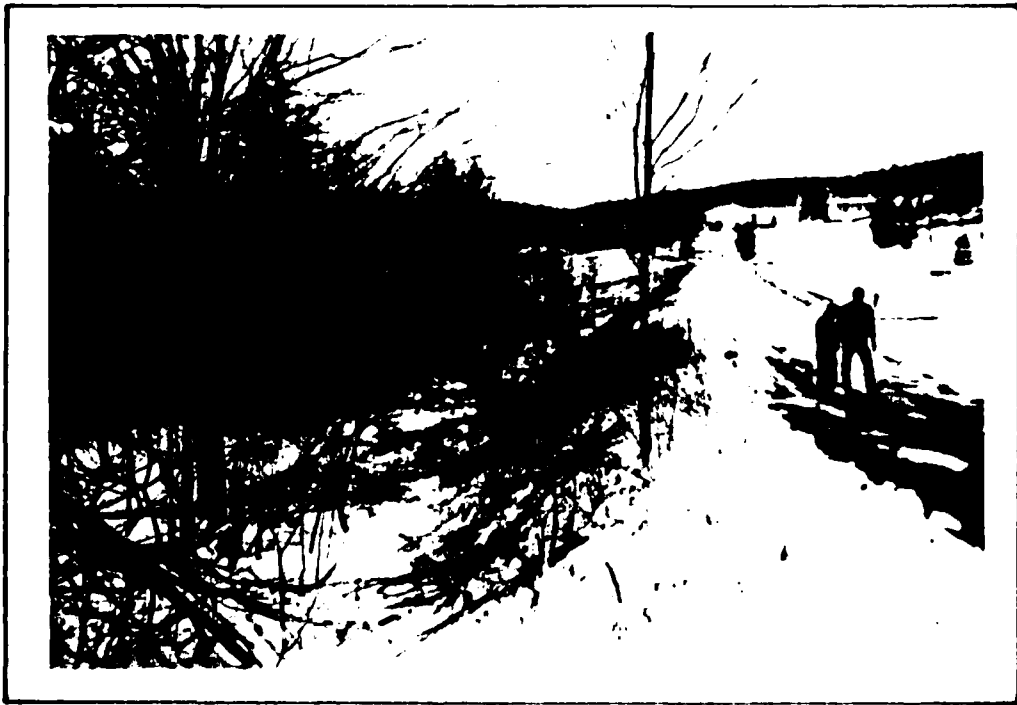
2. VIEW ALONG THE TOP OF THE DAM FROM THE LEFT ABUTMENT.  
(12/20/80)

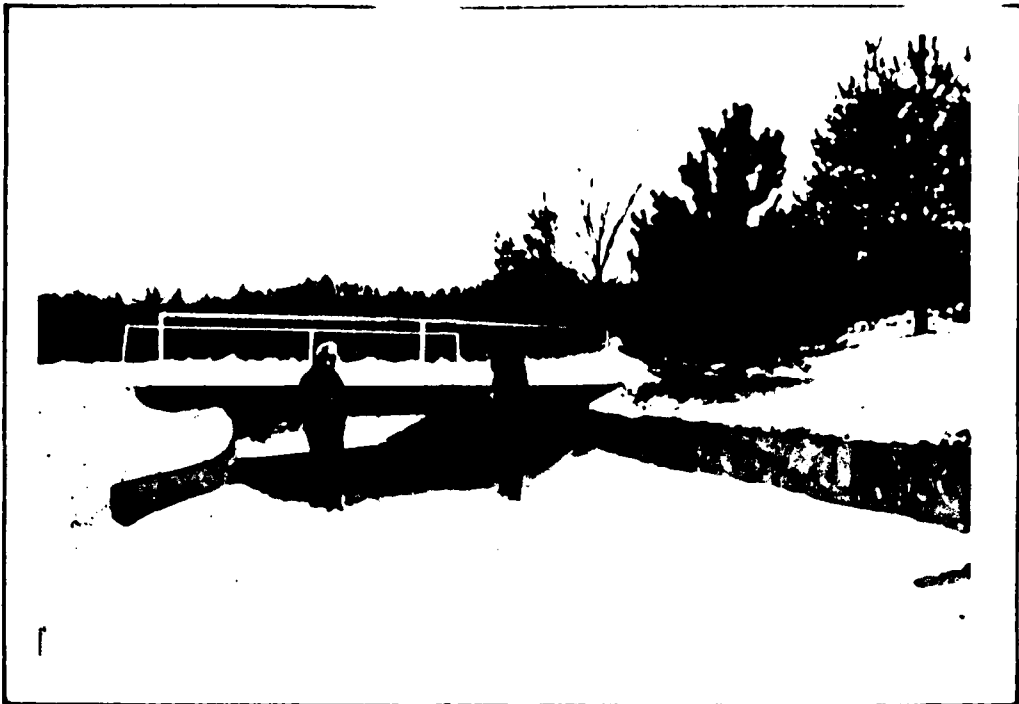
c. Appurtenant Structures. The rectangularly shaped concrete spillway is located at the right abutment. Most of the concrete appears to be in good condition, with some minor spalling noted on the right training wall of the approach section. No settlement was observed in the spillway.

The invert of the approach channel appears to be in good condition. No settlement was noted in the concrete sections. Some minor spalling of the concrete surfaces was noted in the sidewalls of the channel. No reinforcing steel is exposed at these locations.

3. LOOKING DOWNSTREAM AT THE SPILLWAY ENTRANCE CHANNEL.  
(12/20/80)

10. Repair minor spalling of concrete on the approach channel walls of the spillway.

Repair the minor spalling.

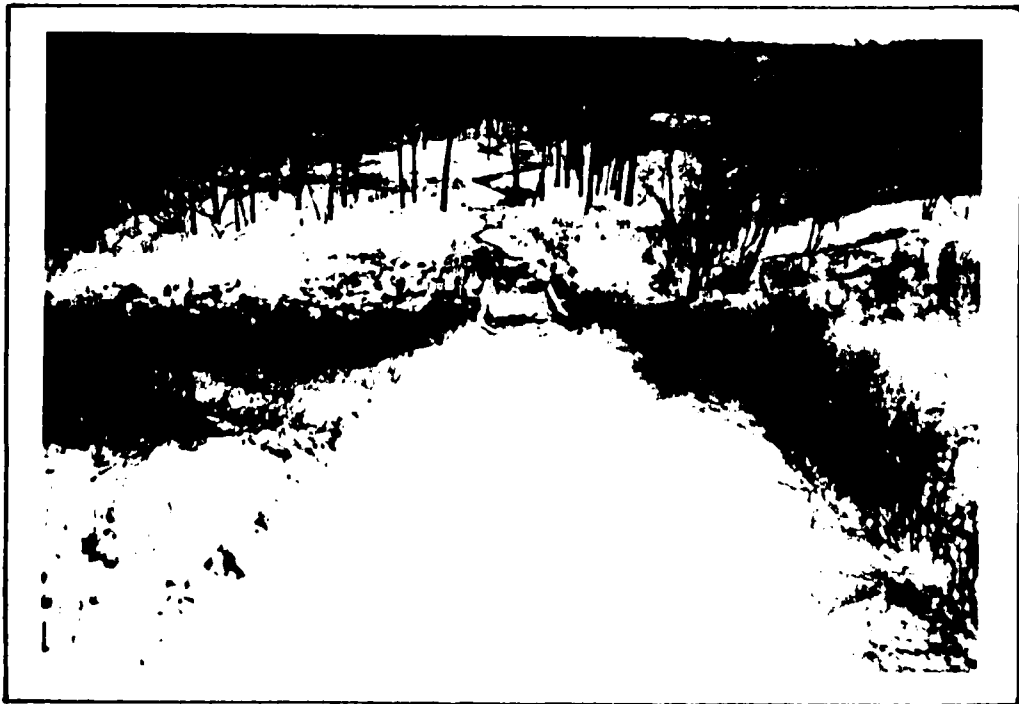
on March 12, 1981, seepage (1 gpm) was observed discharging from a joint on the right side of the spillway discharge chute about 30 feet downstream of the control section of the spillway. No settlement of the individual concrete sections of the chute were noted.

No accumulation of debris was noted in the spillway or in the outlet chute. A small concrete projection is located in the invert at the downstream end of the chute which functions as an energy dissipator. The concrete decked steel bridge over the spillway appears to be in good condition.

The concrete in the discharge channel appears to be in good condition. No settlement was noted in the concrete section. Seepage (1 gpm) was noted coming from the right sidewall of the spillway outlet chute about 30 feet downstream from the top of the dam.

4. LOOKING DOWNSTREAM AT THE SPILLWAY EXIT CHANNEL.

8. Provisions should be made for the emergency closure of the upstream end of the outlet pipe.
9. The adequacy of the energy dissipator at the downstream end of the spillway chute during high discharge conditions should be evaluated.

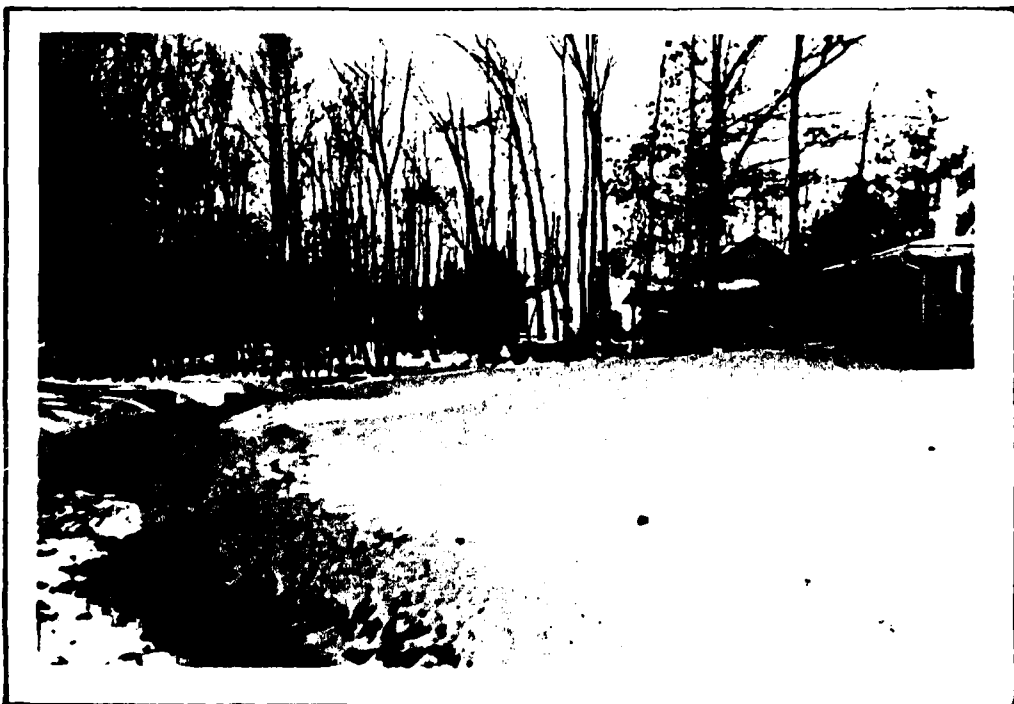
d. Hazard Classification. Five houses which would be affected by the failure of the dam are located within 1,500 feet downstream of the dam. Door sills of the dwellings are as low as five feet above the streambed. Therefore, the dam is classified as a "High" hazard structure due to the potential for the loss of more than a few lives and excessive property damage.

10. POTENTIAL DAMAGE AREA ABOUT 500 FEET DOWNSTREAM OF THE DAM.  
(12/20/80)
