NDI ID PA 00791

SILVER LAKE DAM

PHASE I INSPECTION REPORT
NATIONAL DAM INSPECTION PROGRAM

APRIL 1981

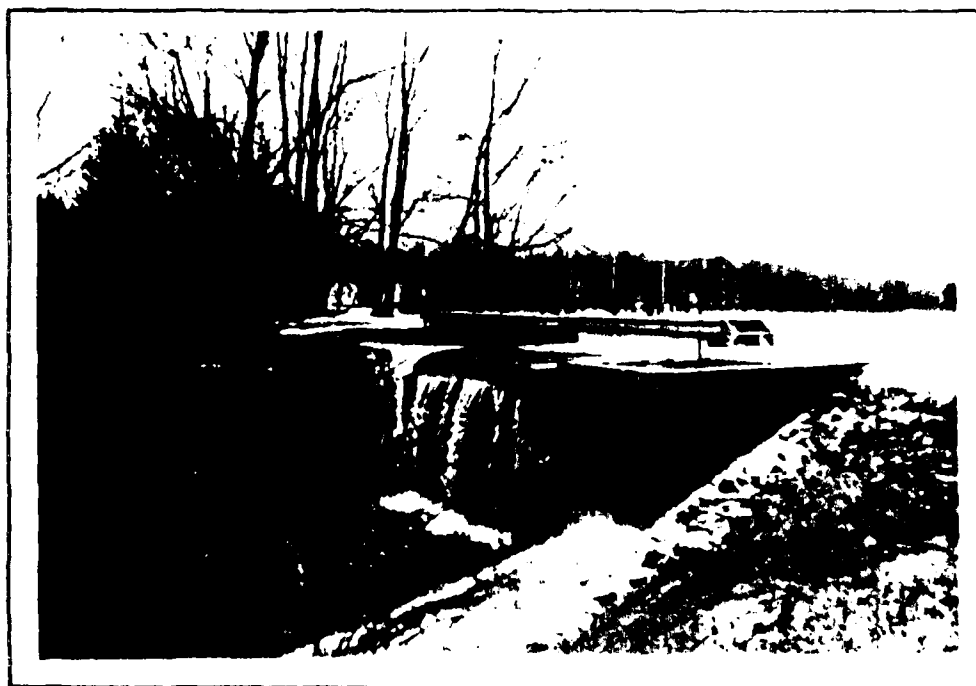
c. Appurtenant Structures. The spillway structure appears to be in good condition. No misalignment was evident in the structure. The exposed concrete surfaces are in good condition. The masonry sidewalls are constructed with relatively large stones. No evidence of joint material deterioration was noted. No seepage through the structure was noted.

The gate chamber structure located immediately to the left of the spillway appears to be in good condition. No spalling or scaling of the concrete was noted. No seepage around the base of the structure was detected.

The overflow waterway is located immediately to the left of the gate chamber structure. The portion of this waterway constructed on the embankment crest is lined with concrete, while the portion constructed on the downstream face of the embankment is lined with grouted riprap. The structure appears to be in good condition. No cracking, settlement or displacement was noted in the concrete or grouted riprap linings.

2. SPILLWAY, CONCRETE BOX OF OUTLET PIPES AND OVERFLOW
WATERWAY IN FOREGROUND. (12/17/80)
